Resolve 60 MW LMZ Steam Turbine Trip Issue During Cooling Water Pump Changeover

Bijay Kumar

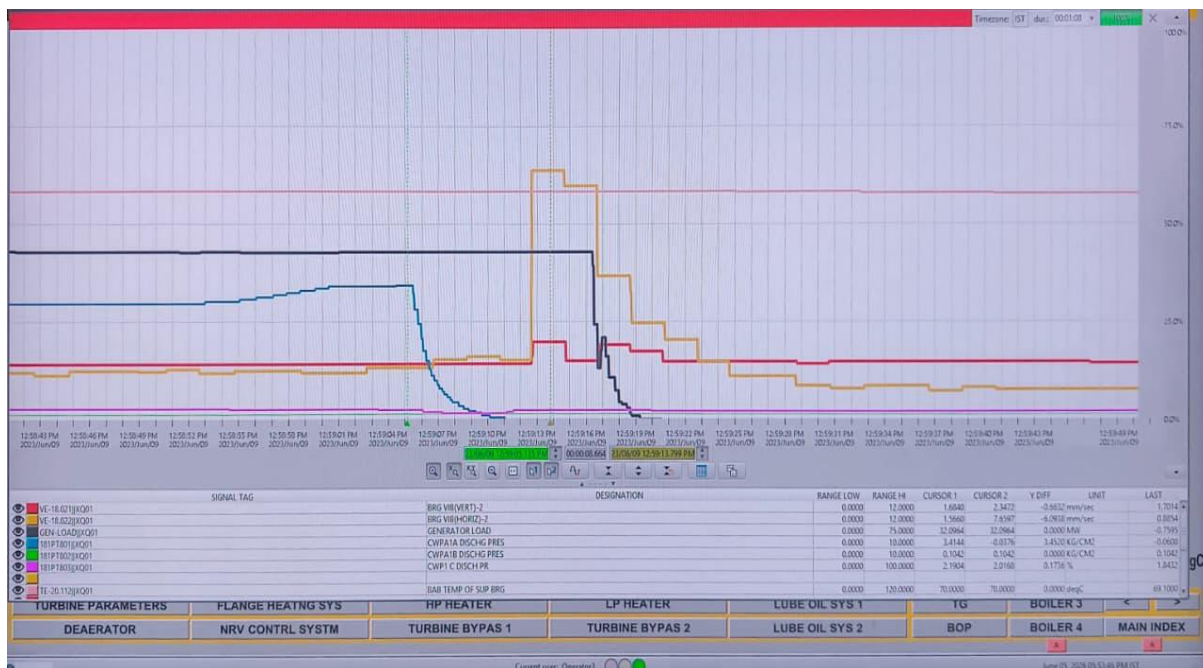
The present case represents such a situation, where vibration 4.5 mmof rear bearing ultimately causing a turbine trip. The below DCS trend show the event:-

- 1) Standby CW Pump-C was started.
- 2) Transfer of condenser cooling duty was initiated.
- 3) Existing CW Pump-A or B was prepared for shutdown.
- 4) Rear Bearing Vibration = 4.5 mm/s
- 5) Time Delay = Approximately 3 Minutes

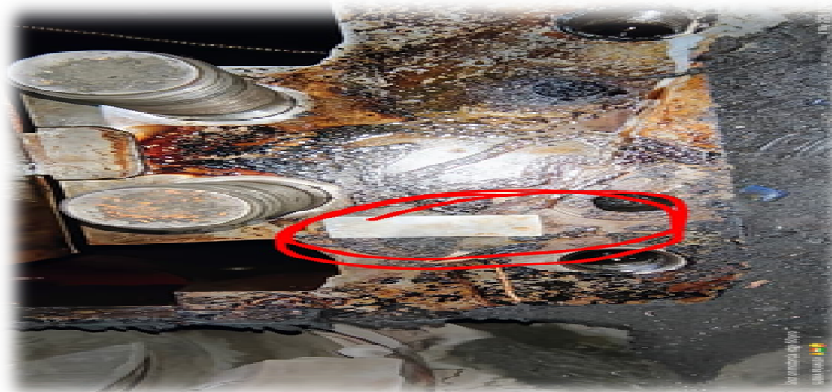
A small piece of shim was observed on the bearing parting plane after dismantling

The presence of a 0.46 mm shim significantly alters bearing geometry.

Latent Cause:0.46 mm shim altering bearing geometry and dynamic characteristics.

- Restore OEM bearing clearances.
- Review necessity of 0.46 mm shim.
- Inspect journal condition.
- Verify rotor alignment.

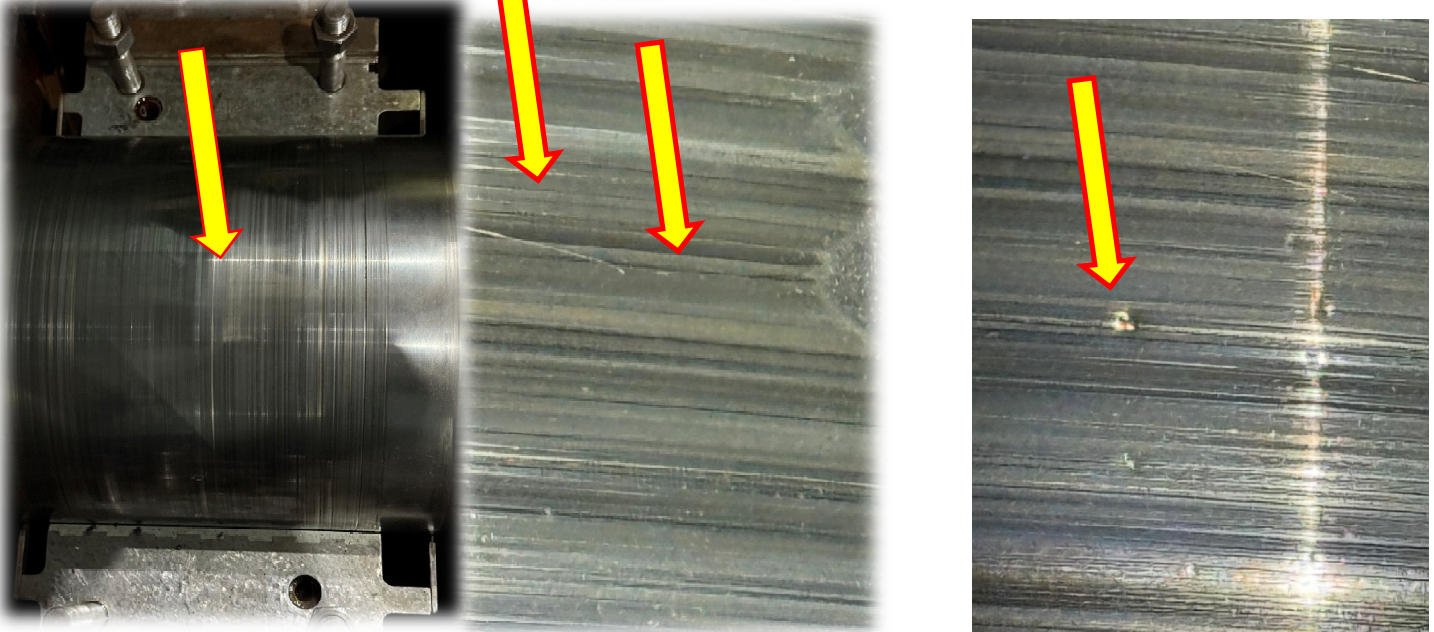
Turbine rotor journal 2 condition

Heavy scar and dent mark lines were observed on the journal, and rubbing was also noted on the bottom half of the bearing. Additionally, the RTD position was found to be slightly below the babbitt material level. The bearing measurements after dismantling are as follows: -

The existing bearing was replaced with a refurbished spare bearing, with the measured Total Oil Clearance (TOC) found to be 0.70 mm. Furthermore, journal polishing was performed using coir rope & fine emery belt to improve maximum surface finish and ensure proper bearing performance.

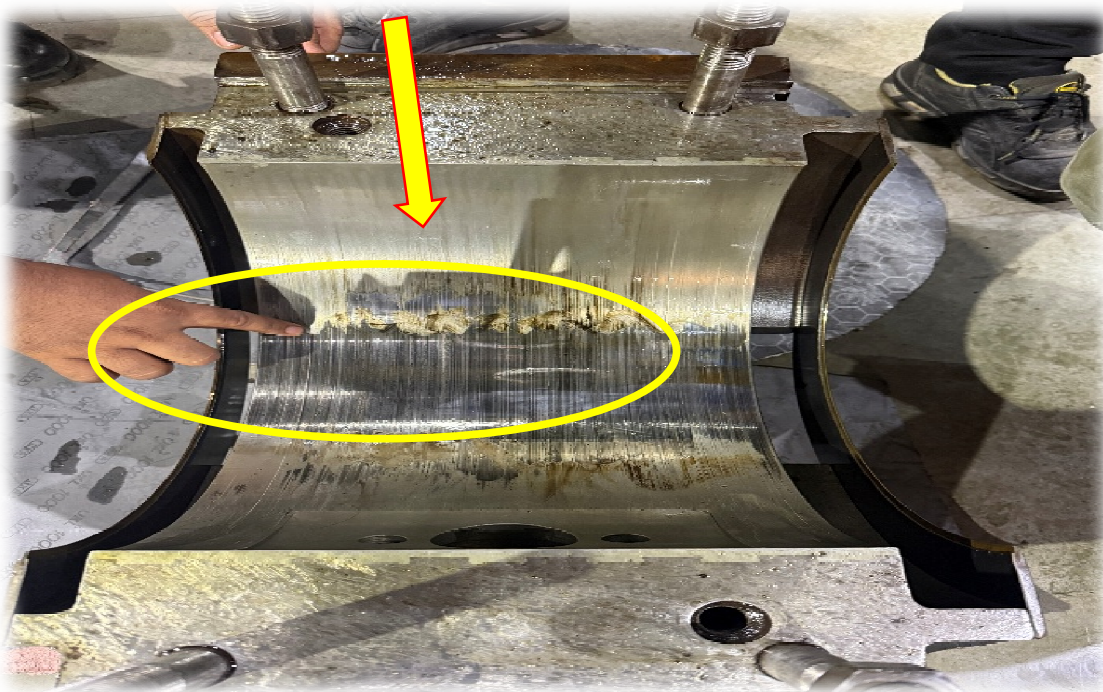
Bearing no 2 bottom porting (Babbitt material dislodged)

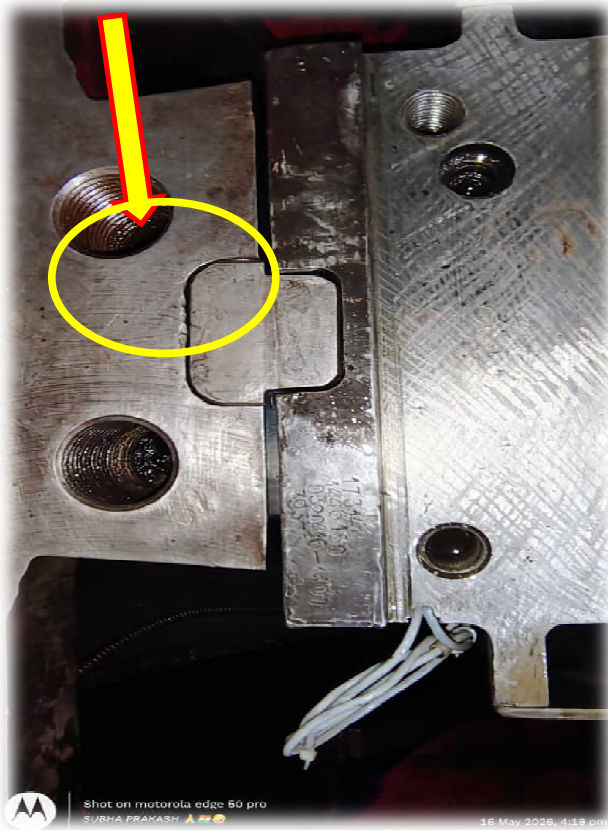
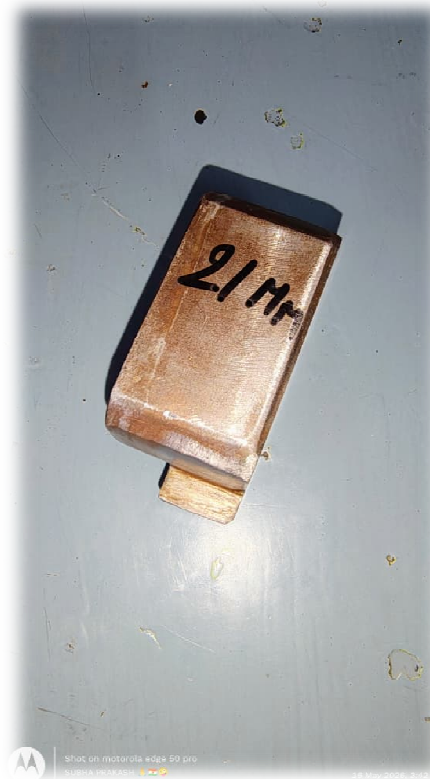
Another observation was that the bearing lock thickness was 9 mm higher. After machining the lock was used during box up of bearing 2.
