A Case Study on Reliability Improvement of New Bar Mill Stand Gearboxes

Ankush Sharma¹, Himangshu S Mandal², T Thirumurugan³, N Rajesh Kumar⁴, Md Perwaiz Kaiser⁵, Rajiv Garg⁶
 One Shared Services Technology Group, Tata Steel Limited, Jamshedpur, 831001, Jharkhand, India

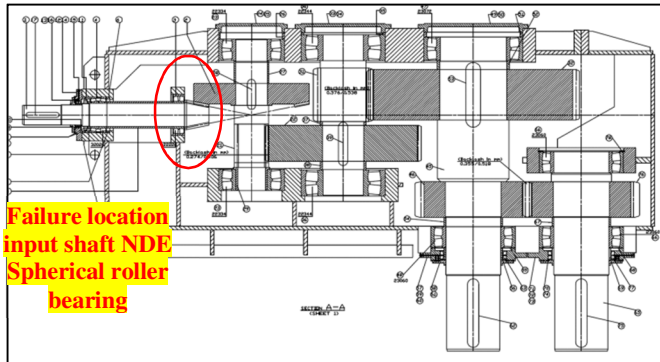
Fig.2 GA drawing of NBM stand 1 Gearbox Fig.3 Failed Bearing of Stand no 1 gearbox.

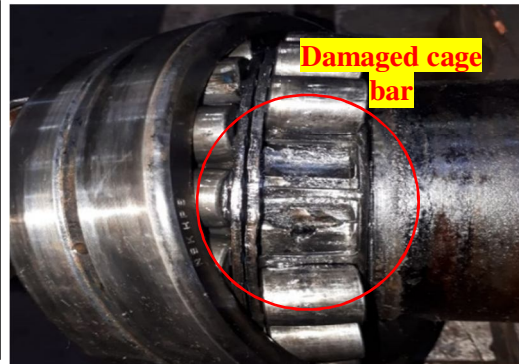
In all the failures of Mill stand gearboxes of NBM in recent past, it has been observed that input shaft bearing was failed and in some cases input shaft gear teeth were also damaged due to misalignment generated post bearing failures. On Spet'2020, NBM stand no 1 vertical gearbox input shaft Non-drive end (NDE) spherical roller bearing was found damaged as inspected through inspection cover after hearing abnormal sound coming from gearbox.

Heating marks were found on bearing rolling elements with cage breakage and few rolling elements came out from cage refer figure 2 & 3. This gearbox (overhauled) failed after giving service life of 1.1 year.

Further due to high number of billets in which peak torque load was found more than rated input torque of gearbox causing the cage failure of input shaft bearing and, in few cases, peak load may cross more than critical 140% of gearbox rated torque which aggravated the cage breakage due to high impact load.

- For all mill stand gearboxes high torque alarm to be given on gear box nominal input torque rating (for example Stand#1 nominal Torque load is 1.65 KNm). If it goes beyond the nominal input torque for 5 seconds, then it will trigger an alarm and auto stoppage of subsequent billet discharge from furnace for 3 minutes.

- Current logic of stand 1 trip at 90 % (2.5KNm) motor torque in case of cold billet to be changed to 78 % (1.91 KNm). Trip command to be generated if stand 1 cross 78 % of motor torque (which is 120% of gearbox nominal torque value) for one second. Tripping of stand#1 in case of cold billet having low temperature will not allow the cold billet to move further in other mill stands thus avoid overloading.

- Gearbox to be procured as per upgraded specification and put in service. Design power rating of the upgraded gearbox should include service factor 2 (or greater than 2) on nominal consumed power rating.

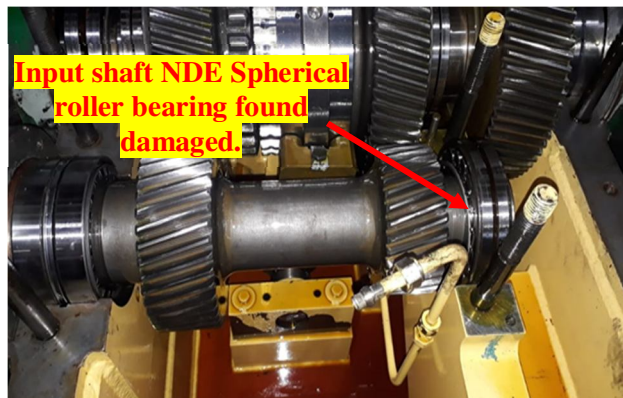
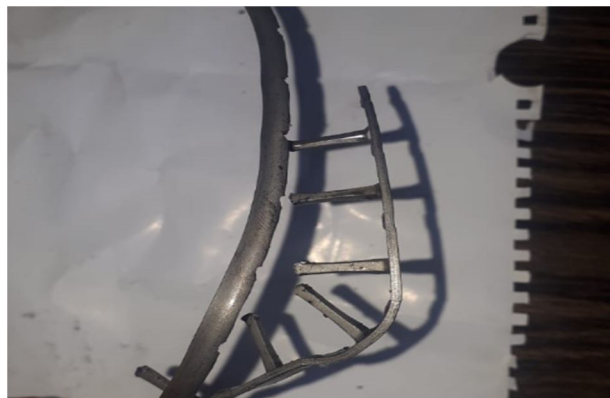
In past also in 2019 abnormal sound was observed during rolling from stand no 16 gearbox. Mill was stopped for inspection of stand no. 16 gearbox by opening the inspection covers and it was found that input pinion shaft NDE spherical roller bearing cage broken refer fig.4 & 5. Similarly, in 2018 Stand no 15-gearbox failed during service with same phenomenon of input shaft NDE bearing damaged & gear teeth damaged refer figure 6. In all the cases the gearbox was failed very prematurely within 2 years. Normally for Mill duty gearboxes ideal TBM is 5 years or more in some cases.

Fig.4 Failed gearbox of stand no 16 Fig.5 Broken cage bar of input shaft bearing of stand no 16-gearbox

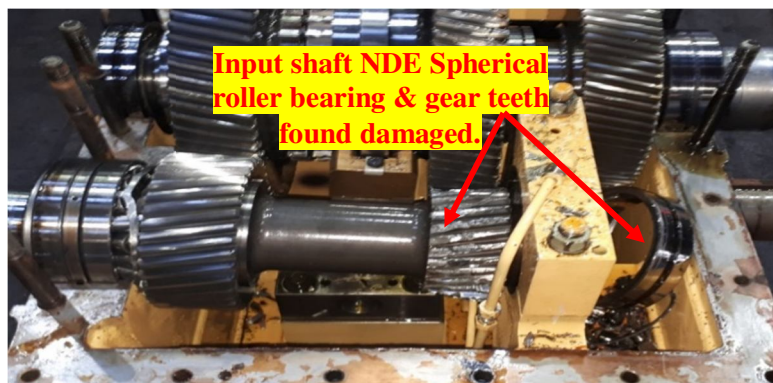
Fig.6 Failed gearbox of stand no 15

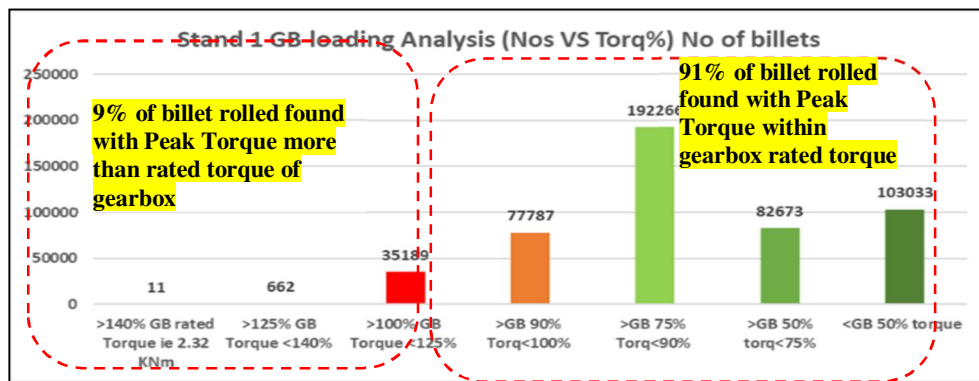
IBA Data was analyzed for all stands during the last one year. The load trend from 01.09.2019 to 22.09.2020 for stand no 1 is plotted in graph trend & given below in figure 7. From below data analysis, it was found that in past one year, there are 35,862 nos. of billet rolled which had peak torque value more than 100% rated input torque of gearbox which constitute around 9% of total billet rolled in a year (i.e. total 4.6 lakh billets) whereas for rest 91% billets peak torque was found within rated capacity of gearbox. As per Mill duty gearbox standard AGMA 6010, only 7 peaks (during start stop i.e. momentarily occasional peaks) are allowed in a day more than rated torque capacity of gearbox. However, there is no standard available for operation peak load more than 100% and it is addressed through proper selection of gearbox. Taking 7 occasional peaks per day, in one year around 2500 occasional peaks are allowed but in this case of stand no 1, number of billets having peak torque more than rated capacity was large in numbers i.e. around 35,862 in which 662 no's of billets were critical cases where peak torque had gone more than 125% of rated input torque & 11 nos. were high impact load cases when peak torque was found more than 140% of rated gearbox torque as shown below in table refer figure 8

Fig.7 NBM Stand no 1 load analysis.

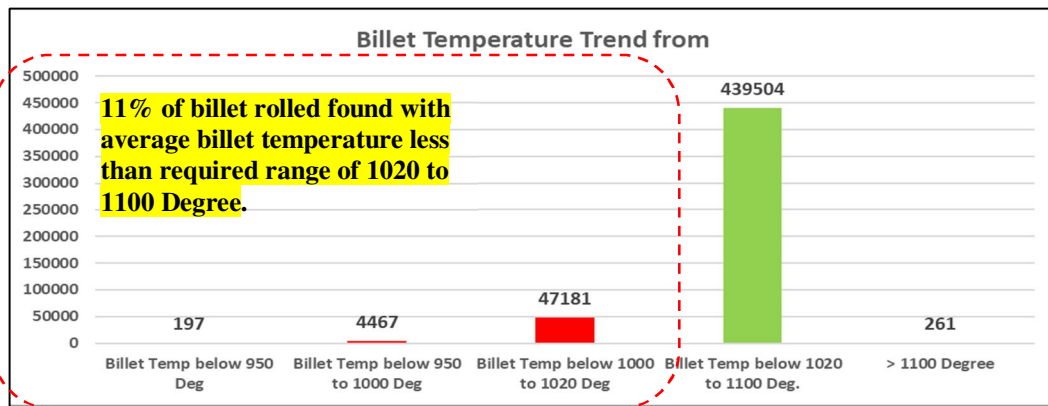
All above 11 nos. critical cases were happened in recent 3 months (i.e between July to Aug'20) and billet temperature was found lower than required range 1020 °C to 1100 °C which means billet soaking & heating was not done adequately and led to high rolling peak torque. Billet temperature trend for last year also plotted below in bar graph as shown in figure

Fig.9 Billet Temperature Analysis

Around 11% of total billet rolled in past one year was found with average temperature less than required range of 1020 °C to 1100 °C which is closer to peak torque cases of 9% in which torque was found more than 100% of the rated capacity of the gearbox.

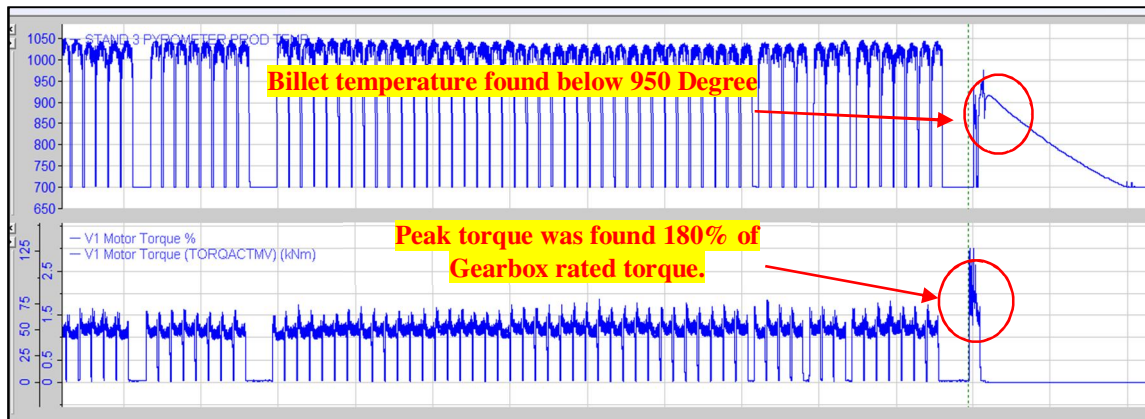
On 25th July at around 11 pm, Maximum peak torque was found 125% of motor Torque ie 3.05 KNm which is equivalent to 180% of gearbox rated torque when the billet temperature found below 950 °C (fig.10).

Such high impact torque load is detrimental for bearings cages & caused initiation of cage breakage.

Fig.9 IBA data Analysis on 25th July'20
