# Exceptional High Rise of Temperature in LV Turret Bolt in Generator Transformer

Gautam Kumar

Hindalco Industries Ltd, India

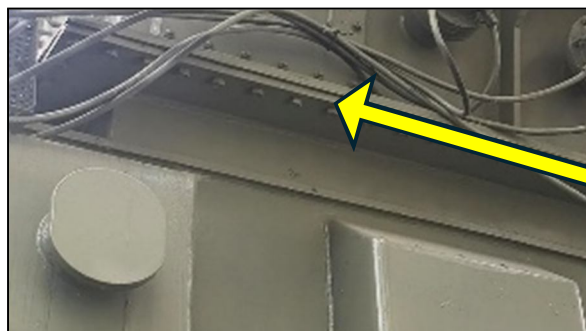
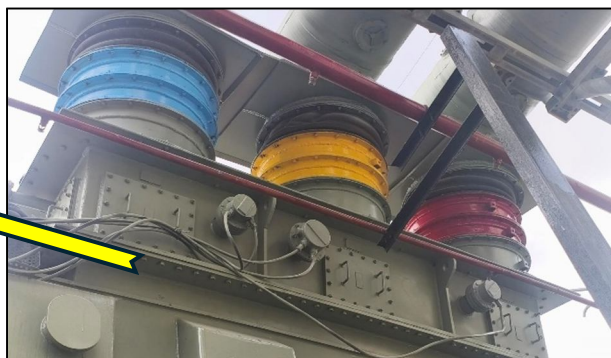
Subsequent thermographic inspection of the LV turret revealed that the temperature of the turret bolts in the affected area was approximately 200°C, which is significantly higher than normal operating limits.

The turret bolt temperature reached 200°C, which is a serious concern since the flash point of transformer oil is approximately 140°C.

Hence it was concluded that the excessive temperature rise in the turret bolt is primarily caused by passage of eddy current, induced by the high LV current in turret structure. The closeness of the turret structure to the current-carrying conductors and the availability of a conductive loop allow circulating currents to develop, which was leading to tank body, through these bolts finally to ground.

Localized concentration of eddy current in a single turret bolt due to unequal current distribution.

The root cause of excessive heating (up to 200°C) in the turret bolt was uneven distribution of induced eddy current, where

- 1) Other bolts had higher contact resistance
- 2) Presence of paint layer acted as insulation
- 3) Only one bolt carried significant induced current

- 5) Surface Cleaning and Equal Current Distribution: On studying the turret design, it was observed that multiple bolts (total 96 nos.) are provided, intended to collectively share any induced current. However, it was found that only one bolt was carrying a major portion of the current, as it was offering the lowest resistance path.

Subsequently, bolts were removed in pairs, and the contact surfaces of the turret were cleaned. It was discovered that paint on the turret surface was acting as an insulating layer, preventing uniform current distribution. After proper cleaning and ensuring good electrical contact, all bolts started participating in current sharing, thereby eliminating localized current concentration.

After removing the insulating effect and ensuring proper metallic contact across all bolts, the induced current was evenly distributed, thereby eliminating localized overheating.
