Experimental Analysis and Mitigation of Soft Foot in Induction Motors

Sushil Sharma

Condition Monitoring- Manager, Technical Services Department, Hindalco Mahan Singrauli, 486886, India

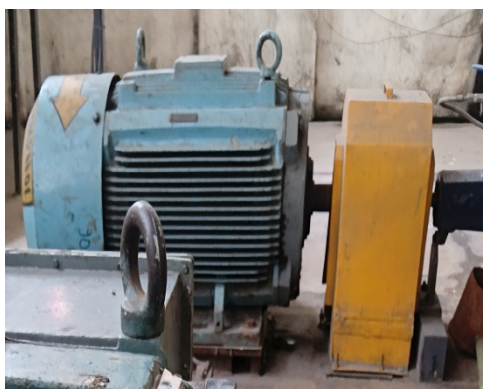
Fig-1(Service water pump)

Hindalco Mahan service water pump was having high vibration issue and heavy noise reported from motor side this motor sound was very high, so motor no load trial was taken even at motor no load condition vibration level was very high and sound was also coming from motor inside and high vibration amplitude at motor side was observed 12.8 mm/s in no load condition.

Motor coast down test was done in which motor vibration was observed during running 12.8 mm/s but as motor power was stopped this vibration immediately down to 1.5 mm/s which indicated the electrical issue with motor.

Service Water Pump (Solo trial)			
V_{rms} (mm/s)			
	H.	V	A
Motor NDE	10.6	3.0	4.9
Motor DE	12.8	6.5	4.9

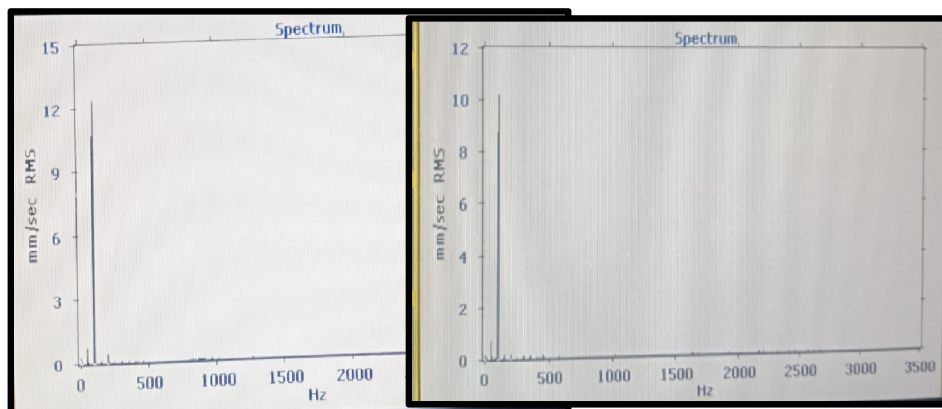
Fig-2(Motor DE side spectrum)

This issue was related to motor stator and rotor issue as per vibration spectrum analysis motor 2X line frequency was observed (100 hz) as shown in fig-1 and Fig-2.

This 2X line frequency many times observed in case of soft footing condition with equipment so equipment soft footing and blue matching was observed missed at some locations during inspection.

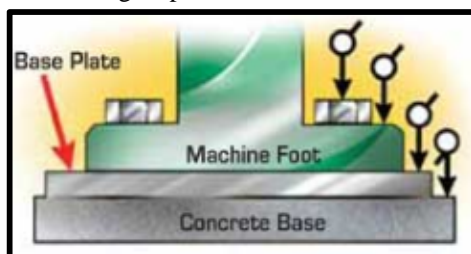
Fig-4 (Motor base vertical phase measurement)

Phase analysis showing 90 to 180 deg phase measurement between vertical measurements at bolts, motor foot, base plate and concrete base.

During phase analysis at motor base it was 180 Deg and vibration at different foots was observed different which was the indication of severe misalignment and soft footing condition and causing the magnetic force imbalance in motor resulting high vibration and noise at motor side.

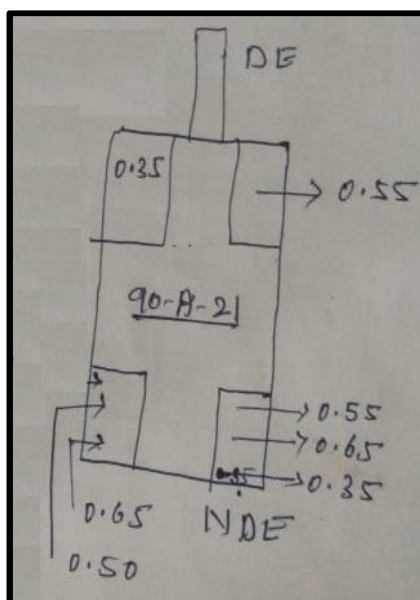
Fig-5 (Motor base blue matched readings)

As shown in Fig-4 and Fig-5 it is very clear that soft footing was inspected through blue matching of motor foot which is not accurate and is found out of limit at many location. Max. blue matching out was observed 0.65 mm at 2 locations which was creating the heavy soft footing and due to this rotor and stator air gap become uneven and magnetic field become uneven resulting high vibration and noise at motor in no load condition.

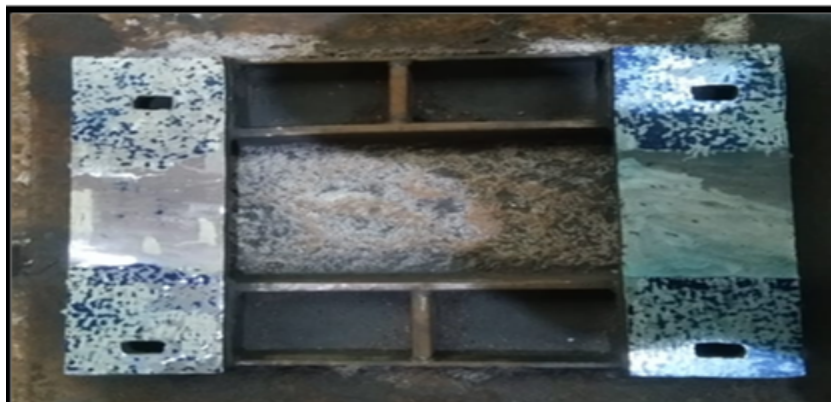
Fig-6 (Motor all 4 foots blue matching)

With vibration spectrum and signature analysis it was clear that 2X line frequency was dominant which is the indication of motor stator and rotor issue. During blue matching test blue matching was out 0.65 mm at 2 locations due to this soft footing was there and soft footing was reason for this rotor and stator condition.

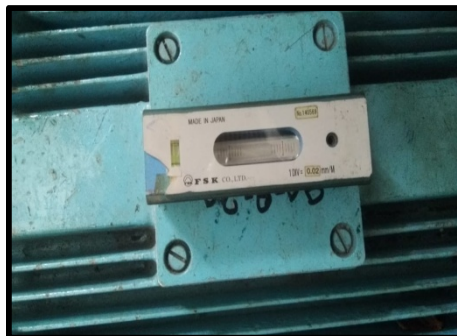
Fig-7 (Master level of motor)

Master level at motor foots and motor base was also observed out that was 0.8 mm.

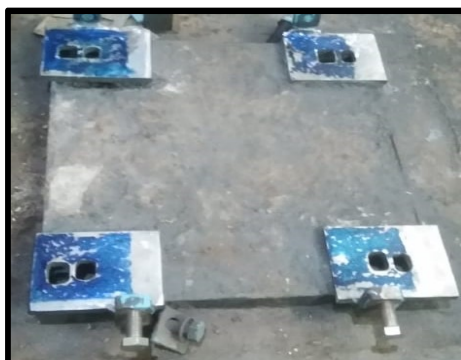
Fig-8: Blue matching after correction

After correcting the soft footing condition and proper blue matching as shown in Fig-8 vibration level reduces from 12.8 mm/s to 0.8 mm/sec at motor DE side and 10.8 mm/s to 1.8 mm/s at motor NDE side location.

As shown in Fig-8 and Fig-9 blue matching was corrected and proper alignment was done.

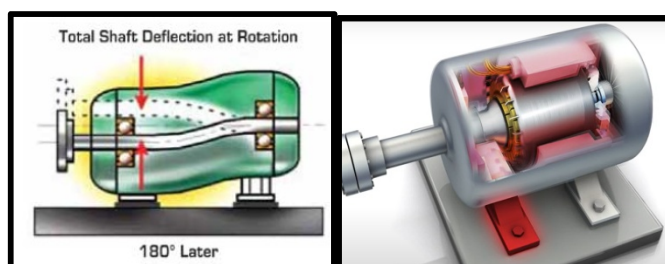
Fig-10 (Rotor shaft deflection at rotation) Fig-11(Uneven Air gap and magnetic field)

In electric motors, soft foot distorts the frame, which in turn can distort the stator magnetic field. This creates unbalanced electrical forces between the rotor and the stator magnetic field this unbalance force between rotor and stator causes high vibration and heavy noise this unbalance force is due to uneven air gap because rotor centre line and stator centre line does not coincide as shown in fig-10 and Fig-11.

This is the reason why soft footing causes distortion in rotor, unbalance magnetic field, Air gap and heavy noise.
