Failure Analysis of Drive Spindle Sleeve of Finishing Mill of Hot Strip Mill

Abstract: This paper analyses the failure of a bottom spindle head sleeve in a finishing mill stand. The sleeve, manufactured by Mill OEM and installed in 2022 (after overhauling), exhibited fatigue cracking after approximately 2.9 years of service. Metallurgical analysis revealed lower hardness and microstructural changes in the interphase weld zone, stemming from multiple previous refurbishments involving hard facing. Repetitive welding during these overhauls induced thermal cycles, leading to softening of the parent material and ultimately, fatigue failure. Finite Element Analysis (FEA) showed that stress levels at the failure location remained within the acceptable range at rated load but exceeded the safe limit at peak loads (150% of rated current). Recommendations include improved supplier oversight, enhanced quality assurance procedures for overhauling, and a more robust maintenance protocol to prevent recurrence.

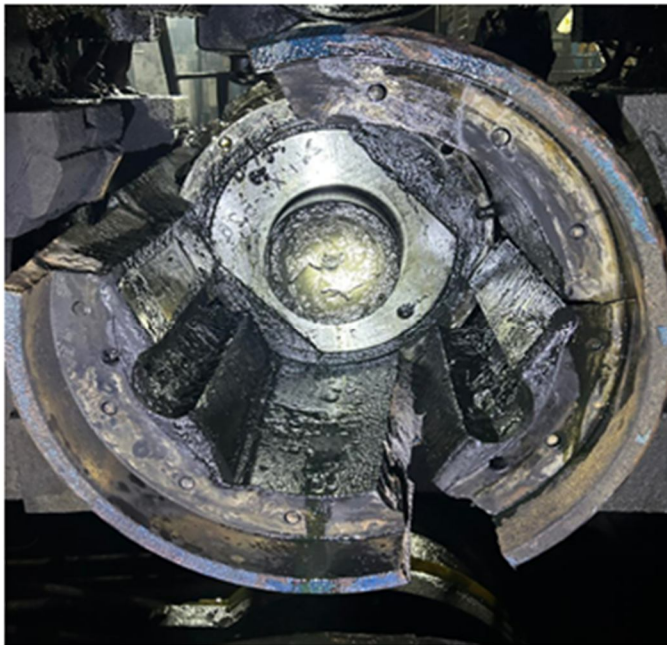
During dismantling of sleeve unit from spindle, sleeve was found cracked at 3 nos of location as shown below in figure 2 and 3. Visual observation of fracture surface indicates, crack has been initiated from wear pad of sleeve. These wear pads are coming in direct contact of work roll neck for transmission circular motion. These wear pads have case hardened as shown in drawing in fig.7. Fracture surface indicating, fatigue crack generated nearby wear pad portion a shown below in fig 8. These were refurbished sleeves of spindle. Exact purchase date of these spindles was not available. this spindle sleeve had undergone 5 no's overhauling. In each overhauling sleeve wear pad window distance were measured and if found out of tolerance limit it was sent to supplier for refurbished. In refurbishing hard facing of wear pad were done as per procedure. There is no TBM based discarding criteria of these sleeves presently in department. Spindle head changed based on CBM (wear measured in spindle sleeve if found out of tolerance limit, sleeve send for refurbishment).

Fig.2 Sleeve found cracked at 3 nos of location

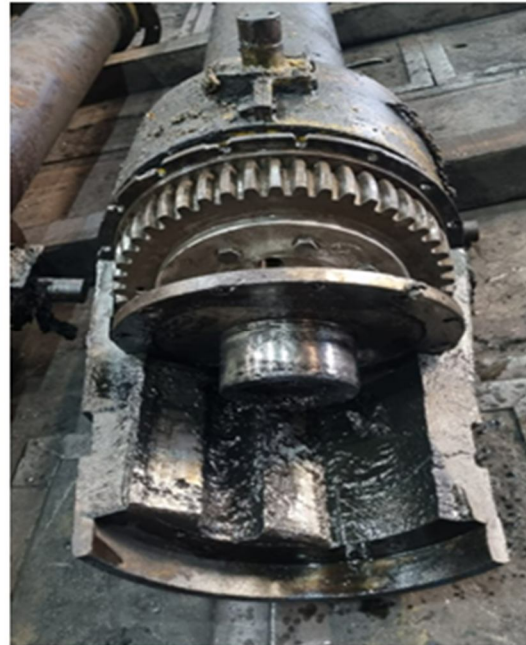
Fig.3 Cracks found nearby wear pad zone

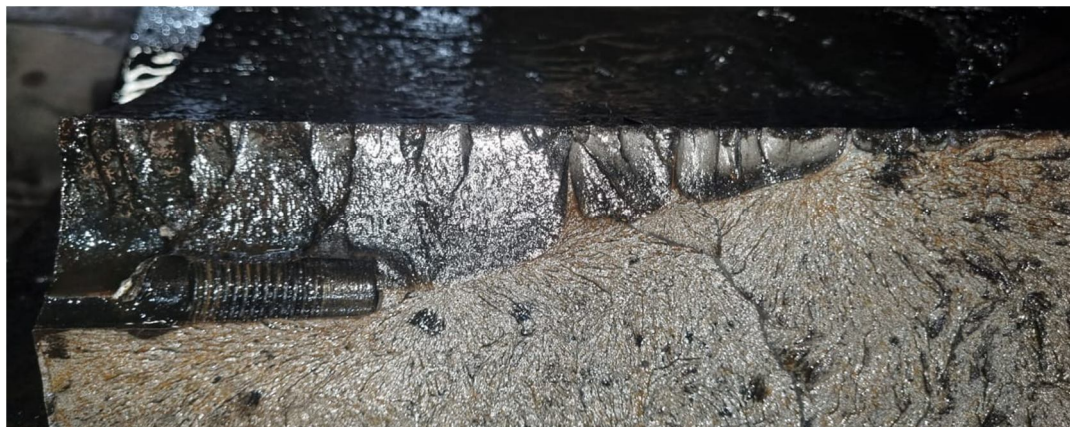
Fig.4 Fatigue crack initiation nearby wear pad of sleeve

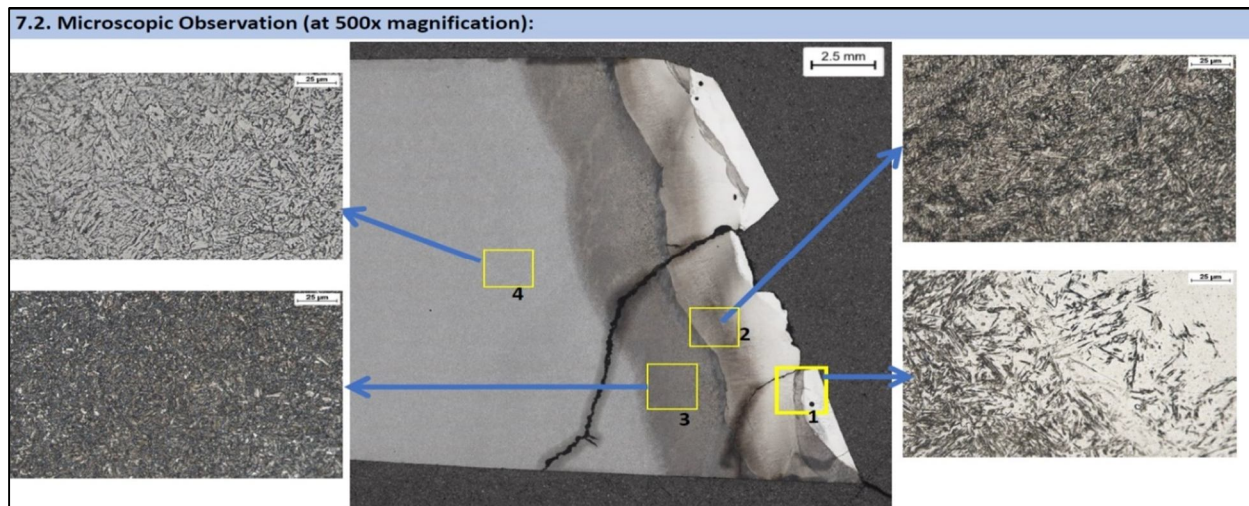
Failed sleeve is refurbished one. This spindle sleeve had undergone 5 no's overhauling. In each overhauling sleeve wear pad window distance were measured and if found out of tolerance limit it was sent to supplier for refurbishment. In refurbishing hard facing of wear pad were done as per procedure. After machining of wear pad zone final UT inspection done for cracks. Presently there is no limit for number of overhauling for these sleeves. However, metallurgical analysis indicated there was lower hardness & microstructure change found around inter phase weld zone as shown below in figure 6 & 7. Overall metallurgical report confirmed, etched microstructure of cladded zone revealed untampered martensite structure. Interphase revealed fine tempered martensite structure. Base material revealed mixture of tempered and bainite structure. Hardness profile also measured from cladded zone to base material. Cladded zone hardness is found around 50-54 HRC, inter phase zone hardness found around 175 BHN, Parent material hardness found 270 to 260 BHN. Multiple cracks observed originated from cladded zone and propagated towards base material.

From above analysis, it can be concluded that repetitive welding in repetitive overhauling can indeed cause softening of the parent material, because of Thermal Cycles, Heat-Affected (inter phase) Zone (HAZ), Microstructural Changes, Grain Growth. The softening of the parent material due to repetitive welding can have significant consequences, including like Reduced Strength, Increased Risk of Failure. To mitigate these effects, it's essential to Optimize Welding Parameter, Use Proper Welding Techniques, monitor parent Material Properties like hardness & microstructure and Consider Post-Weld Heat Treatment.

Fig.6 Fatigue crack initiation nearby wear pad of sleeve.

- 1) Communicate overhauling defects and low hardness issues to the supplier.
- 2) Develop a comprehensive Overhauling Quality Assurance Plan (QAP) for spindle sleeves, including:
 - DPT and UT inspections after removing the hard face layer.
 - In-situ microstructure and hardness checks of the parent sleeve body.
 - Rejection criteria based on abnormalities.
 - Hardness criteria for interphase/parent material.
 - Complete test certificates, including post-weld heat treatment data.
 - Specifications for welding electrode type, size, and number of layers.

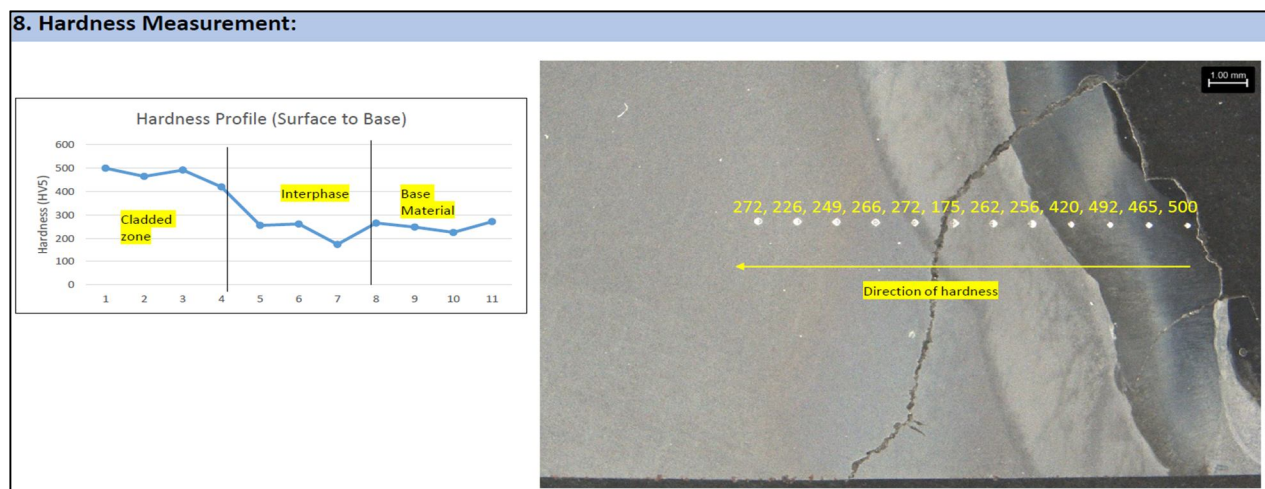
Fig.7 Hardness measurement of cladded portion.

From all above analysis, it is concluded that lower inter phase zone hardness (around 175 BHN) than parent material base hardness of spindle sleeve (270 to 290 BHN) and microstructure change from base material mixture of tempered and bainite structure to interphase weld zone (HAZ) having fine tempered martensite structure caused fatigue cracks to initiate and caused complete failure. Low hardness and microstructure change at inter-phase (HAZ) zone caused by inadequate post welding heat treatment (overhauling defect).
