Failure Analysis of Drive Spindle Sleeve of Finishing Mill of Hot Strip Mill

Abstract: This paper analyses the failure of a bottom spindle head sleeve in a finishing mill stand. The sleeve, manufactured by Mill OEM and installed in 2022 (after overhauling), exhibited fatigue cracking after approximately 2.9 years of service. Metallurgical analysis revealed lower hardness and microstructural changes in the interphase weld zone, stemming from multiple previous refurbishments involving hard facing. Repetitive welding during these overhauls induced thermal cycles, leading to softening of the parent material and ultimately, fatigue failure. Finite Element Analysis (FEA) showed that stress levels at the failure location remained within the acceptable range at rated load but exceeded the safe limit at peak loads (150% of rated current). Recommendations include improved supplier oversight, enhanced quality assurance procedures for overhauling, and a more robust maintenance protocol to prevent recurrence.

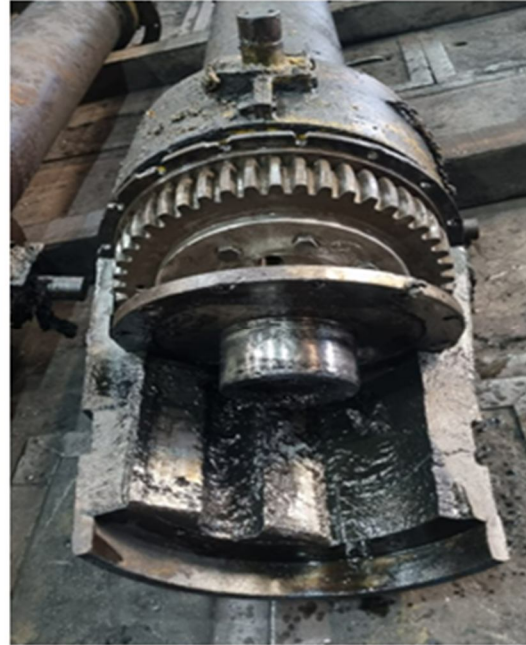
Fig.3 Cracks found nearby wear pad zone

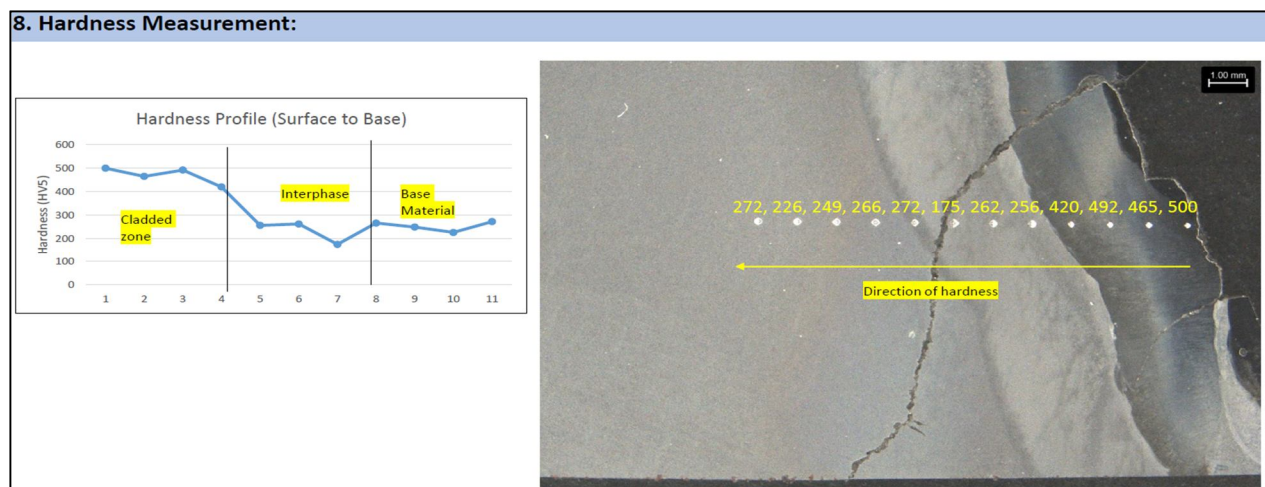
Fig.7 Hardness measurement of cladded portion.

Supplier test certificate was checked, only few parameters were checked like wear pad zone hardness, dimensions & UT inspection of wear pad zone. Rest test reports like parent hardness checking after machining wear pad zone, thorough UT of complete sleeve shell before welding, Post-Weld Heat Treatment graphs were missing as per Reconditioning procedure for HSM spindle sleeves. Thus, it can be concluded that lower inter phase zone hardness (around 175 BHN) than parent material hardness (270 to 290 BHN) and microstructure change from base material mixture of tempered and bainite structure to Interphase area having fine tempered martensite structure caused fatigue cracks to generate and failure. Further low hardness & microstructure change at inter phase zone caused because of inadequate post welding heat treatment.

From all above analysis, it is concluded that lower inter phase zone hardness (around 175 BHN) than parent material base hardness of spindle sleeve (270 to 290 BHN) and microstructure change from base material mixture of tempered and bainite structure to interphase weld zone (HAZ) having fine tempered martensite structure caused fatigue cracks to initiate and caused complete failure. Low hardness and microstructure change at inter-phase (HAZ) zone caused by inadequate post welding heat treatment (overhauling defect).

- 1) Communicate overhauling defects and low hardness issues to the supplier.
- 2) Develop a comprehensive Overhauling Quality Assurance Plan (QAP) for spindle sleeves, including:
 - DPT and UT inspections after removing the hard face layer.
 - In-situ microstructure and hardness checks of the parent sleeve body.
 - Rejection criteria based on abnormalities.
 - Hardness criteria for interphase/parent material.
 - Complete test certificates, including post-weld heat treatment data.
 - Specifications for welding electrode type, size, and number of layers.
