# Health Assessment and Rehabilitation of an Existing Stone Masonry Dam - A Case Study

Nisheeth Agnihotri<sup>1</sup>, Ravi Agarwal<sup>2</sup>, N.P. Honkanadavar<sup>3</sup>

<sup>1</sup>Scientist 'C', Central Soil and Materials Research Station (CSMRS), New Delhi

The present study inculcates the rehabilitation work carried out for Chandpatha Dam, Shivpuri district (M.P.). The Chandpatha dam was constructed on river Barai in between 1915-1918. The project is situated near Shivpuri town in Madhav National Park about 100 km from Gwalior. Madhav Lake is about 3 km at downstream side of this dam from where drinking water is supplied to Shivpuri. Chandpatha Dam is 2164m long stone masonry dam with catchment area 72.52 km<sup>2</sup> and submergence 213ha. It has two under sluices to provide water into Madhav Lake from where drinking and irrigation water is supplied to Shivpuri district. The total length and maximum height of stone masonry dam is 2164m and is 13.87m respectively.

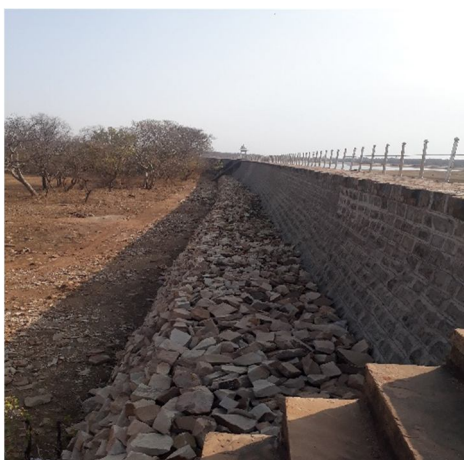
(a) Construction of Gabion wall 2a

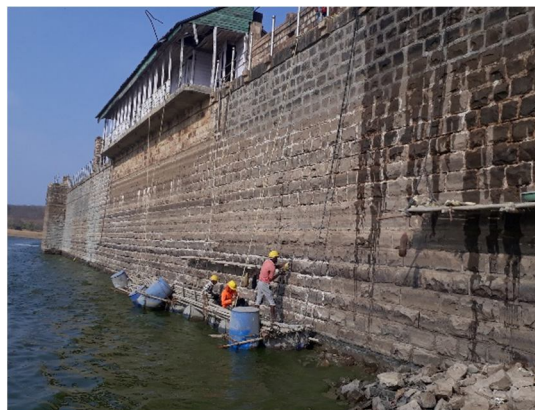
(b) Surface preparation at dam u/s 2b

Surface Preparation activity at site was performed with necessary care so that the stone masonry joints having good appearance remain unaffected during the process, the masonry joints of reaches having seepage, were cleaned using surface grinder and all loose eroded mortar, fungus, algae, oil etc. were removed followed by flush jetting at low pressures.

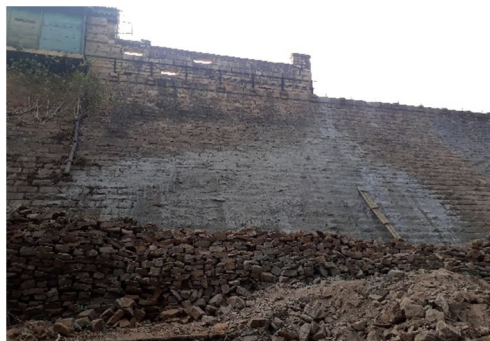
(c) Horizontal grouting from dam d/s 2c

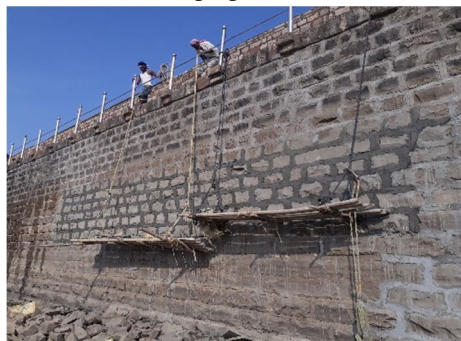
(d) Pointing with crytalline mortar at dam u/s 2d
