# Health Assessment and Rehabilitation of an Existing Stone Masonry Dam - A Case Study

The present study inculcates the rehabilitation work carried out for Chandpatha Dam, Shivpuri district (M.P.). The Chandpatha dam was constructed on river Barai in between 1915-1918. The project is situated near Shivpuri town in Madhav National Park about 100 km from Gwalior. Madhav Lake is about 3 km at downstream side of this dam from where drinking water is supplied to Shivpuri. Chandpatha Dam is 2164m long stone masonry dam with catchment area 72.52 km<sup>2</sup> and submergence 213ha. It has two under sluices to provide water into Madhav Lake from where drinking and irrigation water is supplied to Shivpuri district. The total length and maximum height of stone masonry dam is 2164m and is 13.87m respectively.

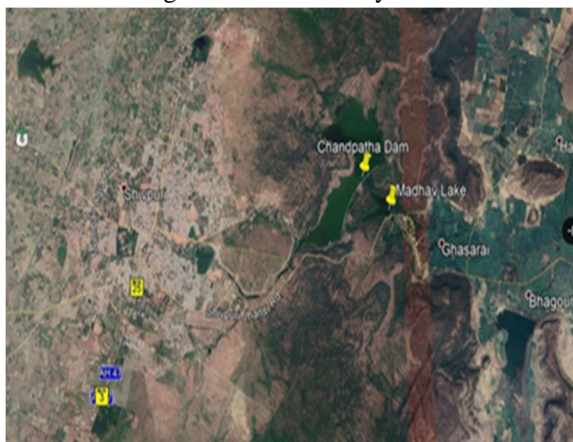
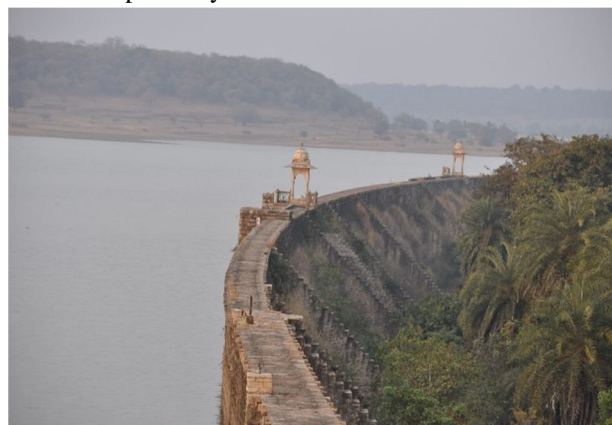
Fig.1 Chandpatha Dam

The rehabilitation was done under Dam Rehabilitation and Implementation Project (DRIP-I) funded by the World Bank, as the dam was facing several issues which could result into safety hazards. The major distress in dam was observed in terms of seepage/leakage from downstream of dam body, which was critical in few reaches. In addition, to blocked/non-functional sluice gates, revised maximum flood and provision of automated gates at left bank and provision of handrails at dam top are also considered as part of comprehensive rehabilitation scheme.

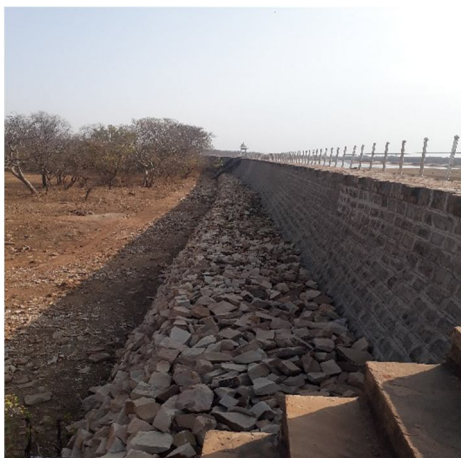
(a) Construction of Gabion wall 2a

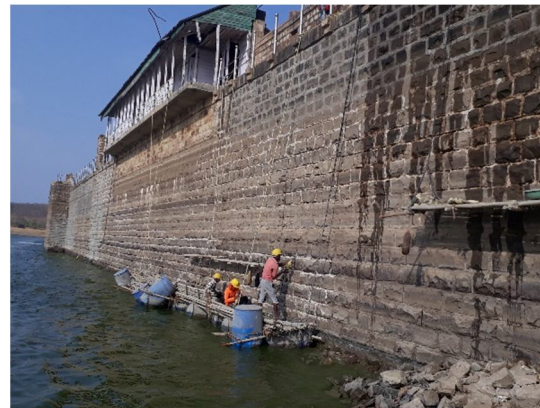
(b) Surface preparation at dam u/s 2b

Surface Preparation activity at site was performed with necessary care so that the stone masonry joints having good appearance remain unaffected during the process, the masonry joints of reaches having seepage, were cleaned using surface grinder and all loose eroded mortar, fungus, algae, oil etc. were removed followed by flush jetting at low pressures.

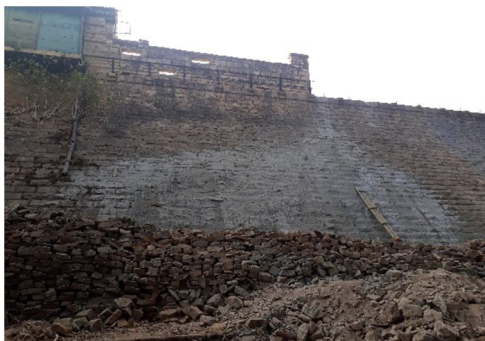
(c) Horizontal grouting from dam d/s 2c

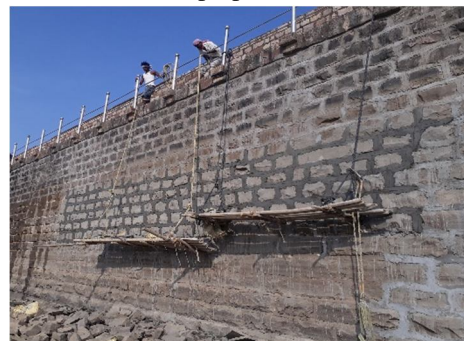
(d) Pointing with crytalline mortar at dam u/s 2d

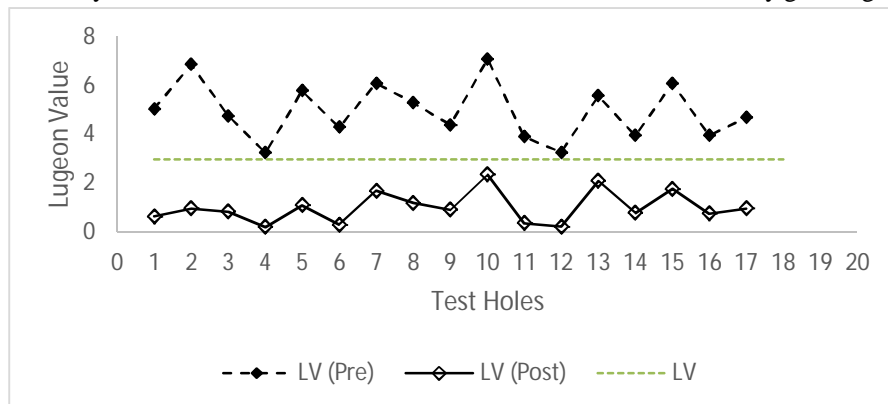
Fig.10 WPT results comparison of pre-grout and post-grout stages in dam body grouting

The water permeability test (WPT) was performed for critical reaches where dam body grouting was executed. The pre-grout and post grout WPT results in Lugeon were determined and analysed for individual test holes. The pre-grout Lugeon value ranged between 3.26 and 7.1. However, post grout for all test holes results were observed under 3.0 as recommended in IS 6066. The pre and post grout water permeability test results in accordance with test holes for vertical dam body grouting are presented in Fig.10.
