Prevention of Damages & Accidents in PSC I-Girders during Stressing & Erection Works

Abhijit Mangaraj¹, Nitin Bobade², Ananya P. Parida³

Department of Civil Engineering, Gandhi Institute For Technology Autonomous

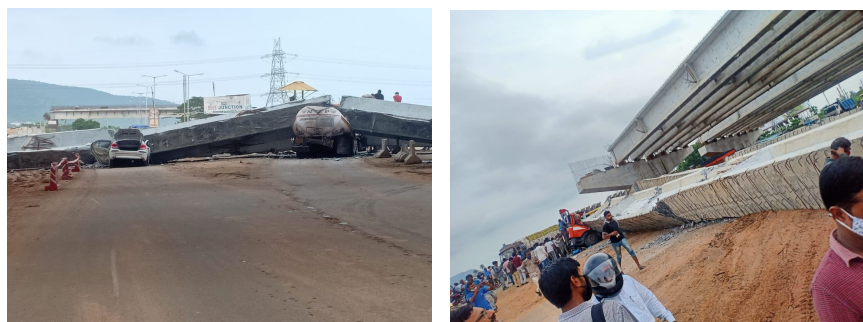
Fig 1.1:- Anakapalli AP NH-16 Flyover Girder Collapse On 6-Jul-2021

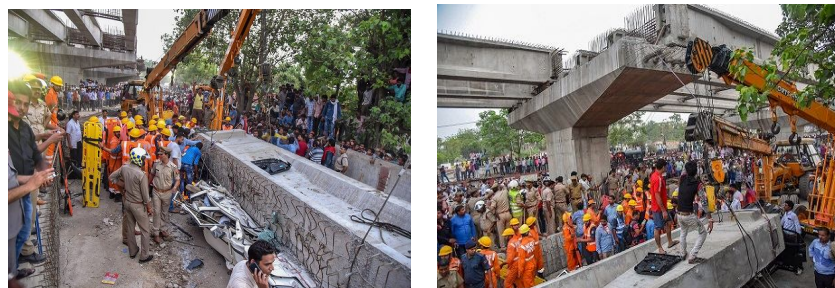
Fig 1.2:- Varanasi UP Flyover Girders collapse on 15-May-2018

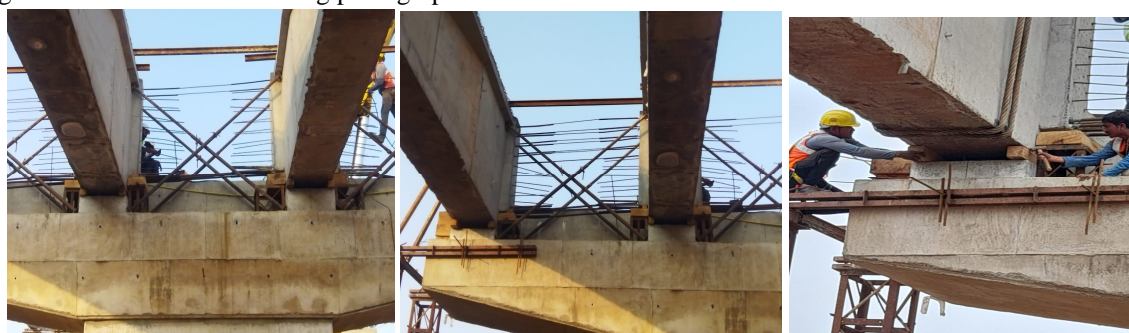
Fig 1.3:- Supporting arrangement of PSC Girdes (3 Photos)

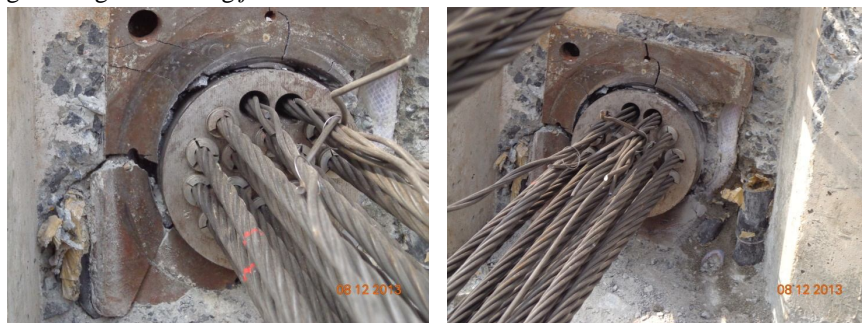
In one case extra ducts were inserted by Site Engineer for the provision of bearing top sleeves grouting. Due to these ducts cavity forms and hollow portion remain inside the girder resulting in insertion of Anchor Head inside girder during stressing. This effect & effect due to cavitation is shown in following photos.

- a) Congestion & lapping of steel at End Block portion.
- b) Provision of unwanted ducts within End Block portion
- c) Improper placing, sequencing, vibrating & curing of Girder Concreting.
- d) Concrete slurry leakage through shuttering joints.

Fig 2.1:- Failure due to cavitation & grouting ducts (Anchor Cone Puncture)

- a) Lapping of steel shall not be provided in end block portion.
- b) Other than sheathing, no ducts shall be provided in end block portion.
- c) During concreting utmost care shall be taken for placing, sequencing, vibrating & curing of concrete. Form vibrators must be additionally used.
- d) Before stressing cavitation, honeycombs around anchor cones and in end block portion must be ensure by hammer ringing test. If any cavitation or honeycomb detect, then grouting of concreting with suitable material must be carried out prior to stressing.
- e) Additional MS square plate can be provided after approval from Engineer-in-Charge.

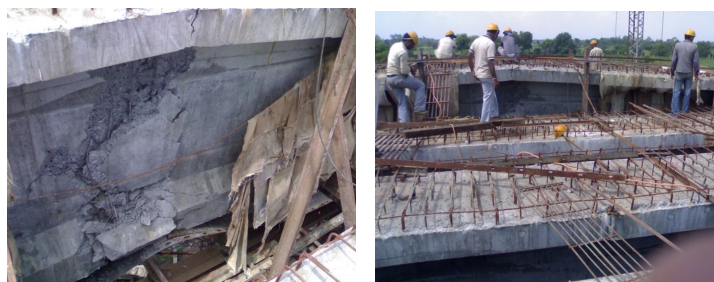
Fig 3.1:- Crushing of concrete at weak flexural zone due to insufficient conc strength

- a) Improper pouring sequencing, placing and vibrating the concrete.
- b) Holding pipe of pump/ boom placer or mouth of concrete bucket over the steel reinforcement resulting in segregation of course aggregates from concrete mix.

- a) Proper pouring sequencing, placing & vibrating of concreting strictly followed.
- b) Pump/ boom placer pipe & concrete bucket mouth shall not hold over the steel reinforcement, to avoid the segregation of concreting.
- c) Strict concrete quality control shall be followed.

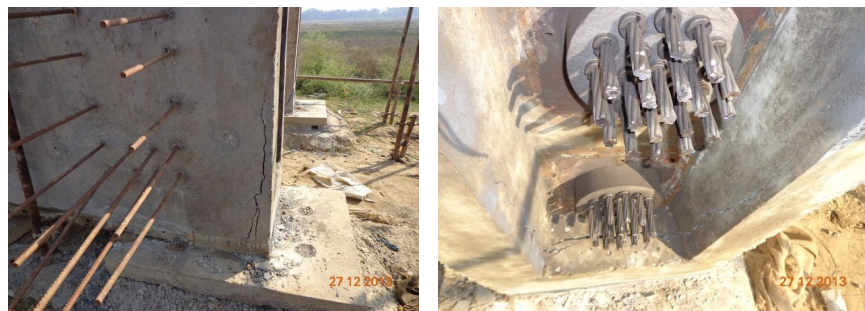
During stressing due to application of high compressive stresses, girder tends to hogging and after full stressing upward deflection of girder (Hogging) is observed at mid-section, and about 70% of girder length remains unsupported due to thus upward deflection. Hence complete girder load came at end block portion of the PSC Girder. Due to this excessive load at end block, end portion of girder tends to move downward in casting bed. If casting bed is rigid at ends, then skin portion of girder soffit and edges cracked, which damages the girder. Sometimes anchor cones get affected in this stage. Cracking & damages due to this cause are shown in photograph.

- a) Providing rigid casting bed at End Block portion of the Girder.

Fig 4.1:- Removal of Girder Concrete skin due to Rigid casting bed at End Block portion.

- a) Providing semi-rigid or flexible bed at End Block portion of the girder.
- b) If rigid bed provided for casting, then prior to stressing convert the End Block Bed into semi-rigid or flexible type by wooden blocks.

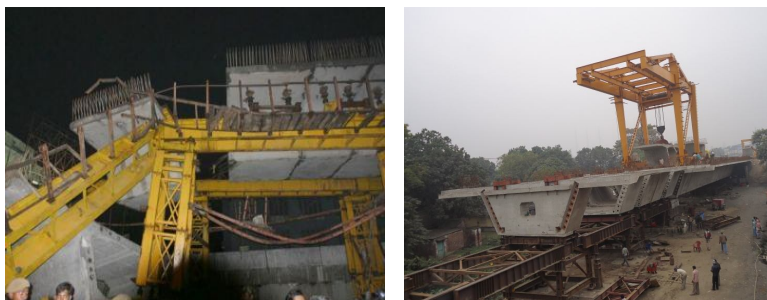
- a) Insufficient compaction of beds for casting, staging & launching platforms.
- b) Unknown presence of pipe lines, storm water drainage, drainage tunnels etc.
- c) Water leakage below beds.

Fig 5.1: (a) Hyderabad Flyover accident in 2007 due to failure of staging. (b) Ground supported launching arrangement before staging failure on NH-16.

- a) Ensure the desired compaction for all ground layers.
- b) Identify the underground ducts, pipelines, drainage lines and prepare the appropriate plan to safeguard the staging from settlement.
- c) There shall be no leakage or underground flow of water below the bed layers.
