# Road Safety Audit: A Detailed Analysis of Dhandhuka to Dholera (SH-20) in Gujrat State

Mateen Ahemed<sup>1</sup>, Dr. Sunil Sugandhi<sup>2</sup>

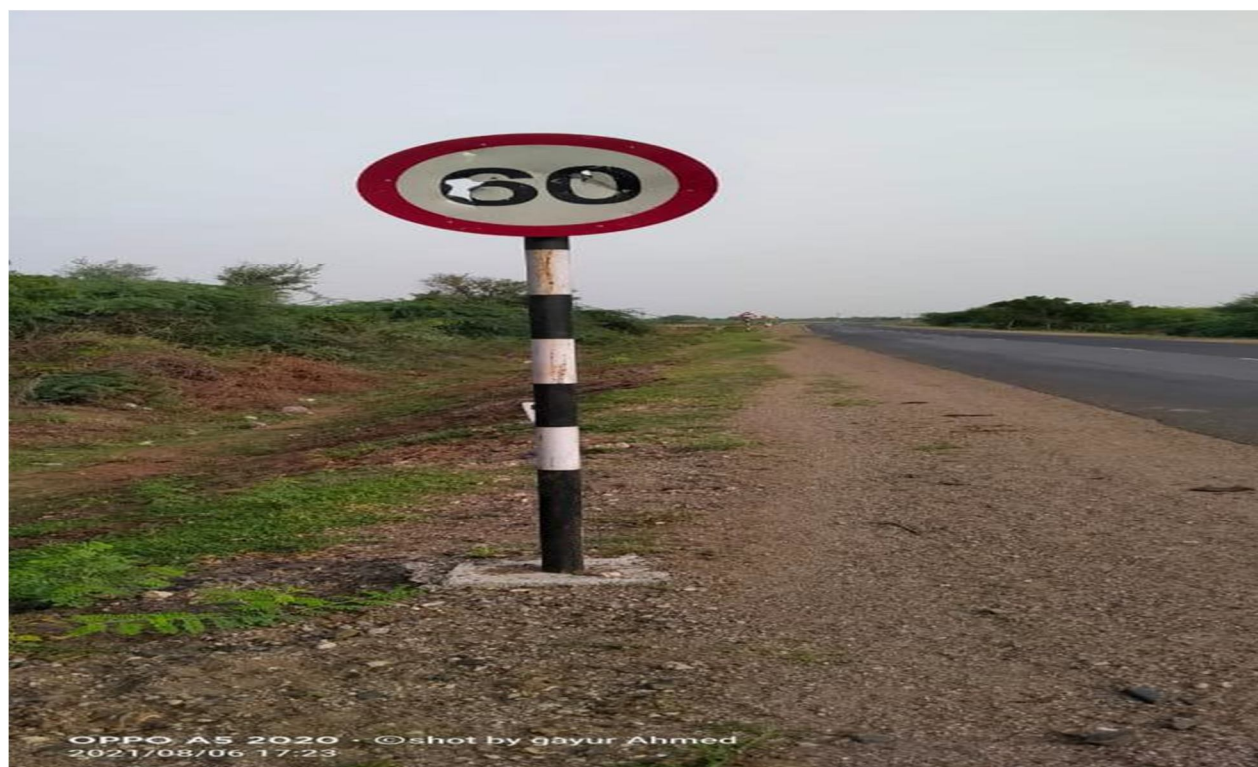
Ch. 26+500 Damaged speed limit sign board

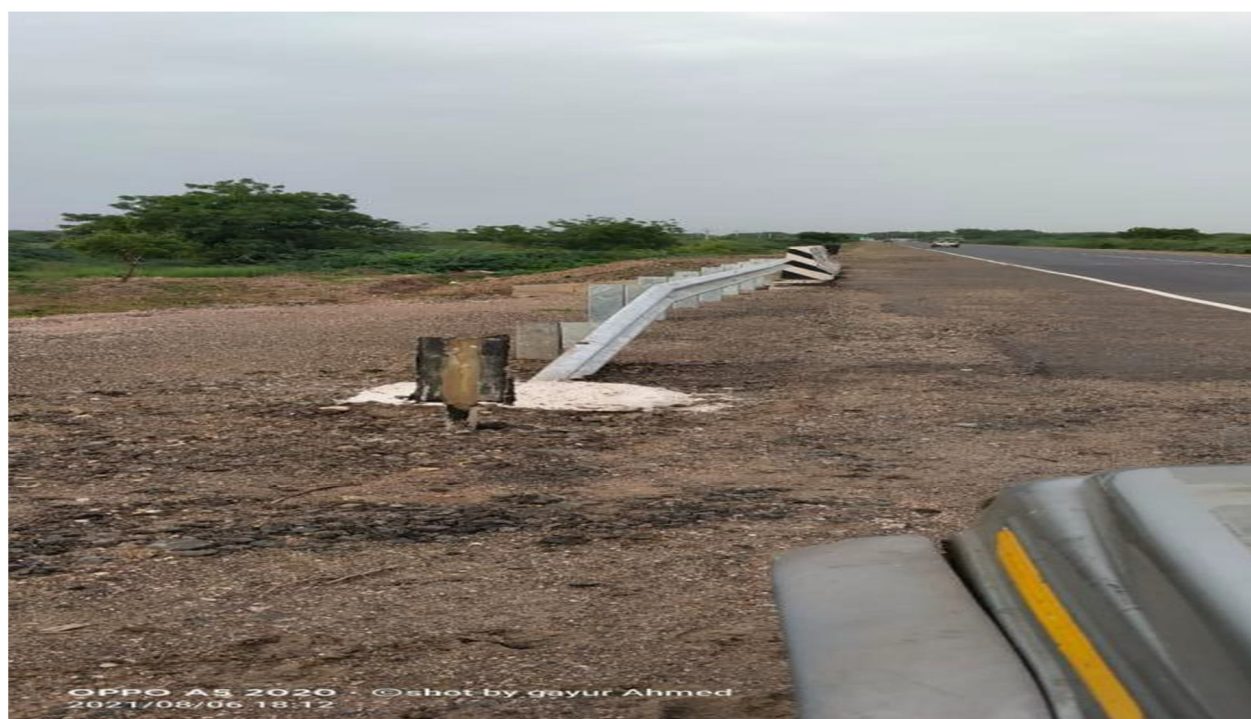
Ch. 7+700 Hazard marking sign board found damaged & faded condition

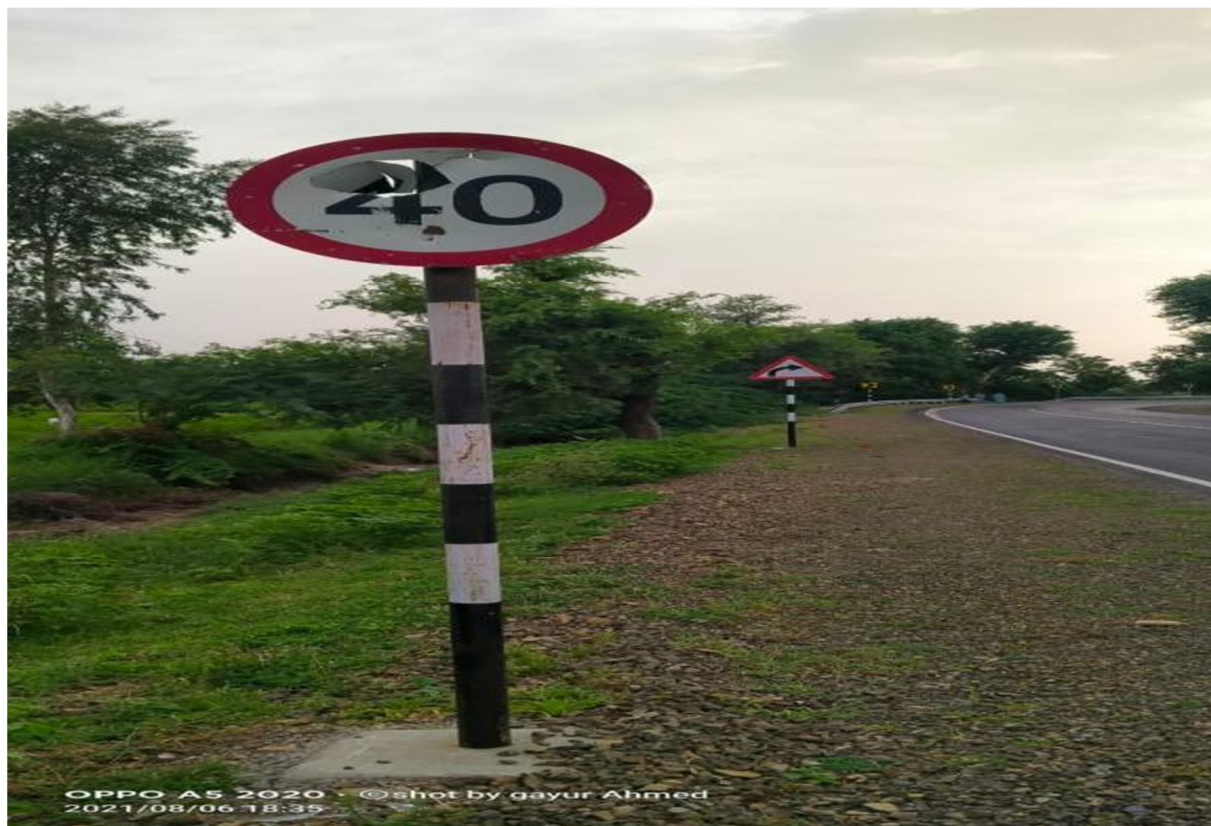
Ch. 16+485 Speed Limit sign board found in damaged condition

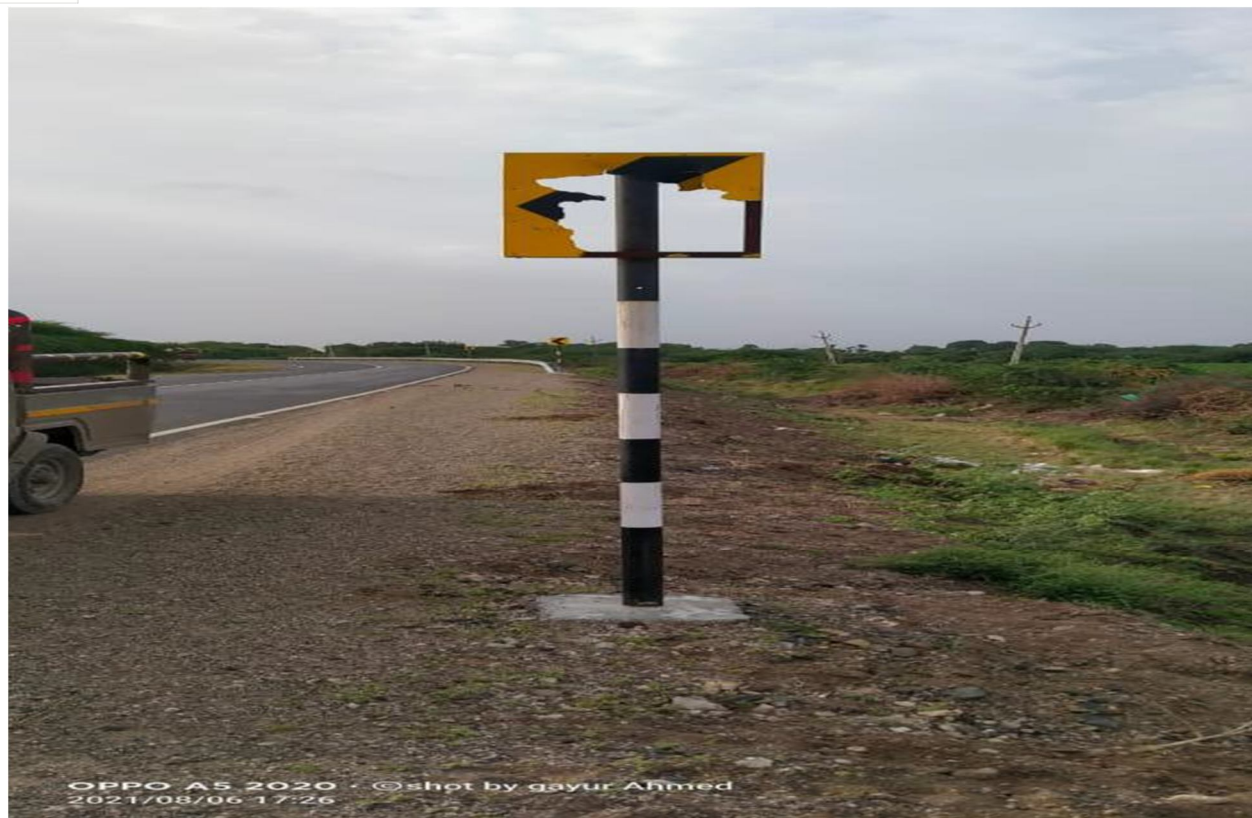
22+300 Left turn chevron sign board found in damaged condition

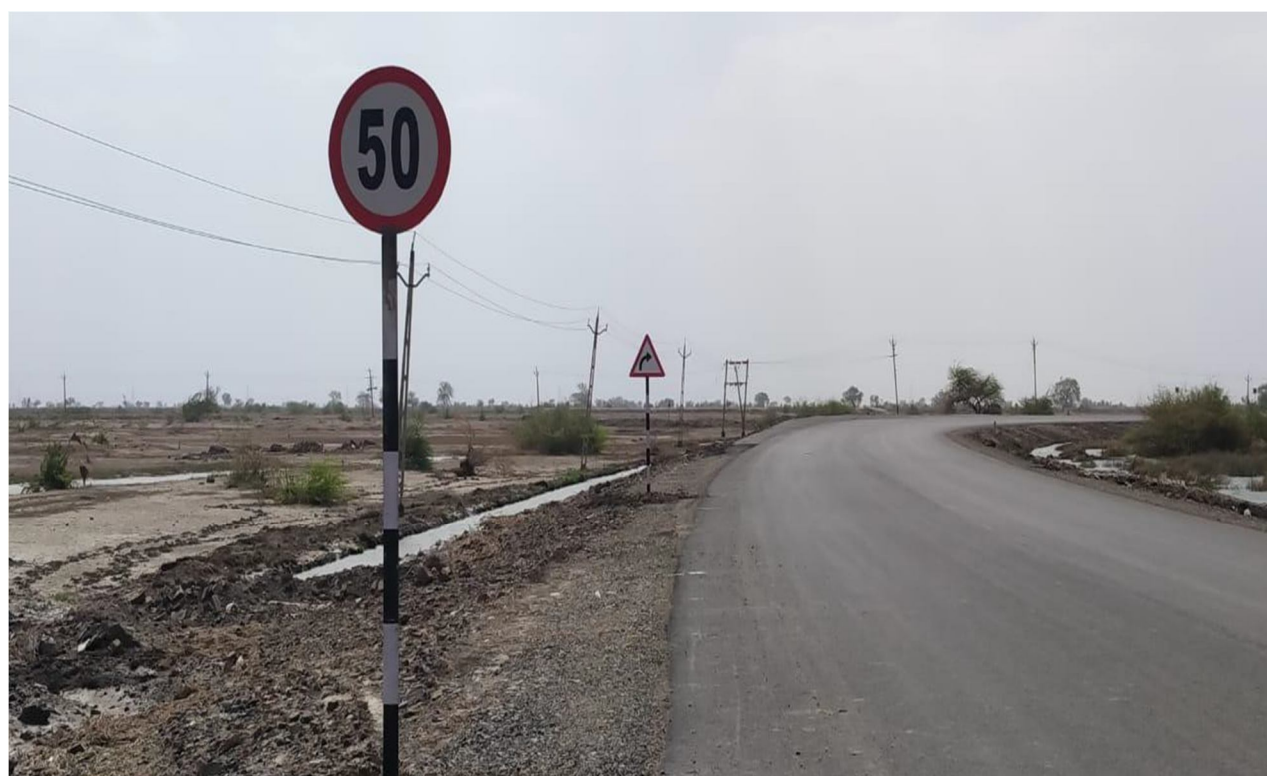
Ch. 20+900 Missing road marking & rain cuts observed near earthen shoulder

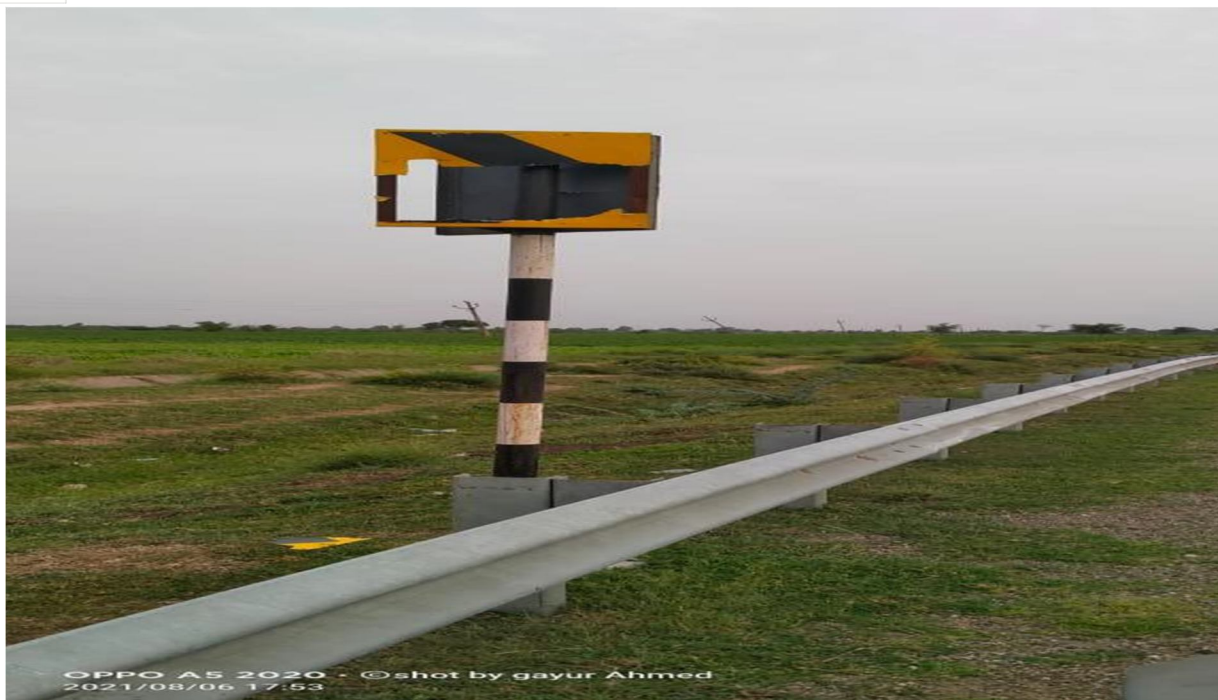
Ch. 16+440 Right hand chevron sign board found in damaged condition

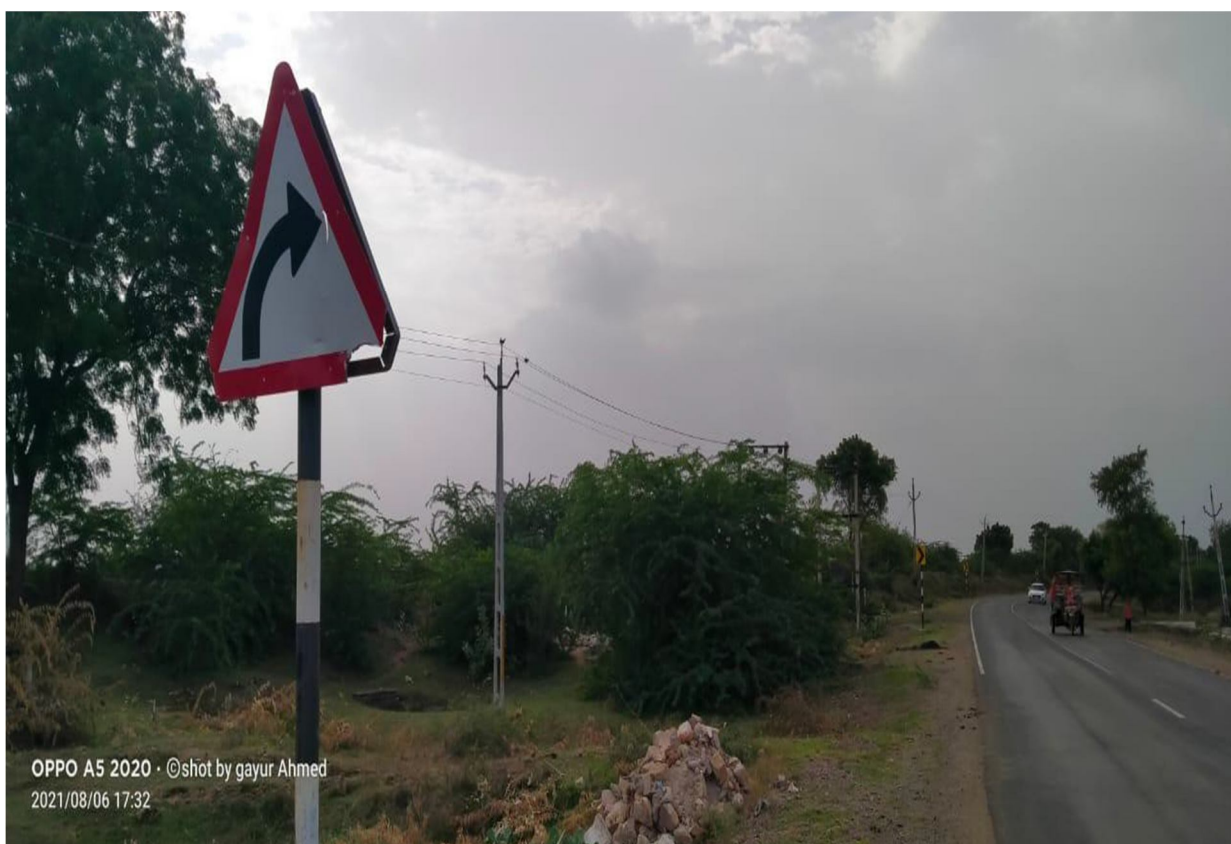
Ch. 3+635 Left turn sign board found in damaged condition & construction material dumped near shoulder

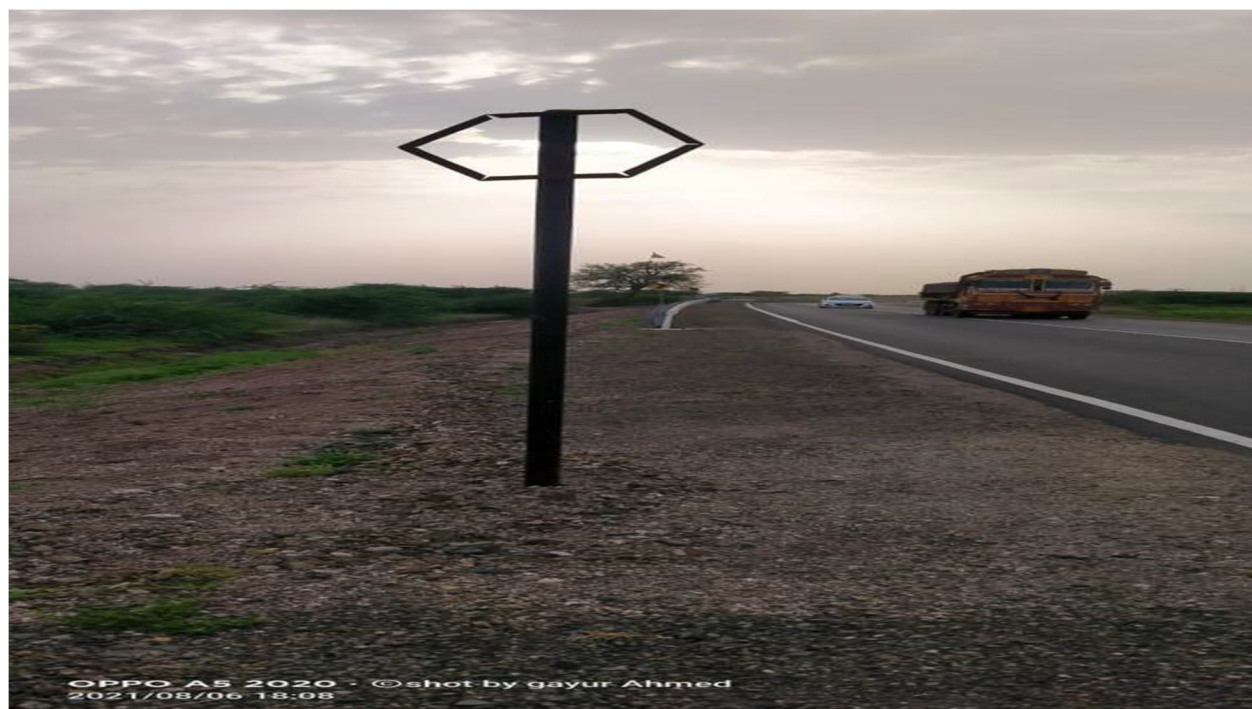
Sign board found damaged at Ch. 7+290

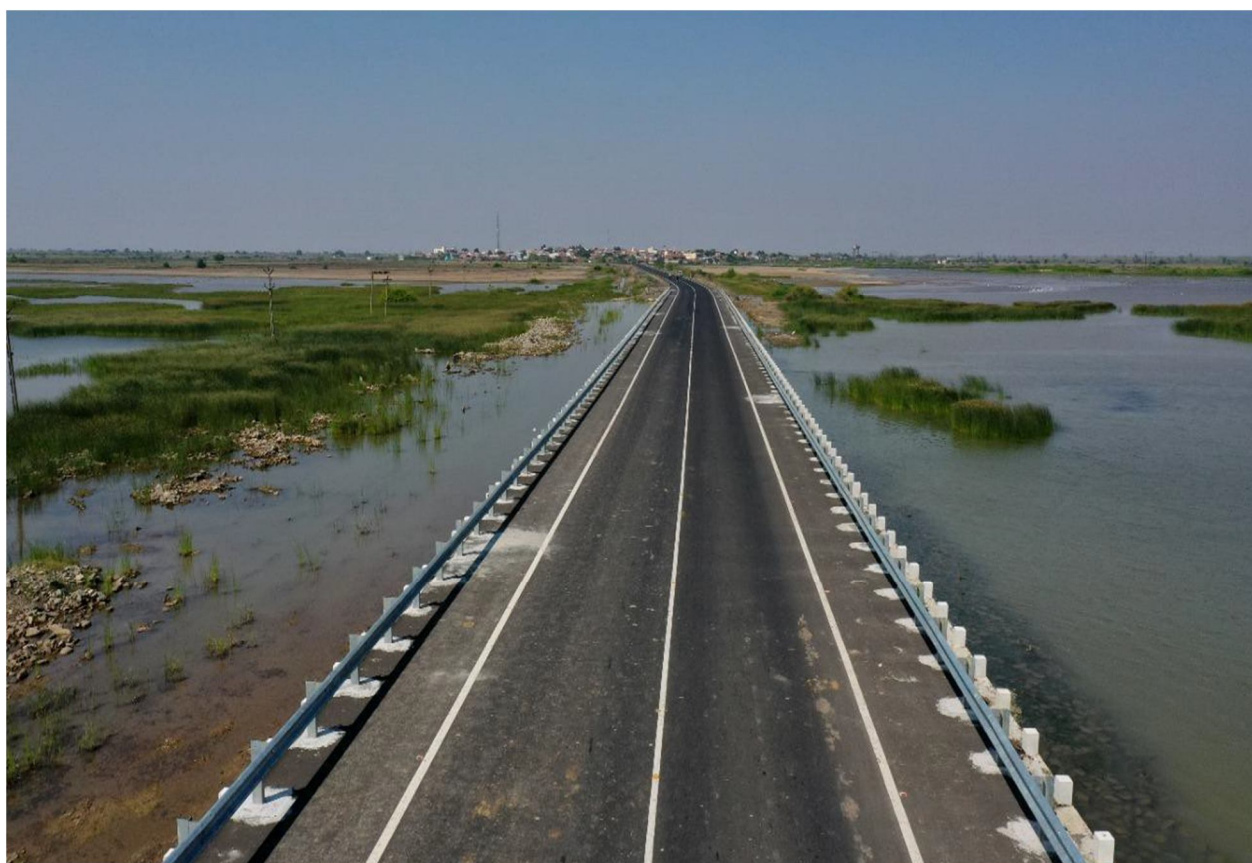
24+260 Left turn chevron sign are missing & protection wall has been suggested in place of W-Beam cross barrier

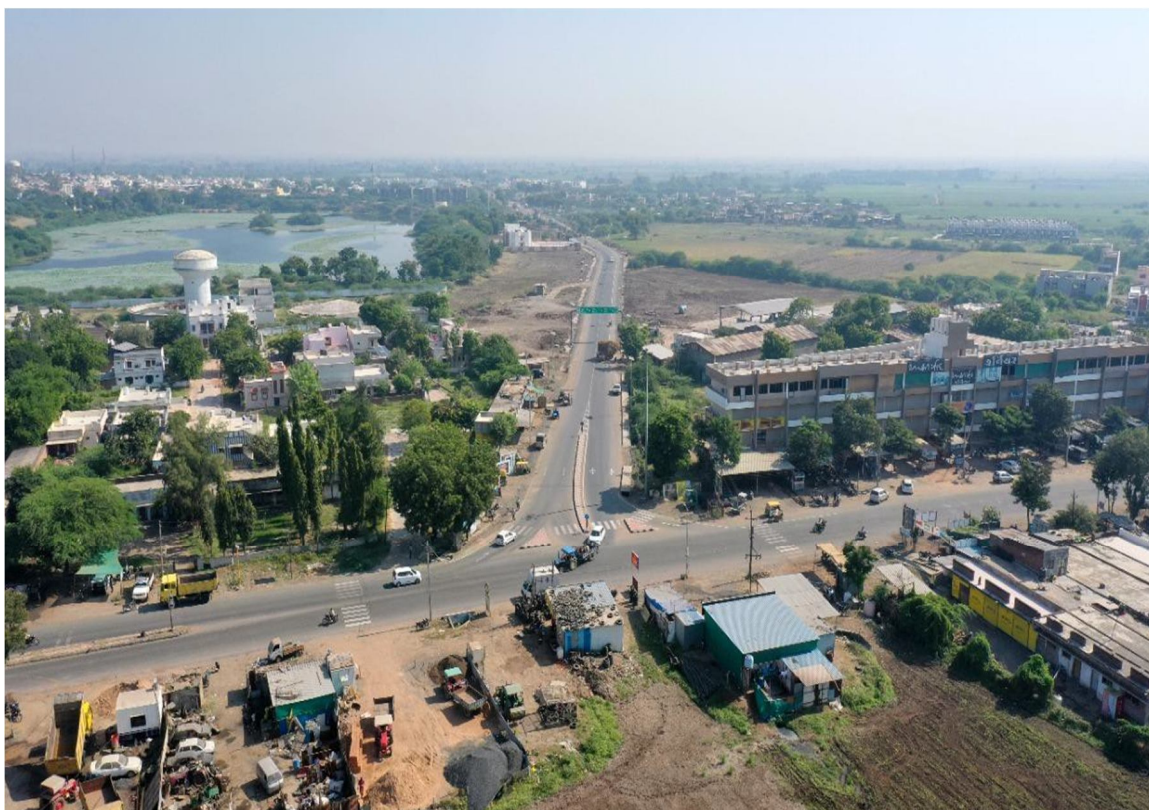
Ch. 0+000 Black Spot point Observed

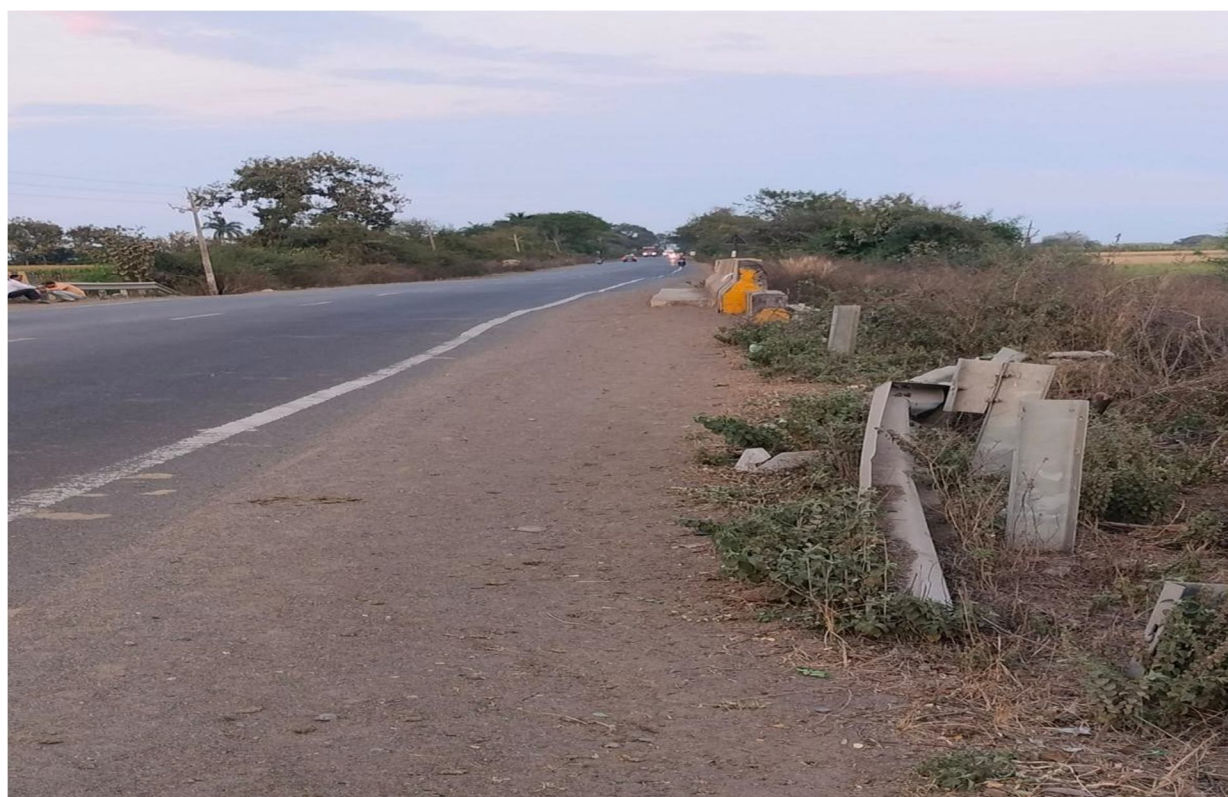
Ch. 15+750 Metal Beam Crush Barrier (MBCB) damaged must be repaired

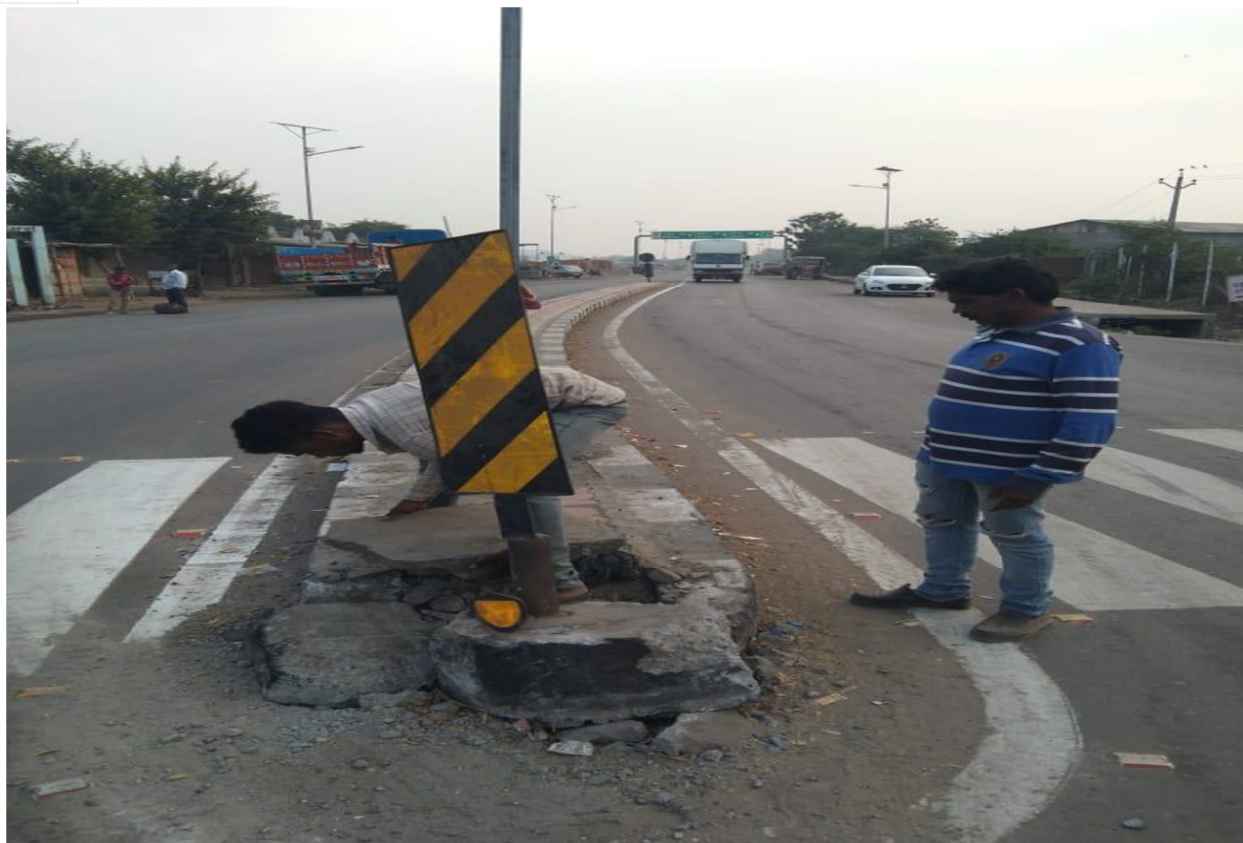
Ch. 0+010 Damaged delineator sign board should be changed & median side kerb should be repaired.

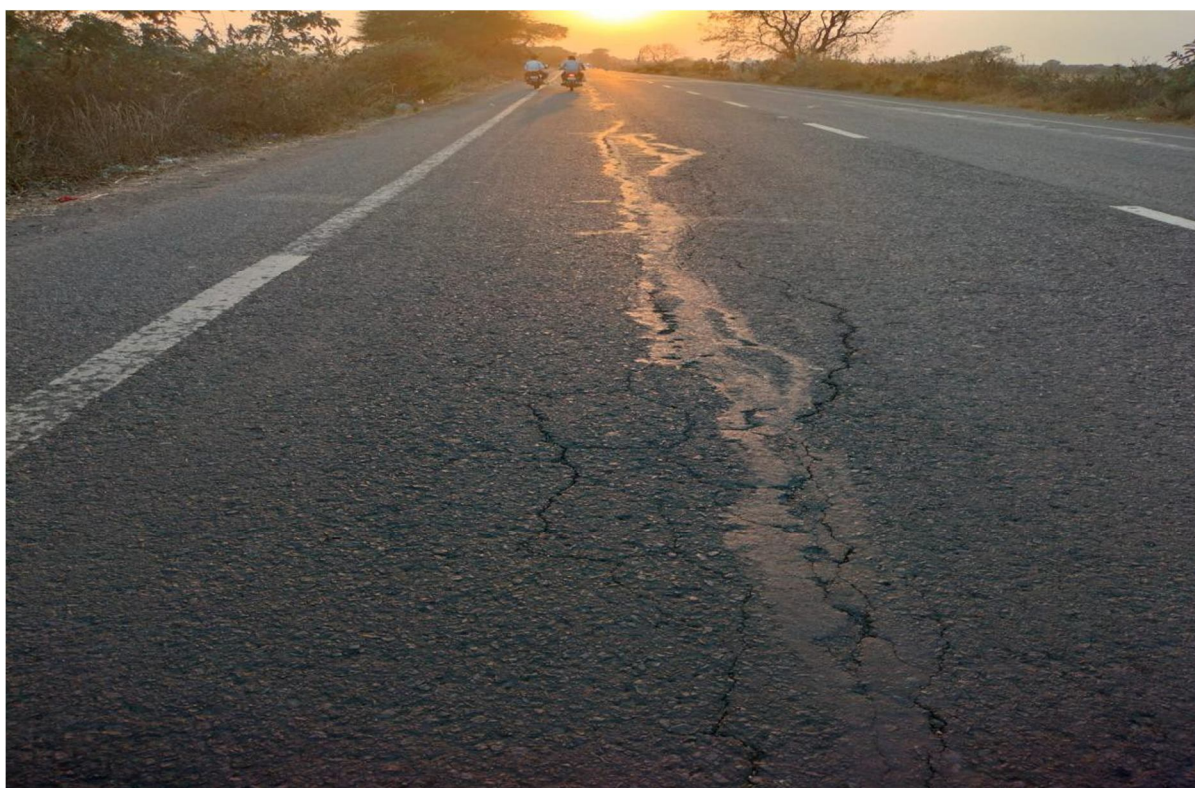
Ch. 3+530 Alligator cracking is observed on Pavement Surface

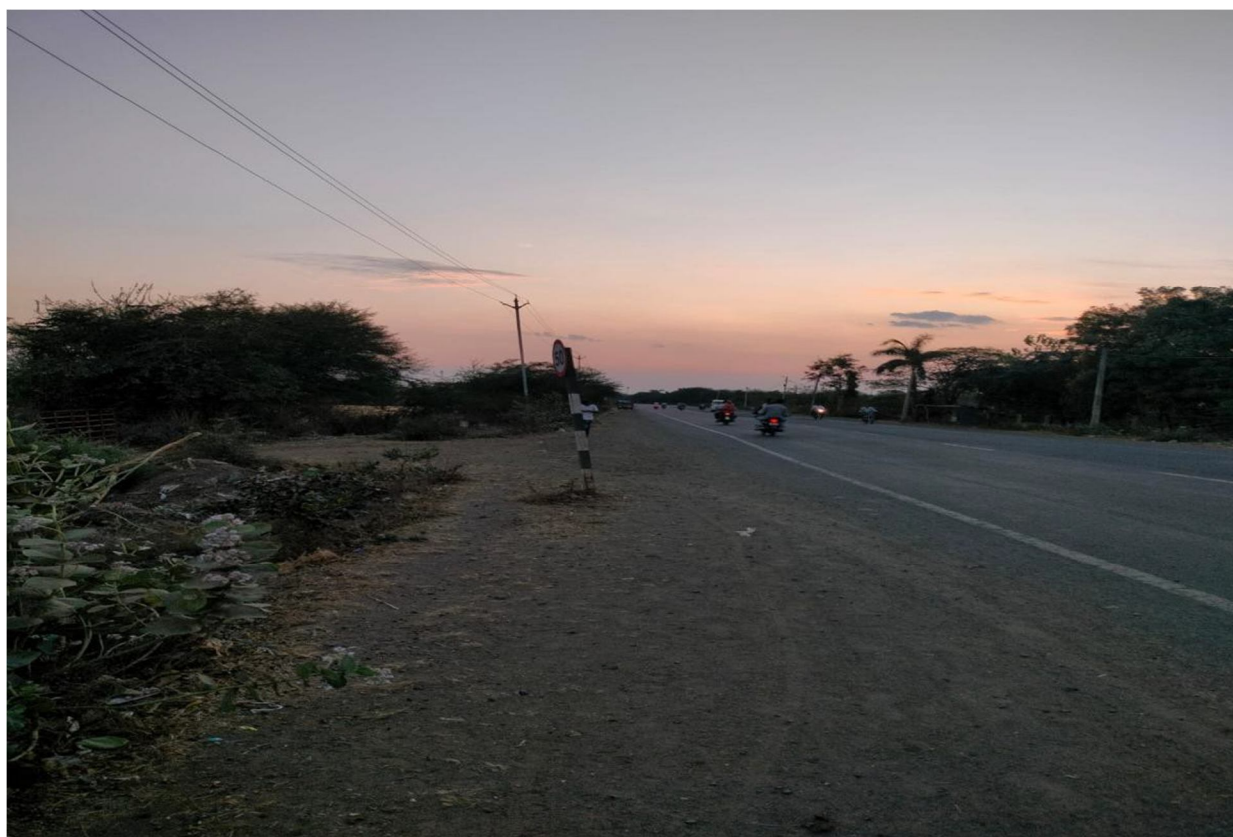
Ch. 20+560 Damaged Speed Limit Sign Must be repaired

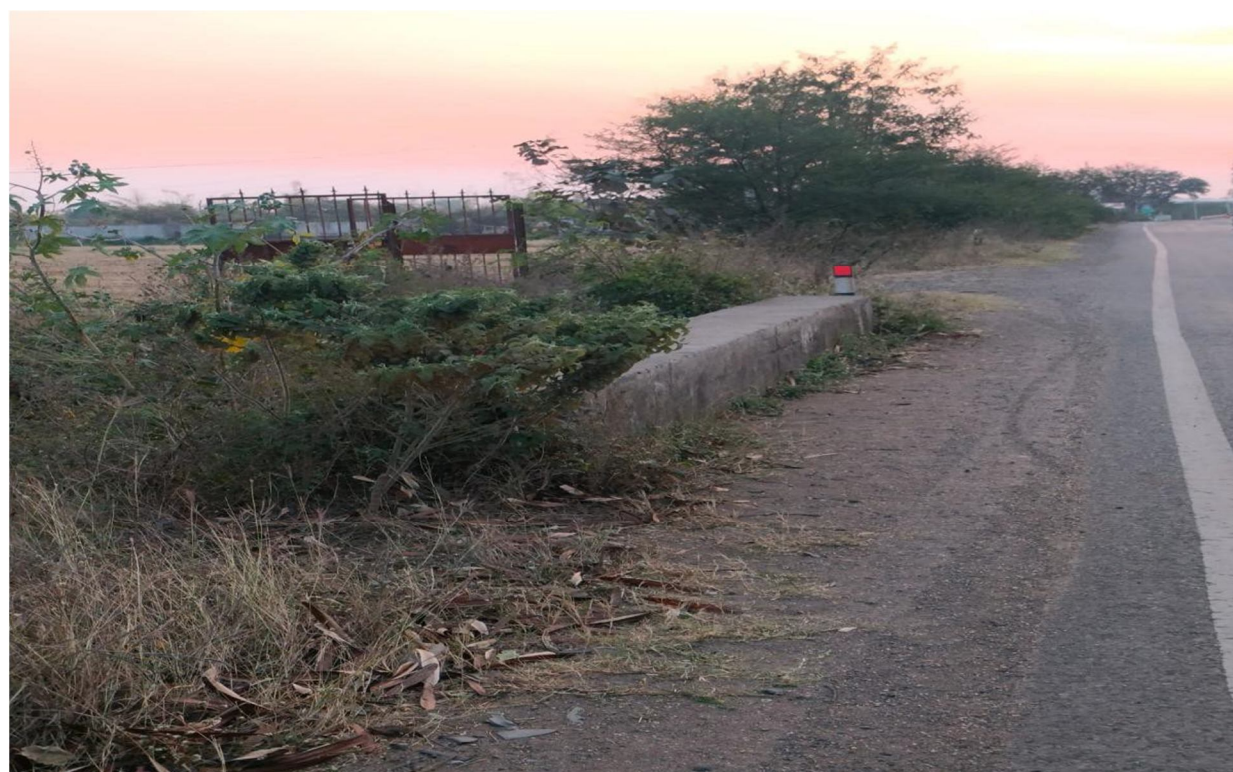
Ch. 17+574 Pipe Culvert Should be painted as per specification
