Road Safety Audit: A Detailed Analysis of Dhandhuka to Dholera (SH-20) in Gujrat State

Mateen Ahemed¹, Dr. Sunil Sugandhi²

Jawaharlal Institute of Technology, Borawan, Khargone

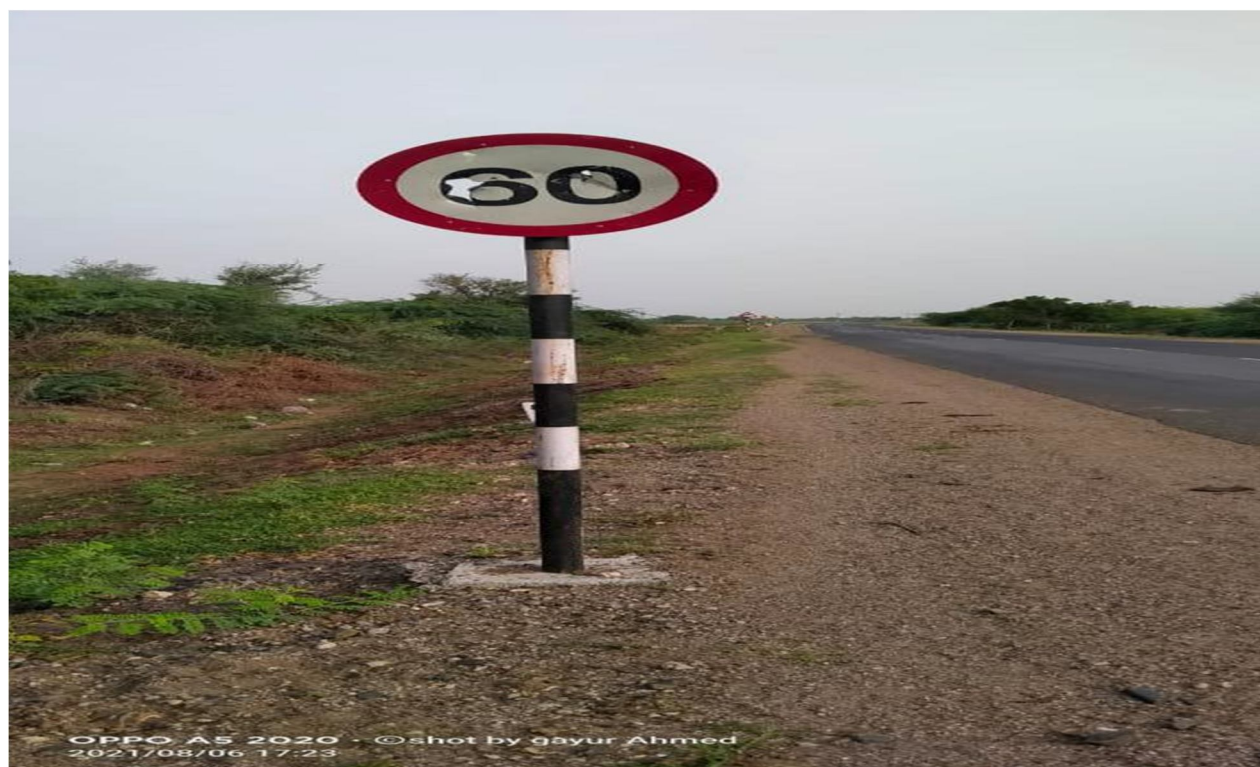
Ch. 26+500 Damaged speed limit sign board

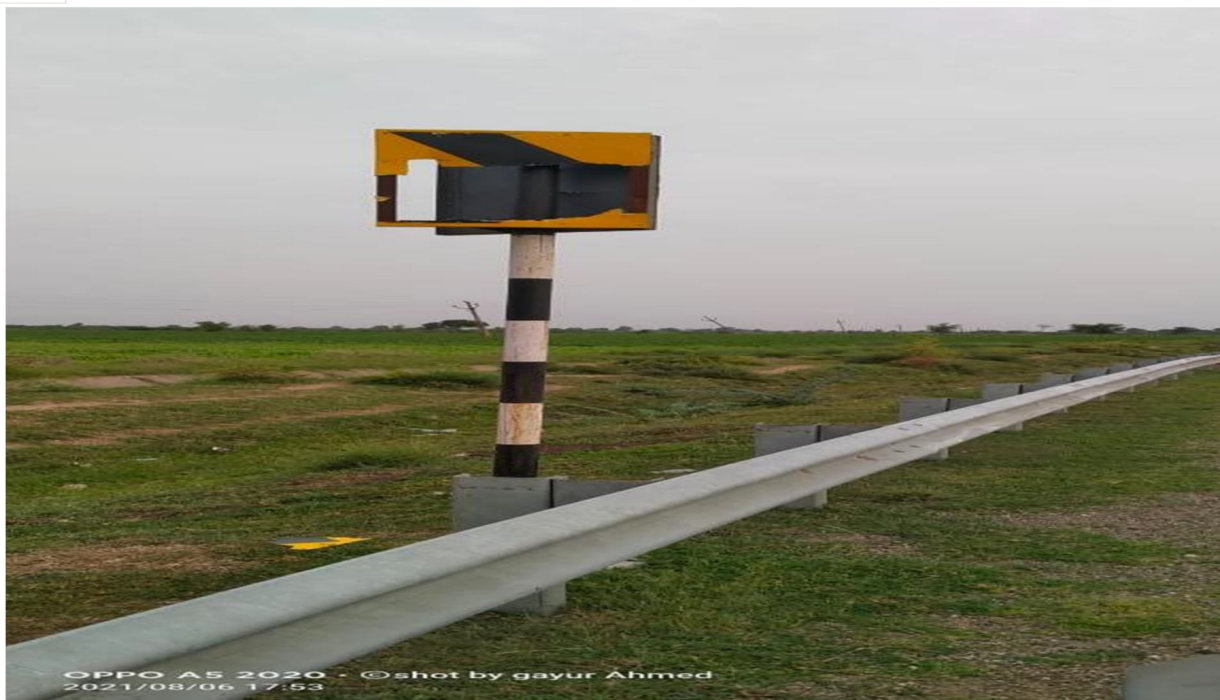
Ch. 16+440 Right hand chevron sign board found in damaged condition

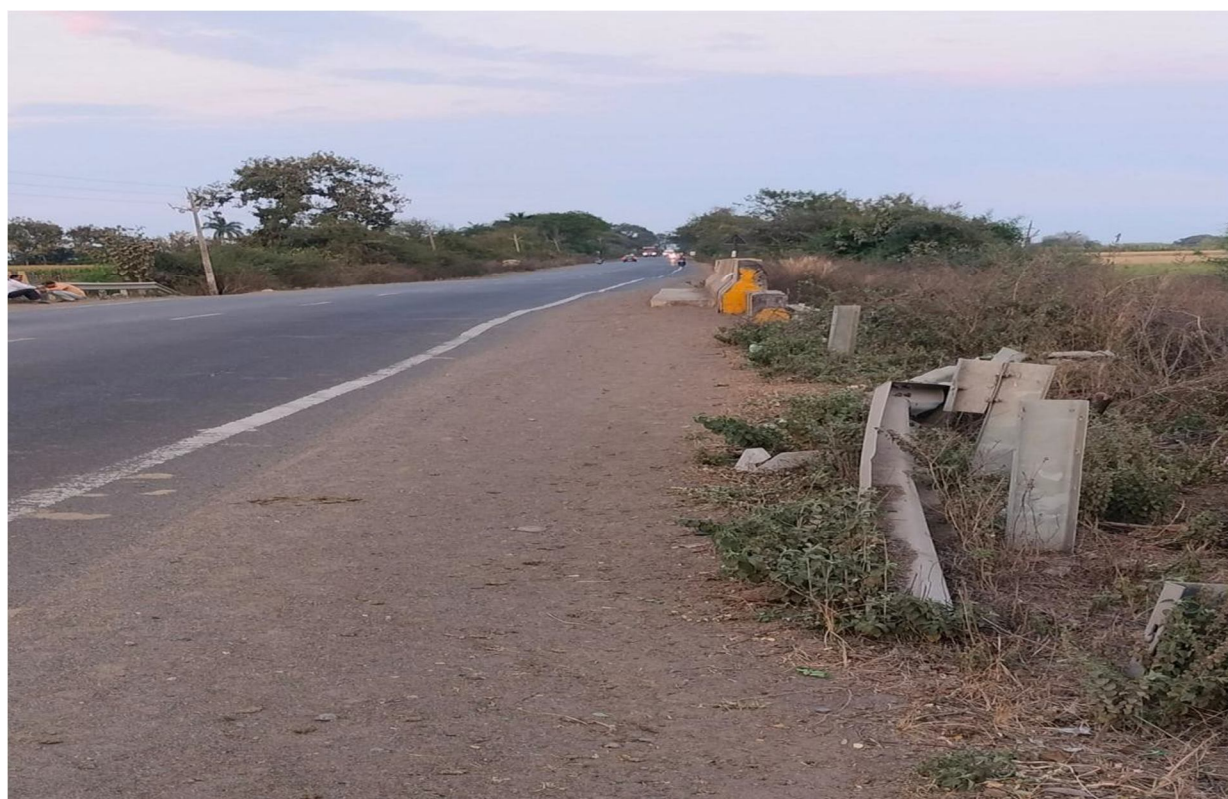
Ch. 15+750 Metal Beam Crush Barrier (MBCB) damaged must be repaired

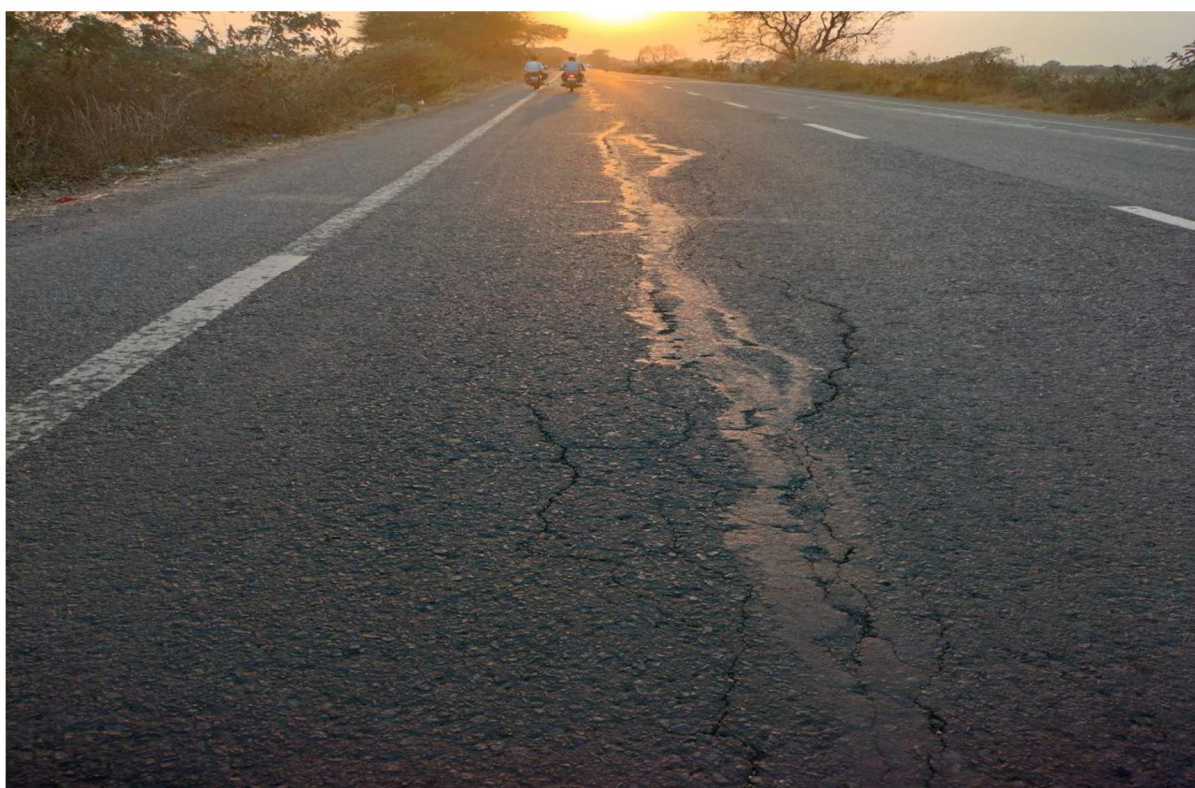
Ch. 3+530 Alligator cracking is observed on Pavement Surface
