### Seismic Assessment of Unreinforced Concrete Block Masonry Buildings Before and After Retrofitting: A Case Study

Jaineshwar Verma<sup>1</sup>, Satish Parihar<sup>2</sup>

<sup>1</sup>PG Student, <sup>2</sup>Associate Professor, Civil Engineering Department, Faculty of Engineering and Technology, Rama University, Kanpur

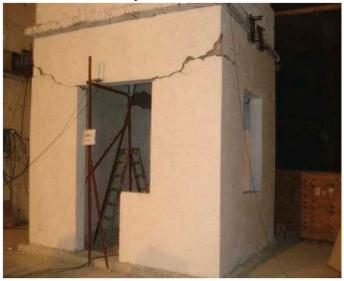
The cracking pattern of the structure after retrofitting is shown observed damage at the in-plane north wall and out-of-plane east wall are provided. A spiral cracking pattern rather than stair stepped pattern was observed for the retrofitted building. The increase in the thickness of the walls due to the application of the ferro-cement overlay caused a reduction in the aspect ratio, which resulted in a stable rocking mode of failure rather than a mixed compression-shear failure.

Fig. Final damage pattern for the retrofitted building

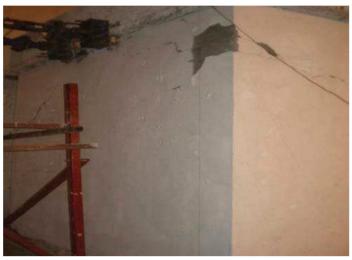
Fig. Falling of plaster observed on retrofitted building.
