Unexpected Inrush Current During Generator Energization at Hindalco Mahan Plant before Synchronization

Kumar Gautam

Hindalco Industries Ltd, India

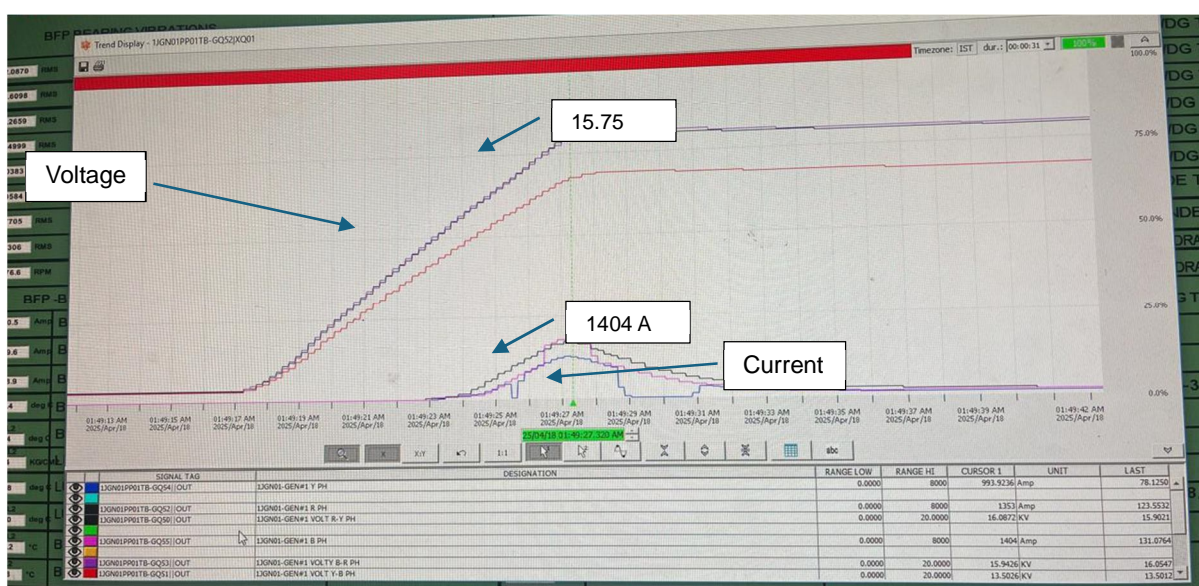
Fig-1

However, as the Generator terminal voltage approached 15.75 kV, an unexpected reading of 1400 A appeared on the amperemeter (Refer to Fig-1). This sudden current draw surprised the desk operator, especially since both the Generator Breaker and Unit Auxiliary Transformer (UAT) Breaker were open at the time Fig.2.

The current lasted only a few seconds before returning to zero. No tripping, fault indication, smoke, or abnormal sounds were observed. All CT and PT connections were checked and found to be in proper condition.

- 4) It might be the Generator transformer drawing this current as the charging inrush current. It was not as voltage was gradually ramped up (Fig-1), not a typical step-energization eliminating this thought.
