Improvisations in Traditional Lime Work, Punjab, India

The case for study is a traditional historic Havelli (Mansion) in Punjab restored by the author as site Conservation Architect under the guidance of CRCI, New Delhi. The project was completed in a span of 6 months in 2008. Many a restorative techniques used are non-conventional and help in giving a new direction to the traditional processes of restoration.

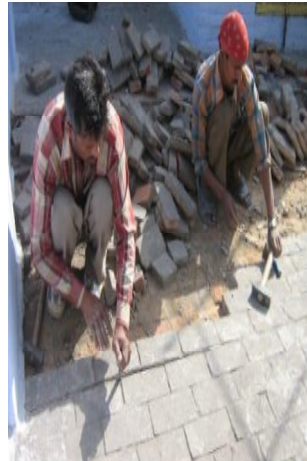
Removal of finishing
brick

- 2) *Removal of finishing layer of roof:* The top finishing layer of the roof was traditional bricks in mud mortar. These were carefully removed piece by piece and were neatly stacked after cleaning with water. In traditional restoration works the objective is to reuse traditional materials as much as possible so all process of removal and stacking of the older material are done with utmost care. Wastage during removal process is minimized.

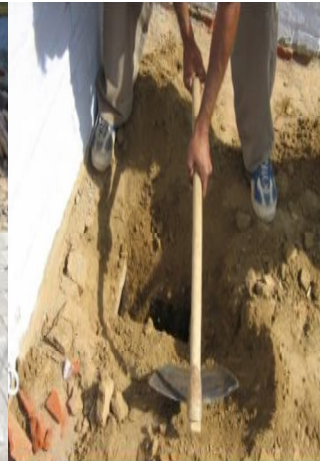
Removal of earth layer

- 3) *Removal of earth:* The earth filling is removed by ploughing all the earth to the room below
- 4) *Removal of brick layer:* The bottom most layer of the traditional bricks are removed. These again are done with care to reduce on breakage and wastage so that they can be reused at a later stage. The brick surface at the soffit of the roofing was white washed white; this shall be upturned and reused.

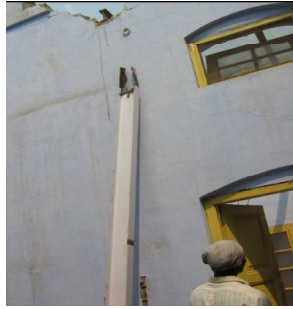
Corroded iron girder end

- 1) *Iron girder ends:* The iron girders in one room seemed to be sagging while in rest of the rooms the girders on visual inspection seemed stable before removal of the roofing. Once the roofing layers were removed, the ends of these girders embedded in wall were exposed. This brought to light the most precarious condition of the girders, unimaginable during visual inspection. In the past it seems that the original wooden purlins were replaced by iron girders, during which time a blunder was committed by the masons. The iron girder was embedded in masonry with lime mortar joints. Lime has a highly corrosive effect on iron, hence they should never be placed in close proximity to each other, this was not taken into cognizance by the earlier masons, due to which the iron girder ends in contact with lime mortar corroded over the years. The girders would have collapsed any moment if not checked and replaced. The masonry in immediate contact with iron girders were laid in cement mortar 1:2, while rest of the wall was restored in lime mortar 1:2.

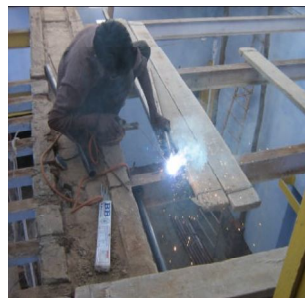
Welding of hollow steel pipes

- 3) *Structural strengthening:* As per the advice of structural engineer the iron girders were structurally strengthened by stiffening of ends. This was achieved by welding iron hollow pipe sections 32mm nominal bore size, 2.60mm thick weighting 2.54kg/m at the ends of iron girders.

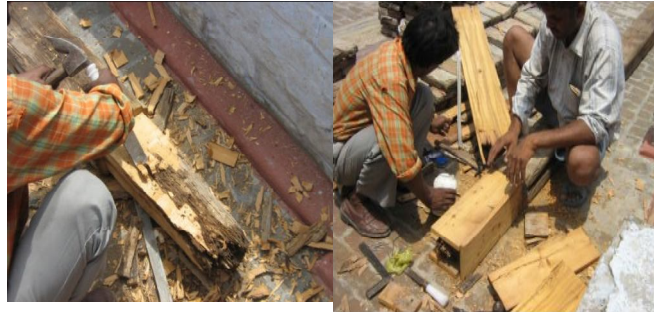
Removal of wood end

Deodar wood planks

The original wooden beam in one of the rooms was in a good state but the ends were deteriorated due to moisture content in wall. This end section of the wooden beam was consolidated. The weathered part of the beam was chiselled and removed. The end was encased within new planks of deodar wood 20mm thk. and the gap was filled with wood shavings mixed with resin of industrial bonding. This beam was then rested upon wooden wall pad.

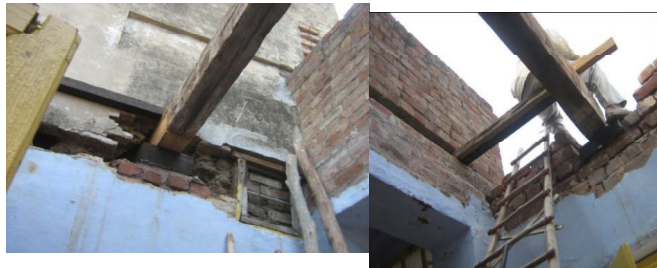
Insertion of wood pad

Wooden purlins laid

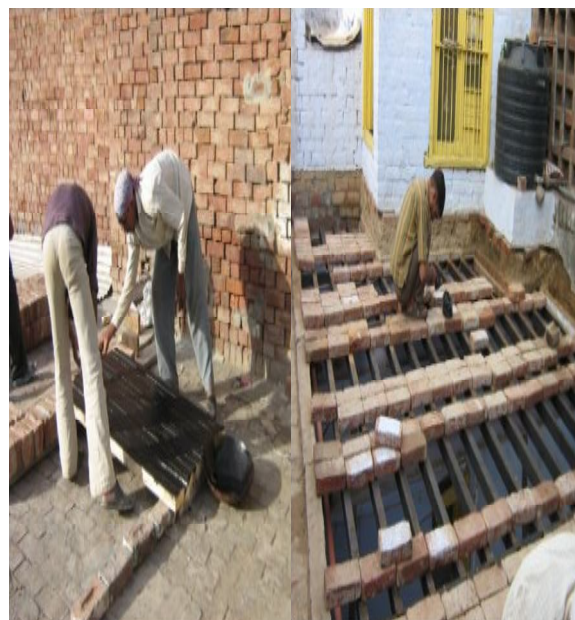
Anti-Termite treatment of purlins

Wooden spacers for purlin placement

- 1) *Laying of wooden purlins:* Wooden purlins were checked for any defects and those found structurally stable were reused. Others were replaced by purlins of same size as originals, 65mm x 50mm in cheer wood. Purlins were cleaned of any dirt and grime. Thereafter, all the purlins were treated with application double coat of termite proof mixture of burnt engine oil and turpentine oil in 1:2 proportions. The centre to centre distance between purlins was maintained at 230mm c/c. as wide as the brick length. The wooden purlins are fixed in position c/c by fixing small wooden batten pieces as spacers between two purlins. These spacers are positioned above iron girders and they help in avoiding the dislocation of purlins while placing the top layer of brick tiles.

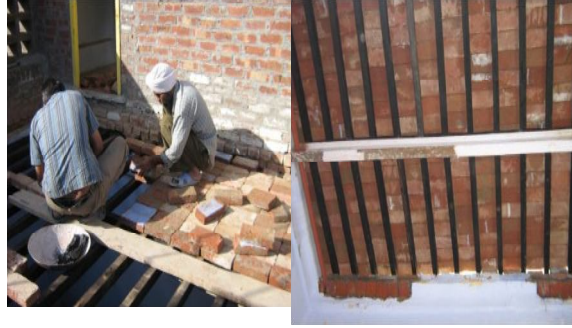
First layer of tile laid

Soffit of roof restored

- 2) *First layer of brick:* the first layer of brick was laid over the wooden purlins, reusing most of the original bricks and by inter changing the face of the brick. Whitewashed brick faces were laid facing the terrace as against their earlier positions when they were facing below.

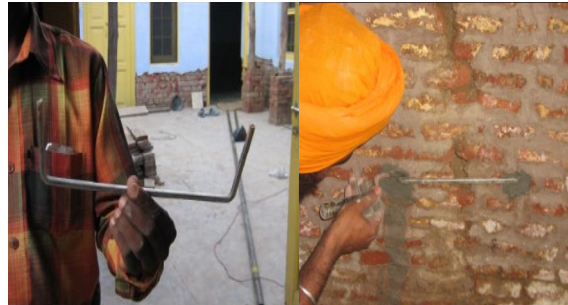
Mild steel C pin

C Pin Staple on wall crack

3) *Lime grouting*: lime pressure grouting was undertaken for consolidating a crack in masonry. The crack was first stitched with mild steel C Pins of 10mm dia. Thereafter, the crack was filled with lime grout forced into the fissures of the masonry through a grouting machine. The lime forced with pressure reaches the internal fissures of the masonry and fills in the gap. This operation though proved to be a failure in the said case and the wall in 24hrs time bulged out. After further investigation into the cause of the same, it was learnt that the wall so treated has internal mud mortar layer and the thus the mud after absorption of moisture from lime grout swelled up causing the bulging effect in the wall.

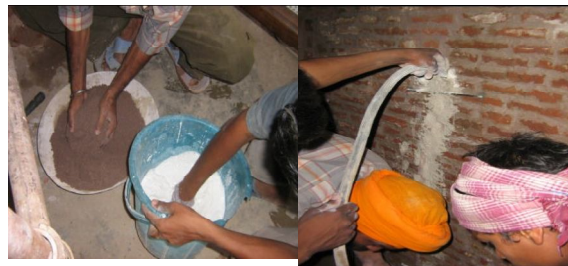
Lime grouting mixture

Lime grouting of crack

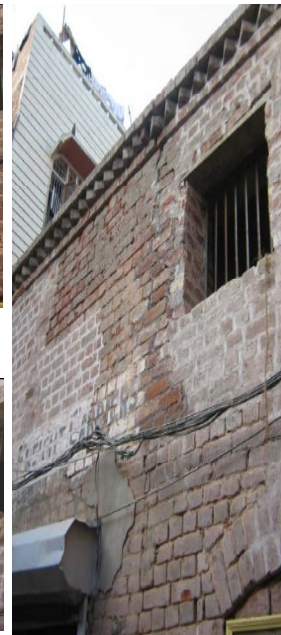
Crack masonry opened up

Consolidated restored wall

- 4) *Masonry consolidation through rebuilding*: Many cracks in the masonry which were only one course deep were restored by removing the bricks and re-laying the masonry in lime mortar, carefully building in interconnected joints between the new and old masonry. The important aspect to take into account though is that before consolidating the masonry the probable cause for crack was identified and the corrective measures were taken so that the restored masonry might not fall under stress.
- 5) *Plinth protection to walls*: plinth protection was provided to walls both from the inside and outside of the building. This ensured check of rising damp in case of traditional walls lacking the damp proof course.

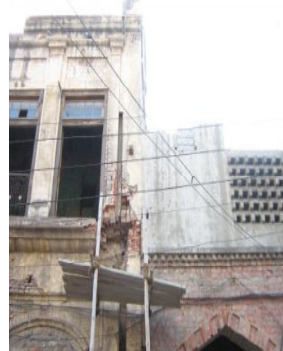
Vegetation removed

A Peepal plant had taken roots into the masonry of the Havelli, this could cause collapse of the wall if the plant was not removed. Plants if not carefully and completely removed have a tendency to regrow. The plant was injected with chemical compound which slowly dried up the plant. The masonry along the roots was removed to pull out the entire vegetation growth. Terracotta jaalis from the adjacent property belonging to the client were carefully removed and cleaned. These jaalis are rare as they are not casted anymore and have been replaced steadily by cement jaalis in the market.

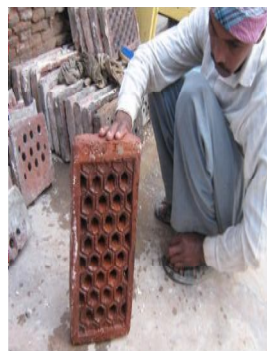
Terracotta tile restored
