Road Safety Audit and a Case Study of SH-26 & SH-27 from Khandwa to Sanawad (M.P.) India

Siddhant Karahe¹, Dr. Sunil Sugandhi²

¹P.G.scholar, Transportation Engineering, ²Professor and Dean academic, Civil Engineering Department of Jawaharlal Institute Of Technology Borawan, Khargone (M.P) India

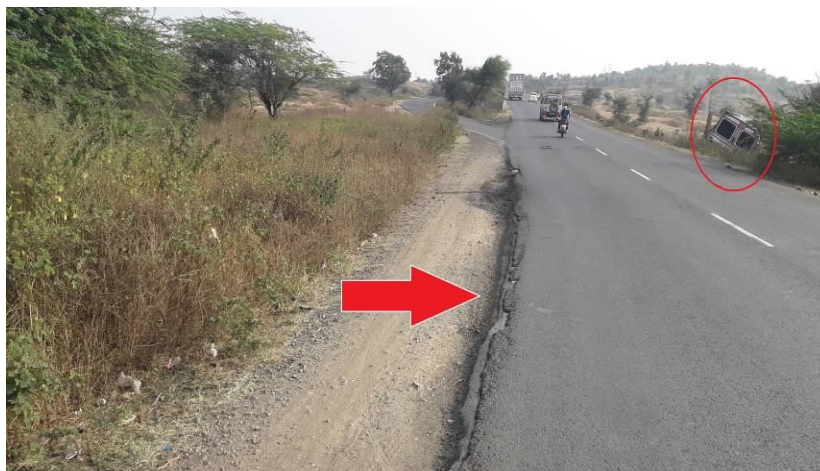
Figure 7:-Improper shoulders at ghat section between Chhegoan Makhan (Kherda village) To Roshiya

- F. Figure 7 showed that shoulders are not trafficable for vehicles and road users due to the damage caused by poor drainage and soil erosion Edge drop observed which may be fatal for high-speed vehicles and motorcyclist .Level difference may cause accidents.

- F. Shoulders shall maintain to the level of the carriageway.
- G. Buses stopped randomly are to be strictly prohibited.
- H. Retaining wall to be constructed to increase formation width. If the side hill is cut then the formation width and shoulder width is increased. There should be proper marking and sign board to warn the vehicles.

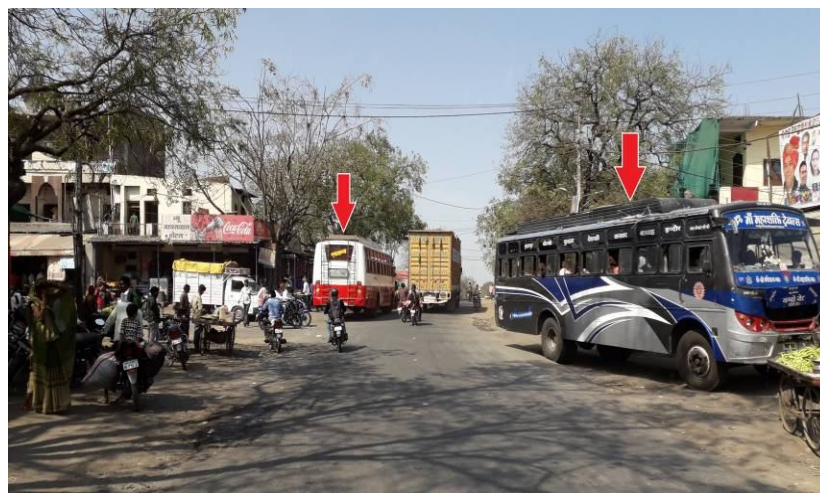
Figure8:- Bus stops on the shoulders of the highway at Deshgaon

- G. Figure 8 showed that due to lack of availability of Bus-Stops, Roadways Buses as well as private Buses stopped randomly. Stoppage makes movement of through vehicles unsafe and on the highway congestion and compels through vehicles to use opposite lane on the highway.

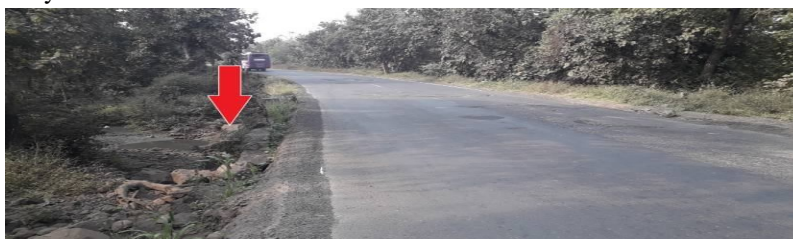
Figure 9:-Formation width is eroded due to excess rainfall.

- H. Figure 9 showed that formation width is eroded due to excess rainfall. Chance of vehicle to fall into drain at night and also it has insufficient berm width. Shoulders are not there on both this place should be declared as non-over taking zone because chance of vehicle to fall into valley at nights Diver may not know the situation of the road ahead, moves with the same speed. This causes the vehicle to lose the control and may be a chance of overturning and after few days the construction of new retaining wall is started.

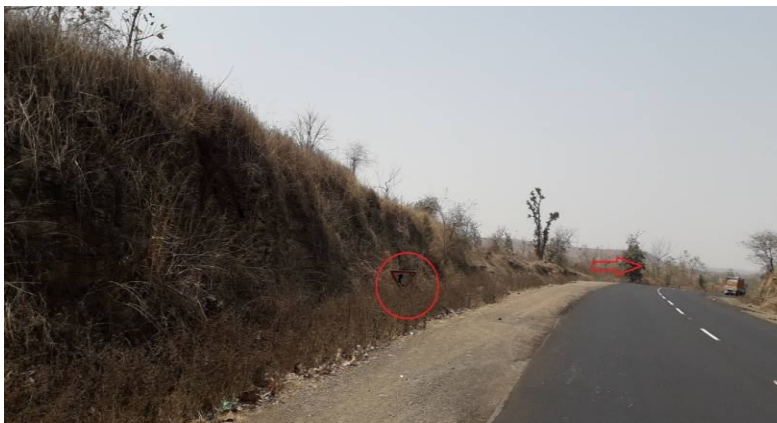
Figure 10:-Sign board direction changed due to wind force or hit by any vehicle

- I. Figure 10 showed that Sign board direction changed due to wind force or hit by any vehicle. Improper directional signs create confusion to the drivers and they mislead the travel time. Sharp curves lessen the sight distance and create tension to the drivers.

- I. Proper maintenance of the sign board needs to be done at regular intervals. Sign boards and markings need to be checked once in six months.
- J. Designated waiting areas for trucks are to be provided. Stoppage of vehicle on the shoulders is to be strictly prohibited.

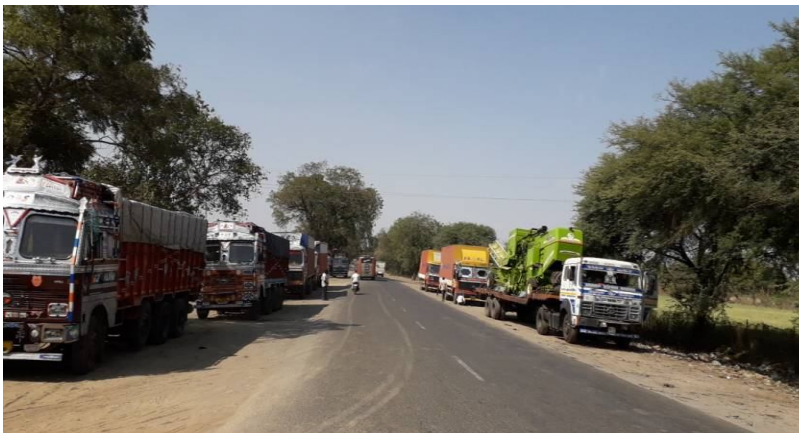
Figure 11:-Provision for Heavy Vehicles

- J. Figure 11 showed that there is no waiting area for trucks waiting. As a result, trucks wait occupying walkway and shoulder. Illegal parking/ stoppage makes movement of through vehicles unsafe. Parking of trucks on the shoulder creates congestion and compels through vehicles to use opposite lane on the highway. Parking vehicles can create a blind spot and they will be as an accident causing elements on roads

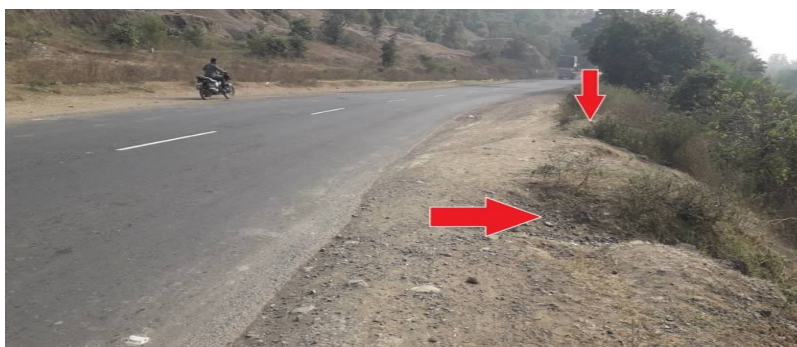
Figure 12:-Unguarded deep valley

- K. Figure 12 showed that deep valley Unguarded deep valley adjacent to road. Hazard for a vehicle to ran into the valley during poor visibility and rains. Guard rails are to be provided to prevent the vehicle from falling and rumble strips are to be provided to alert the driver near the valley. Due to damaged shoulder makes movement of through vehicles unsafe. Vehicles may be fall into the valley during night.

- K. Guard rails are to be provided to prevent the vehicle from falling and to alert the driver near the valley. Rumble strips are to be provided to alert the driver near the valley.

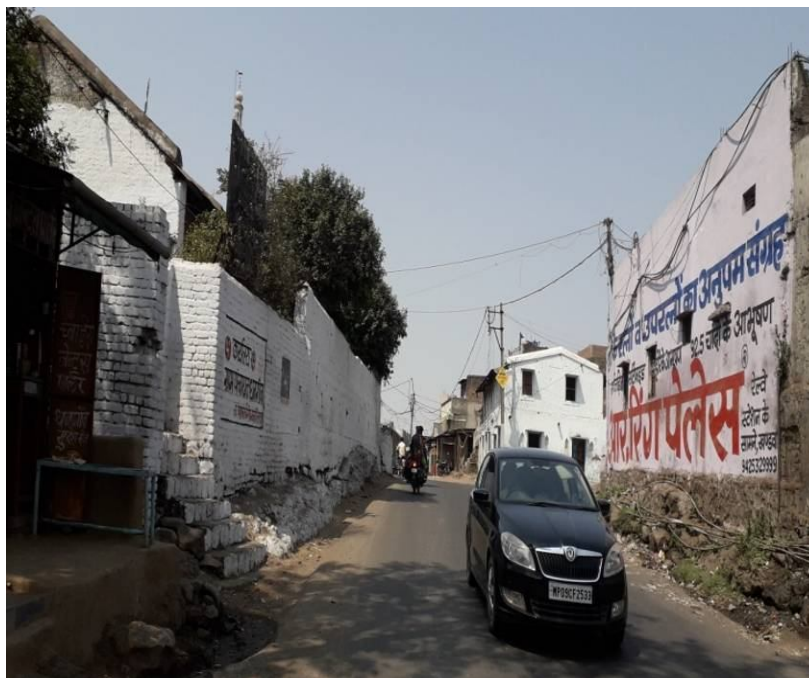
Figure 13:- Shoulder, carriageway width & sight distance due to occupation of wall at dhangoan

- L. Figure 13 showed that the obstruction to line of sight is insufficient sight distance due to occupation of wall the sight distance along the road is inadequate or restricted when wall is on the edges of carriageway. Obstruct the sightlines to stationary objects or oncoming vehicles. Inadequate sight distance results in a shorter reaction and response time available to the driver when the change is sighted which results in a higher crash risk. Besides, due to obstructed longitudinal sight distance drivers assume continuation of the present conditions, though alignment changes or traffic hazards suddenly appear. Highway required wide shoulders on each side. Shoulder width and condition is absent at near Dhangoan village on highway (SH 27). It is observed that at this area with high concentration of vehicles and pedestrian such as bazaar, village, bus-stands etc. The jams occur only when a truck or any other heavy vehicle breaks down in the mid of the road. As the stretch is narrow, it becomes difficult for other vehicles to pass on it

- L. The wall should shift at some distance to clear the line of sight. In order to improve pedestrian safety, raised shoulder is recommended. Shoulder should be maintained by increasing width.

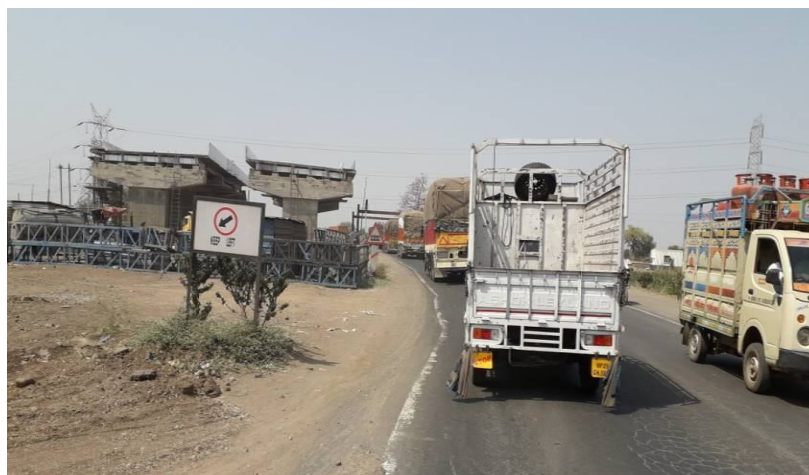
Figure 14:- By having construction of bridge and broad gauge railway on these path problems of traffic jams is raised frequently

- M. Figure 14 showed that by having construction of bridge and broad gauge railway on these path problems of traffic jams is raised frequently. By having construction of bridge and broad gauge railway creates congestion. Waiting or stoppage of vehicles can create a blind spot and they will be as an accident causing elements on roads. The road becomes unsafe and pedestrians are unable to use shoulders.

- M. Due to speed difference, light vehicles need to have a diversion for it not only to improve the traffic performance but also for safety purpose
- N. Guard rails are to be provided to prevent the vehicle from falling and to alert the driver near the river. Rumble strips are to be provided to alert the driver near the river.

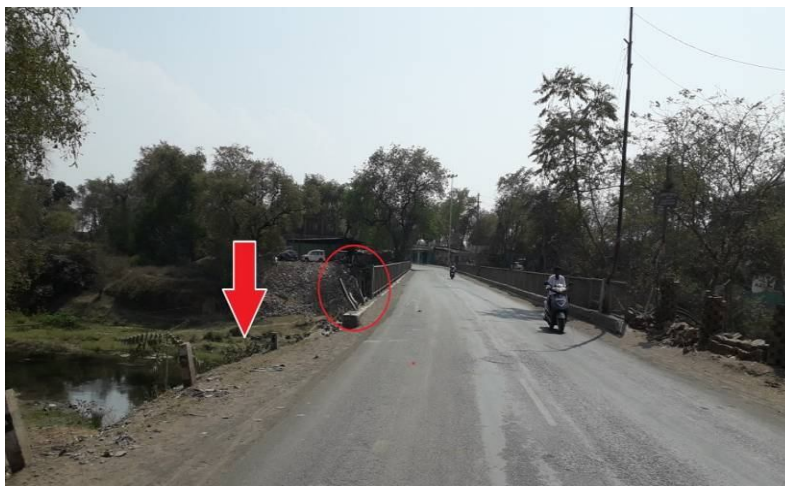
Figure 15:- Guardrails are broken at Sanawad Bridge

- N. Figure 15 showed that guard rails are not there to prevent the vehicle from falling and to alert the driver near the river. Hazard for a vehicle to ran into the valley during poor visibility and rains. During night Vehicle may fall into the valley.

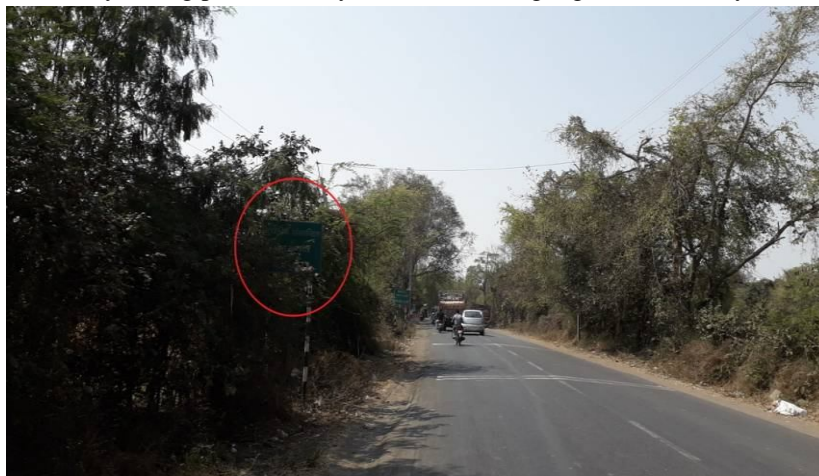
- O. Figure 16 showed that signs board are not at all visible due to vegetation this board also not visible from a distance due to vegetation. During day time due to the shadow of vegetation sign board is not visible.

- O. Tree branches need to trim at regular intervals to maintain visibility.
