# Road Safety Audit and a Case Study of SH-26 & SH-27 from Khandwa to Sanawad (M.P.) India

Siddhant Karahe<sup>1</sup>, Dr. Sunil Sugandhi<sup>2</sup>

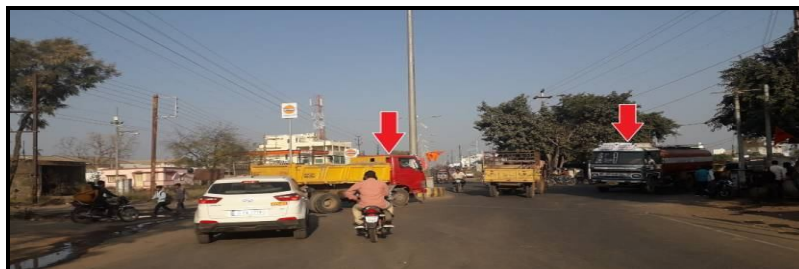
Figure 2:- uncontrolled intersection at bhairaw mandir square

- A. Figure 2 showed that in this intersection road user not doesn't follow the rules and regulation and turn their vehicle on the wrong Side for saving their fuel and time. There are more chances of head on collision of vehicles Absence of appropriate sign and road marking.

- A. At Bhairaw mandir square necessary regulatory and warning signs with clear visibility and retro-reflective markings on pavement. There should be properly marking on speed breaker with sign board. The Road user must follow rules and regulation. Retro-reflective materials or paintings to be used at all speed reducing devices. Lane marking, stop line marking, directional arrows, pedestrian markings etc, have to be done in this junction. As per IRC, it is necessary to provide road hump on minor arms at a distance of 10m from edge of project road to regulate the speed of vehicles entering the project road. Stop signs are to be properly installed on minor arms and shall be located at a distance of 3m from stop line and aligned perpendicular to face the oncoming traffic.

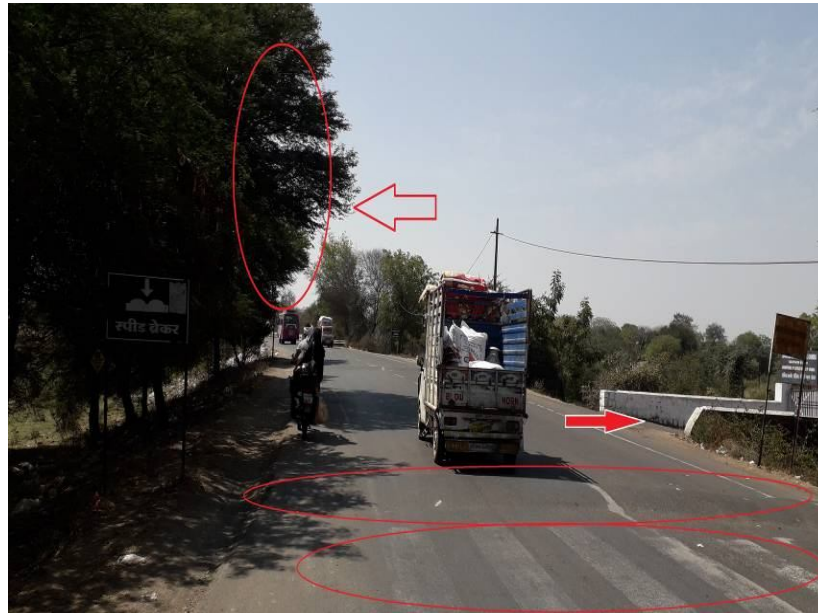
Figure 3:- Sight distance, Faded marking and Non-engineered speed breaker in front of Sophia convent school

- B. Figure 3 showed that the obstruction to line of sight insufficient sight distance due to occupation of tress. The sight distance along the road is inadequate or restricted when plantation on the edges of embankments. Obstruct the sightlines to stationary objects or oncoming vehicles. Although zebra marking for Pedestrian crossing was present at the site but due to poor maintenance it was faded and was not clearly visible No proper sign board for Pedestrian crossing was present near the zebra crossing. Presence of speed-breakers indicates that these places are hazardous and lacks appropriate engineering measures. In Front of Sophia Convent School & Kishore Kumar Samarak and Crematorium Khandwa speed-breaker are not marked or poorly marked and contributing to accidents of different natures. Speed-breakers and raised pedestrian crossings are either not painted or poorly painted with white colour, thus posing surprise situations to drivers at night.

- B. Tree branches need to trim at regular intervals to maintain visibility. Adequate sight distance and visibility is to be provided. Pedestrian crossing markings, speed breaker markings should be regularly maintained.

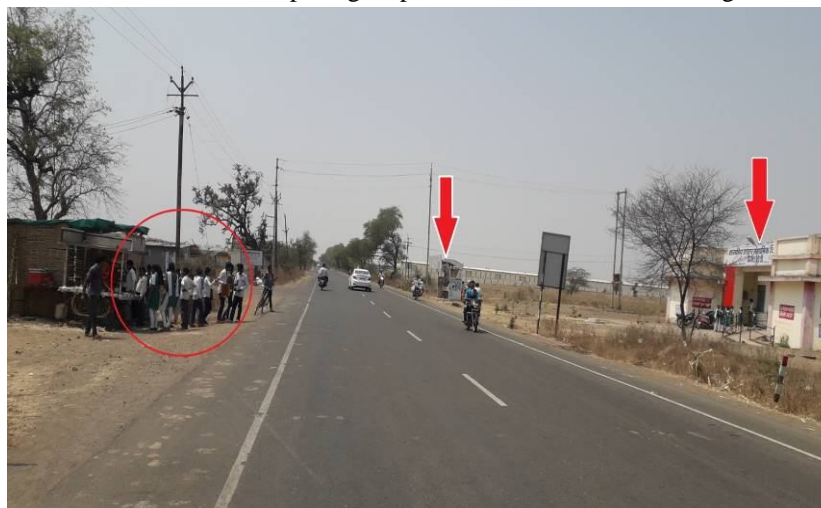
Figure 4:- No signs boards, road markings and speed breaker In Front of Govt.School Takali Mori (Chhegaon Devi)

- C. Figure 4 showed that there is a school on the right side of the highway near Takali mori (Chhegaon Devi). It is approximately outside the nearby village, and it appears most of the young children attending the school walk along the edge of the highway from the village. This exposes them to a risk of a collision with fast-moving traffic. Young children who attend the school cross the highway. This location is identified as hazardous locations during safety audit. Appropriate crossing sites are not found with proper signs, marking, delineations and speed reducing devices and proper engineered speed-breakers are also not found at this place.

- C. Pedestrian crossing markings, speed breaker on both side (enter& exist of school zone) with markings should be provided and speed limit sign board to control the speed of the vehicle. Appropriate speed reducing devices prior to the locations are to be provided. Crosswalks with appropriate marking and delineations should be placed. Appropriate signs should be erected to warn through traffics about school zones.

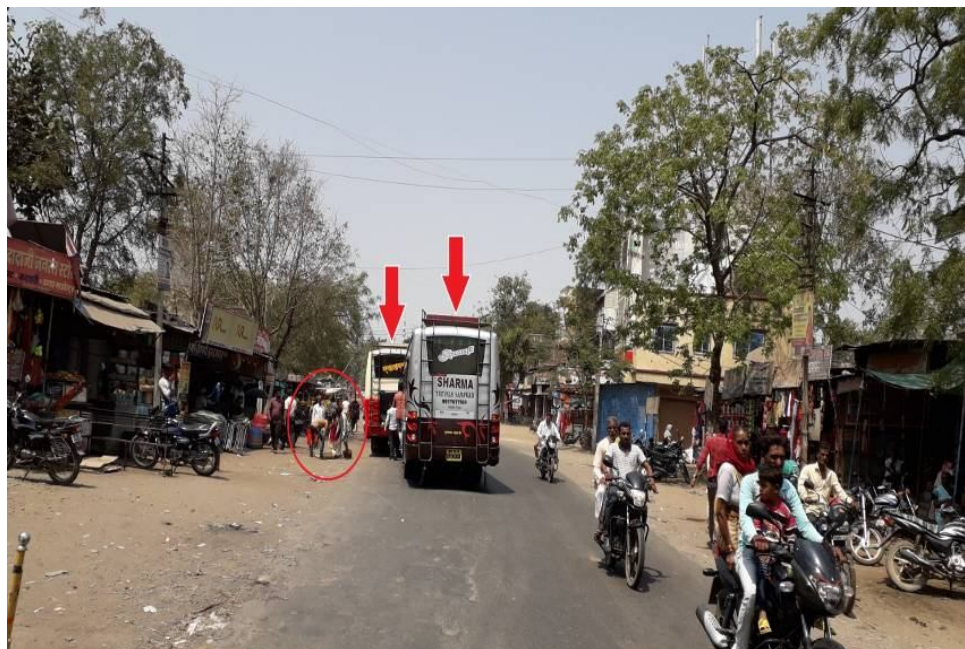
Figure 5:- Passenger boarding and alighting, bus stops on the carriageway of the highway at chhegaon Makhan (kherda village)

- D. Figure 5 showed that road markings missing and Passenger boarding and alighting, bus stops placed exactly at the carriageway of the highway. Stoppage makes movement of through vehicles unsafe and on the highway congestion and compels through vehicles to use opposite lane on the highway. Further, people also waited for public transport System on road side and created lot of congestion problems on road side. Bus stops causes' traffic jams on the highway and even accidents.

- D. Proper road markings should be given on the road. Zebra crossing and Stoppage of vehicle on the carriageway is to be strictly prohibited. Stoppage of passenger bus should be on bus stand only.

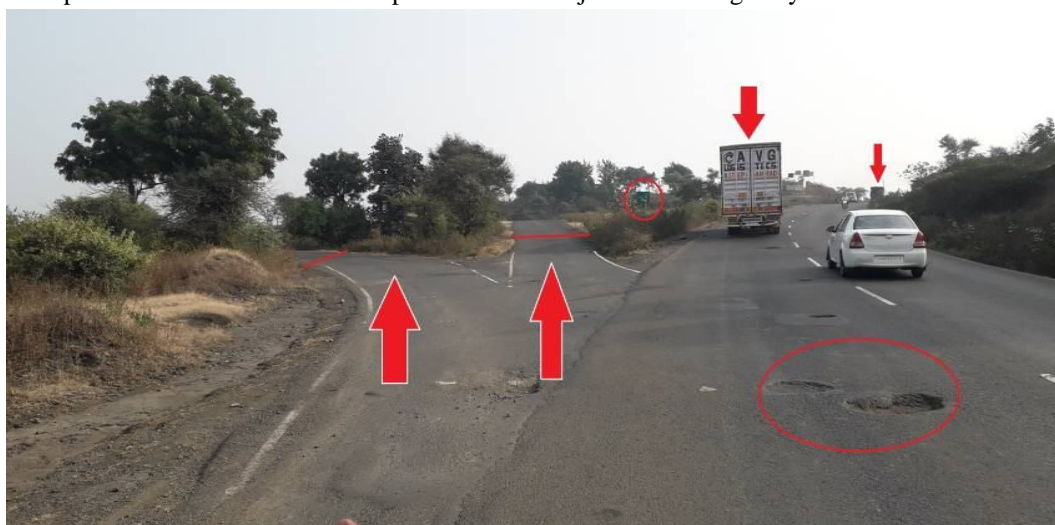
Figure 6:- Heavy trucks do not follow diversion road and rule & regulations and potholes at ghat section between Chhegaon Makhan (Kherda village) To Roshiya

- E. Figure 6 showed that due to speed difference, heavy vehicles need to have a special lane for it not only to improve the traffic performance but also for safety purpose. To avoid the steep gradient for heavy vehicle diversions are given as shown in photo but the heavy trucks not follow the rule & regulation and go straight on steep gradient which results in a higher crash risk. Heavy vehicle (i.e. trucks) need more space due to their large dimensions but the diversions which are given have not proper width. It shows the speed of the heavy vehicle in the uphill grade is slower than passenger cars. This speed difference created delays and reduce the traffic performance of the road. Road traffic accidents increases due to potholes on the road cause the traumatic spinal injuries, bones injuries, etc. The continuous contact with potholes present on the road leads to major effects on the human health like back pain, etc. No. of accidents are increases day by day. Potholes damage to human body and vehicles.

- E. Carry out regular or needy maintenance and markings of road safety signs. Required improvement in the form of proper width at diversion roads. Heavy trucks must follow diversion road with rule & regulations.

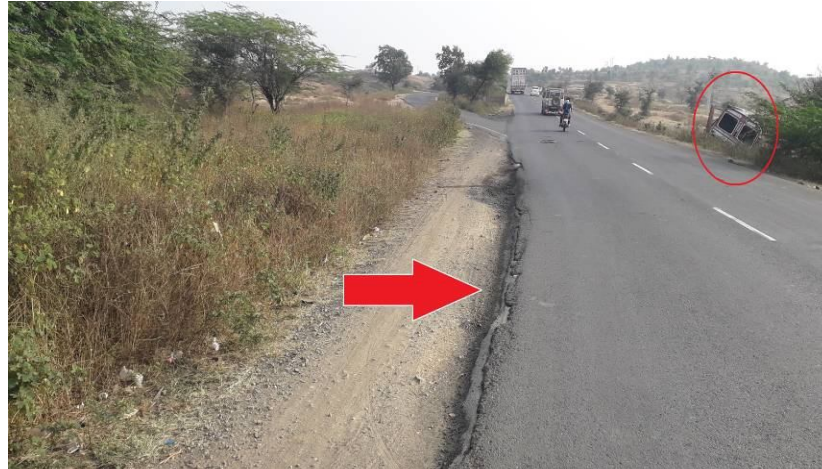
Figure 7:-Improper shoulders at ghat section between Chhegoan Makhan (Kherda village) To Roshiya

- F. Figure 7 showed that shoulders are not trafficable for vehicles and road users due to the damage caused by poor drainage and soil erosion Edge drop observed which may be fatal for high-speed vehicles and motorcyclist .Level difference may cause accidents.

- F. Shoulders shall maintain to the level of the carriageway.
- G. Buses stopped randomly are to be strictly prohibited.
- H. Retaining wall to be constructed to increase formation width. If the side hill is cut then the formation width and shoulder width is increased. There should be proper marking and sign board to warn the vehicles.

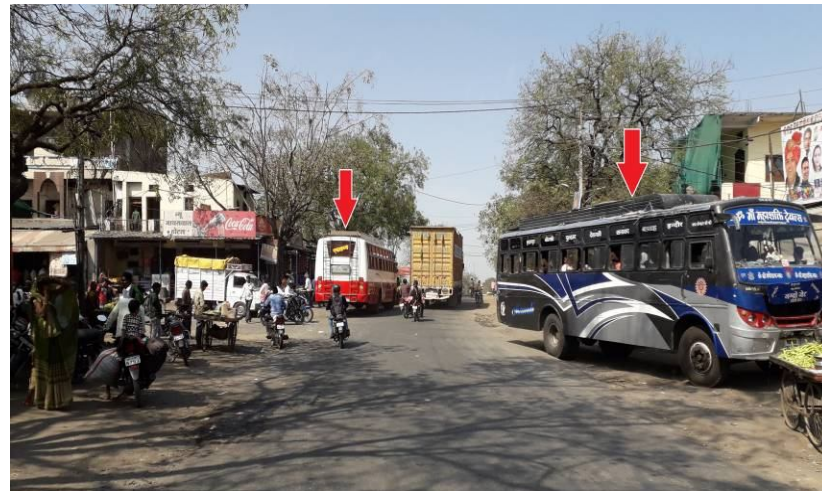
Figure8:- Bus stops on the shoulders of the highway at Deshgaon

- G. Figure 8 showed that due to lack of availability of Bus-Stops, Roadways Buses as well as private Buses stopped randomly. Stoppage makes movement of through vehicles unsafe and on the highway congestion and compels through vehicles to use opposite lane on the highway.

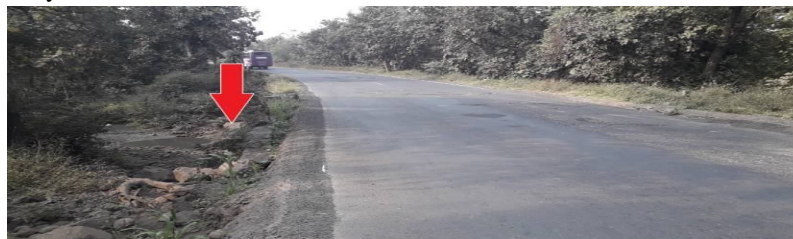
Figure 9:-Formation width is eroded due to excess rainfall.

- H. Figure 9 showed that formation width is eroded due to excess rainfall. Chance of vehicle to fall into drain at night and also it has insufficient berm width. Shoulders are not there on both this place should be declared as non-over taking zone because chance of vehicle to fall into valley at nights Diver may not know the situation of the road ahead, moves with the same speed. This causes the vehicle to lose the control and may be a chance of overturning and after few days the construction of new retaining wall is started.

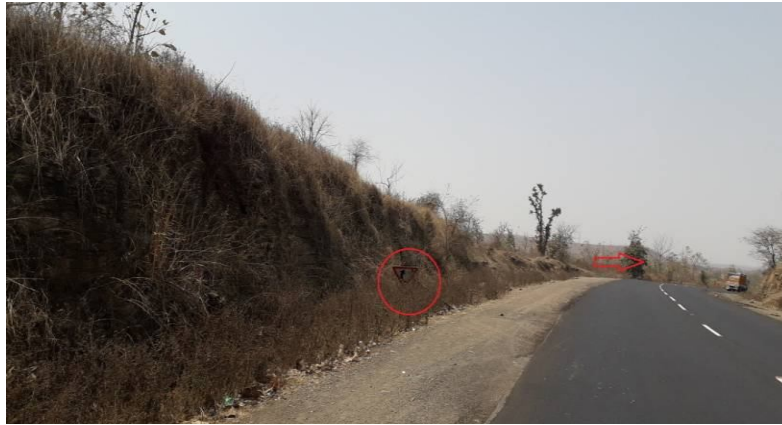
Figure 10:-Sign board direction changed due to wind force or hit by any vehicle

- I. Figure 10 showed that Sign board direction changed due to wind force or hit by any vehicle. Improper directional signs create confusion to the drivers and they mislead the travel time. Sharp curves lessen the sight distance and create tension to the drivers.

- I. Proper maintenance of the sign board needs to be done at regular intervals. Sign boards and markings need to be checked once in six months.
- J. Designated waiting areas for trucks are to be provided. Stoppage of vehicle on the shoulders is to be strictly prohibited.

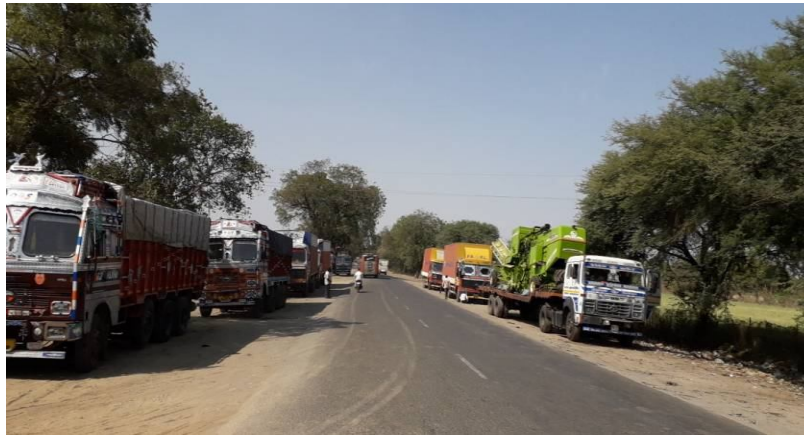
Figure 11:-Provision for Heavy Vehicles

- J. Figure 11 showed that there is no waiting area for trucks waiting. As a result, trucks wait occupying walkway and shoulder. Illegal parking/ stoppage makes movement of through vehicles unsafe. Parking of trucks on the shoulder creates congestion and compels through vehicles to use opposite lane on the highway. Parking vehicles can create a blind spot and they will be as an accident causing elements on roads

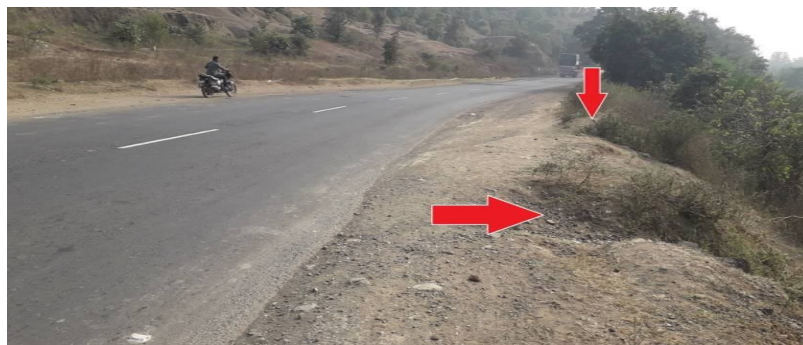
Figure 12:-Unguarded deep valley

- K. Figure 12 showed that deep valley Unguarded deep valley adjacent to road. Hazard for a vehicle to ran into the valley during poor visibility and rains. Guard rails are to be provided to prevent the vehicle from falling and rumble strips are to be provided to alert the driver near the valley. Due to damaged shoulder makes movement of through vehicles unsafe. Vehicles may be fall into the valley during night.

- K. Guard rails are to be provided to prevent the vehicle from falling and to alert the driver near the valley. Rumble strips are to be provided to alert the driver near the valley.

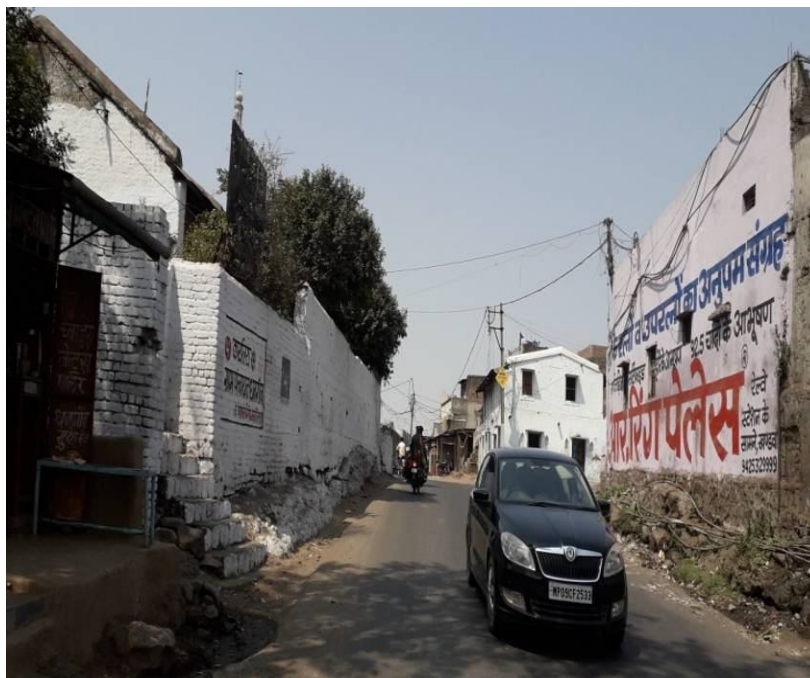
Figure 13:- Shoulder, carriageway width & sight distance due to occupation of wall at dhangoan

- L. Figure 13 showed that the obstruction to line of sight is insufficient sight distance due to occupation of wall. The sight distance along the road is inadequate or restricted when wall is on the edges of carriageway. Obstruction of sightlines to stationary objects or oncoming vehicles. Inadequate sight distance results in a shorter reaction and response time available to the driver when the change is sighted, which results in a higher crash risk. Besides, due to obstructed longitudinal sight distance, drivers assume continuation of the present conditions, though alignment changes or traffic hazards suddenly appear. Highway requires wide shoulders on each side. Shoulder width and condition is absent at near Dhangoan village on highway (SH 27). It is observed that at this area with high concentration of vehicles and pedestrian such as bazaar, village, bus-stands etc. The jams occur only when a truck or any other heavy vehicle breaks down in the mid of the road. As the stretch is narrow, it becomes difficult for other vehicles to pass on it.

- L. The wall should shift at some distance to clear the line of sight. In order to improve pedestrian safety, raised shoulder is recommended. Shoulder should be maintained by increasing width.

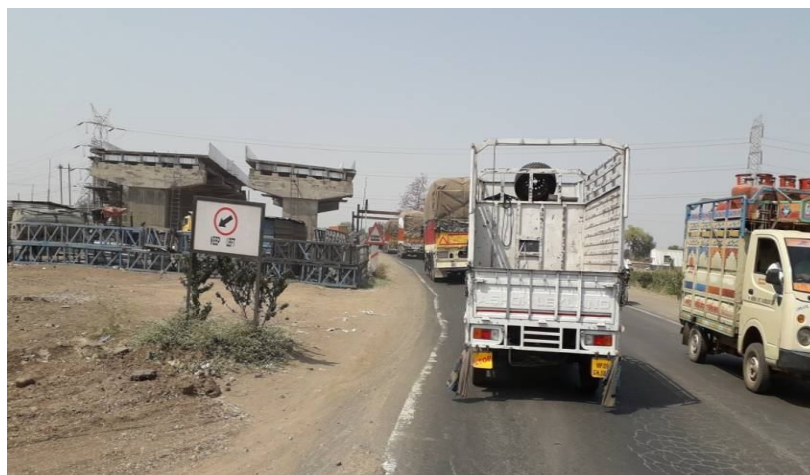
Figure 14:- By having construction of bridge and broad gauge railway on these path problems of traffic jams is raised frequently

- M. Figure 14 showed that by having construction of bridge and broad gauge railway on these path problems of traffic jams is raised frequently. By having construction of bridge and broad gauge railway creates congestion. Waiting or stoppage of vehicles can create a blind spot and they will be as an accident causing elements on roads. The road becomes unsafe and pedestrians are unable to use shoulders.

- M. Due to speed difference, light vehicles need to have a diversion for it not only to improve the traffic performance but also for safety purpose
- N. Guard rails are to be provided to prevent the vehicle from falling and to alert the driver near the river. Rumble strips are to be provided to alert the driver near the river.

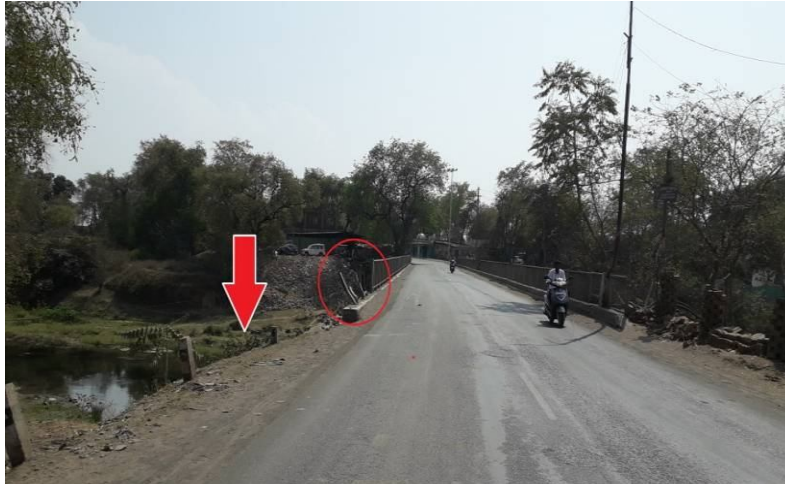
Figure 15:- Guardrails are broken at Sanawad Bridge

- N. Figure 15 showed that guard rails are not there to prevent the vehicle from falling and to alert the driver near the river. Hazard for a vehicle to run into the valley during poor visibility and rains. During night Vehicle may fall into the valley.

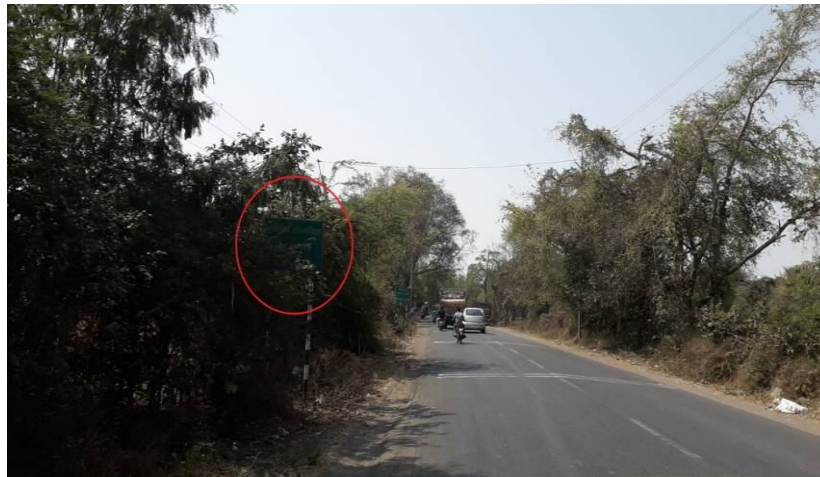
- O. Figure 16 showed that signs board are not at all visible due to vegetation this board also not visible from a distance due to vegetation. During day time due to the shadow of vegetation sign board is not visible.

- O. Tree branches need to trim at regular intervals to maintain visibility.
