# Structural damage at Florida Cando Complex – An Overview

**Abstract:** In this paper the structural damage at Florida complex is being discussed. In spite of an early report by engineering consultant, giving evidence of possible structural damage and necessity of repairs required, the delay in repair works resulted in a catastrophic collapse of the building in the middle of the night. The study on this collapse of the building opens the discussion on timely actions to be taken during the construction as well as maintenance of the buildings.

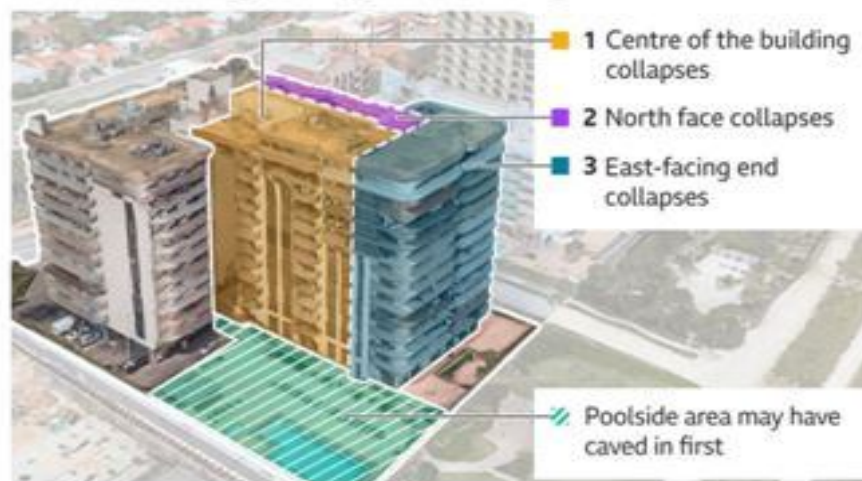
### The building collapsed in stages
