Review of Failure Analysis of Ground Level Reservoir and Remedial measures

Abstract - This paper presents failure analysis of ground level reservoir. During operation one side wall of the Ground Level Reservoir collapse. The detailed study involves preliminary assessment of structural conditions, detailed analysis of causes of failure. A major part of the civil Engineering infrastructure will need significant repairs. This innovative rehabilitation and strengthening method of reinforced concrete ground level reservoir can be done after assessing the failure reasons due to the stresses developed in extremely loaded condition.

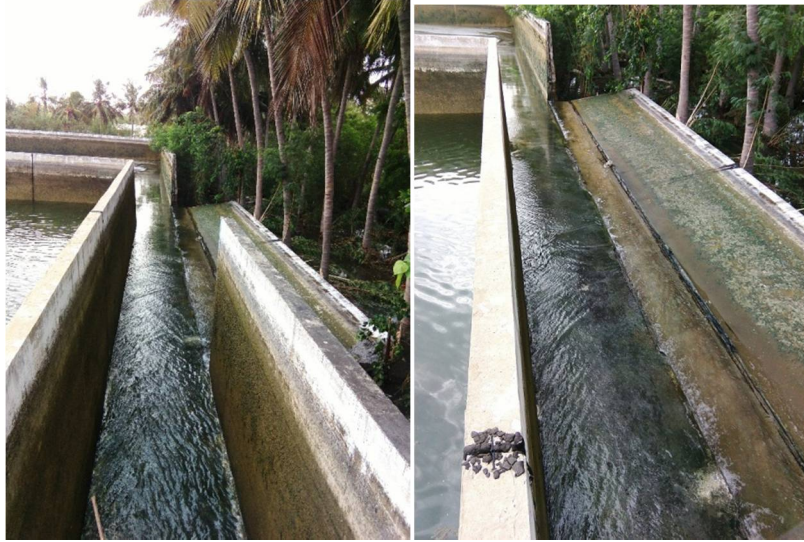
Figure 1 : Collapsed Ground level reservoir Photos

On 12.07.2015, a portion of the wall toppled as a rigid body near the beginning of diversion channel. The separation occurred at the raft and side wall connection. At the time of collapse, the level of water is approximately 90% of its capacity.

This indicates that the pressure all along the wall is higher than the design pressure at the time of failure. The higher pressure causes the shear failure of rods and the wall was collapsed. The photograph shows the collapsed wall and three places where the concrete and rod samples collected. The higher dynamic pressure may be due to the sudden drawl of water from the compartment.
