# A Case Study on Reliability Improvement of New Bar Mill Stand Gearboxes

Ankush Sharma<sup>1</sup>, Himangshu S Mandal<sup>2</sup>, T Thirumurugan<sup>3</sup>, N Rajesh Kumar<sup>4</sup>, Md Perwaiz Kaiser<sup>5</sup>, Rajiv Garg<sup>6</sup> One Shared Services Technology Group, Tata Steel Limited, Jamshedpur, 831001, Jharkhand, India

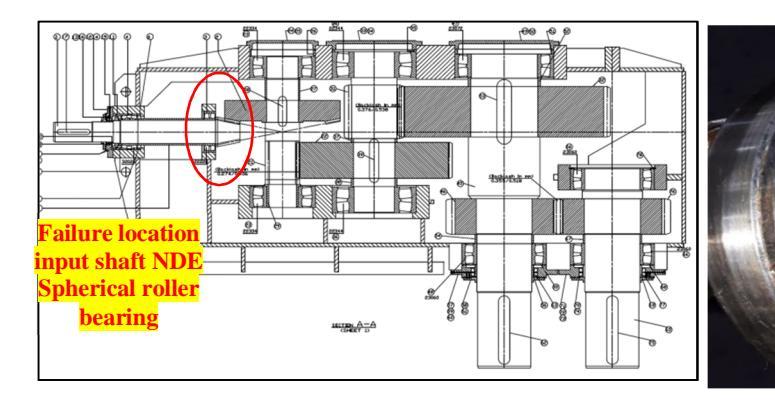
Fig.2 GA drawing of NBM stand 1 Gearbox

In all the failures of Mill stand gearboxes of NBM in recent past, it has been observed that input shaft bearing was failed and in some cases input shaft gear teeth were also damaged due to misalignment generated post bearing failures. On Spet'2020, NBM stand no 1 vertical gearbox input shaft Non-drive end (NDE) spherical roller bearing was found damaged as inspected through inspection cover after hearing abnormal sound coming from gearbox.

Heating marks were found on bearing rolling elements with cage breakage and few rolling elements came out from cage refer figure 2 & 3. This gearbox (overhauled) failed after giving service life of 1.1 year.

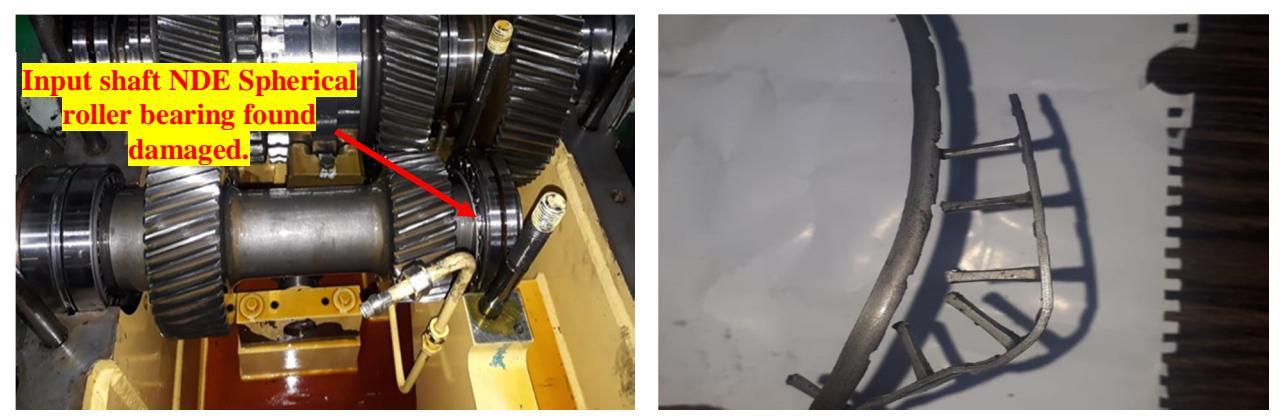
In past also in 2019 abnormal sound was observed during rolling from stand no 16 gearbox. Mill was stopped for inspection of stand no. 16 gearbox by opening the inspection covers and it was found that input pinion shaft NDE spherical roller bearing cage broken refer fig.4 & 5. Similarly, in 2018 Stand no 15-gearbox failed during service with same phenomenon of input shaft NDE bearing damaged & gear teeth damaged refer figure 6. In all the cases the gearbox was failed very prematurely within 2 years. Normally for Mill duty gearboxes ideal TBM is 5 years or more in some cases.

Fig.4 Failed gearbox of stand no 16 Fig.5 Broken cage bar of input shaft bearing of stand no 16-gearbox

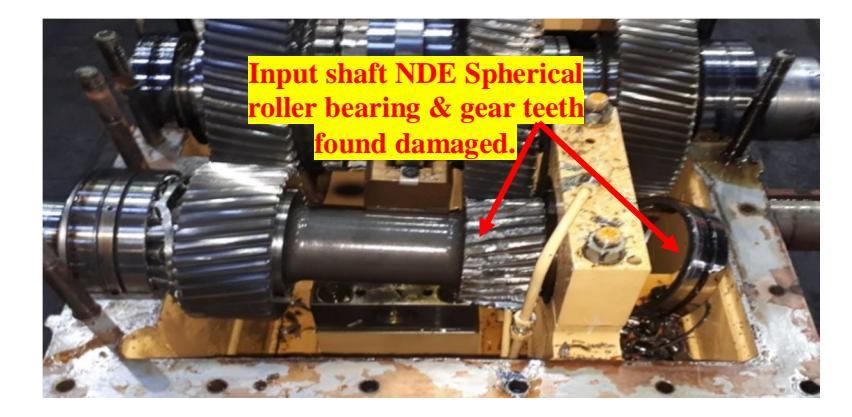
Fig.6 Failed gearbox of stand no 15

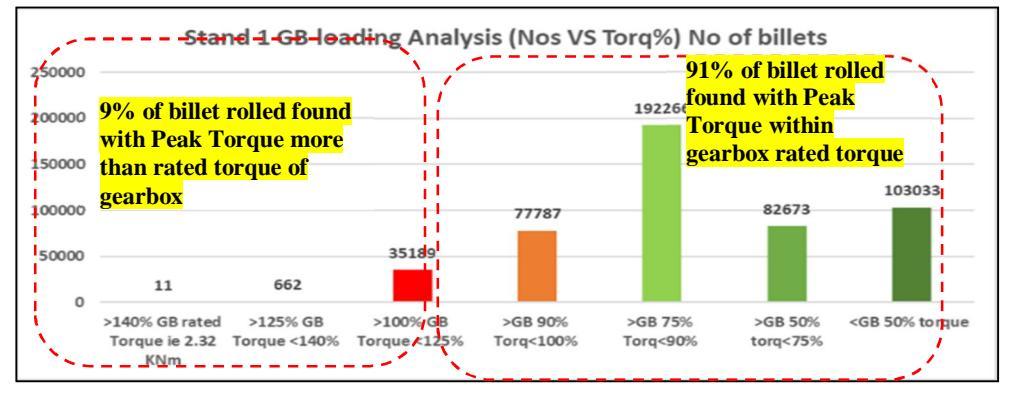
Fig.7	NBM	Stand	no 1	l load	analysis.

IBA Data was analyzed for all stands during the last one year. The load trend from 01.09.2019 to 22.09.2020 for stand no 1 is plotted in graph trend & given below in figure 7. From below data analysis, it was found that in past one year, there are 35,862 nos. of billet rolled which had peak toque value more than 100% rated input torque of gearbox which constitute around 9% of total billet rolled in a year (i.e. total 4.6 lakh billets) whereas for rest 91% billets peak torque was found with in rated capacity of gearbox. As per Mill duty gearbox standard AGMA 6010, only 7 peaks (during start stop i.e. momentarily occasional peaks) are allowed in a day more than rated torque capacity of gearbox. However, there is no standard available for operation peak load more than 100% and it is addressed through proper selection of gearbox. Taking 7 occasional peaks per day, in one year around 2500 occasional peaks are allowed but in this case of stand no 1, number of billets having peak torque more than rated capacity was large in numbers ie around 35,862 in which 662 no's of billets were critical cases where peak torque had gone more than 125% of rated input torque & 11 nos. were high impact load cases when peak torque was found more than 140% of rated gearbox torque as shown below in table refer figure 8

- For all mill stand gearboxes high torque alarm to be given on gear box nominal input torque rating (for example Stand#1 nominal Torque load is 1.65 KNm). If it goes beyond the nominal input torque for 5 seconds, then it will trigger an alarm and auto stoppage of subsequent billet discharge from furnace for 3 minutes.

- Current logic of stand 1 trip at 90 % (2.5KNm) motor torque in case of cold billet to be changed to 78 % (1.91 KNm). Trip command to be generated if stand 1 cross 78 % of motor torque (which is 120% of gearbox nominal torque value) for one second. Tripping of stand#1 in case of cold billet having low temperature will not allow the cold billet to move further in other mill stands thus avoid overloading.

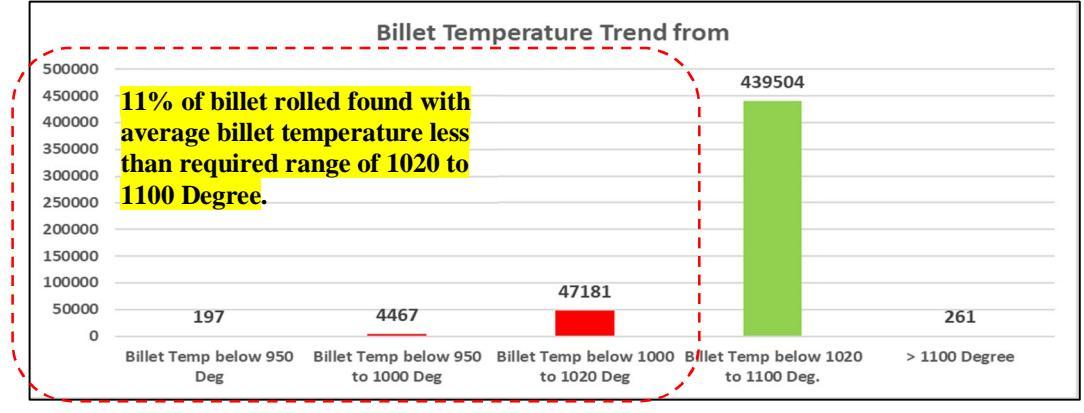
Fig.9 Billet Temperature Analysis

All above 11 nos. critical cases were happened in recent 3 months (i.e between July to Aug'20) and billet temperature was found lower than required range  $1020 \,^{0}$ C to  $1100 \,^{0}$ C which means billet soaking & heating was not done adequately and led to high rolling peak torque. Billet temperature trend for last year also plotted below in bar graph as shown in figure

Around 11% of total billet rolled in past one year was found with average temperature less than required range of  $1020 \, {}^{0}$ C to 1100  ${}^{0}$ C which is closer to peak torque cases of 9% in which torque was found more than 100% of the rated capacity of the gearbox. On 25<sup>th</sup> July at around 11 pm, Maximum peak torque was found 125% of motor Torque ie 3.05 KNm which is equivalent to 180% of gearbox rated torque when the billet temperature found below 950  ${}^{0}$ C (fig.10).

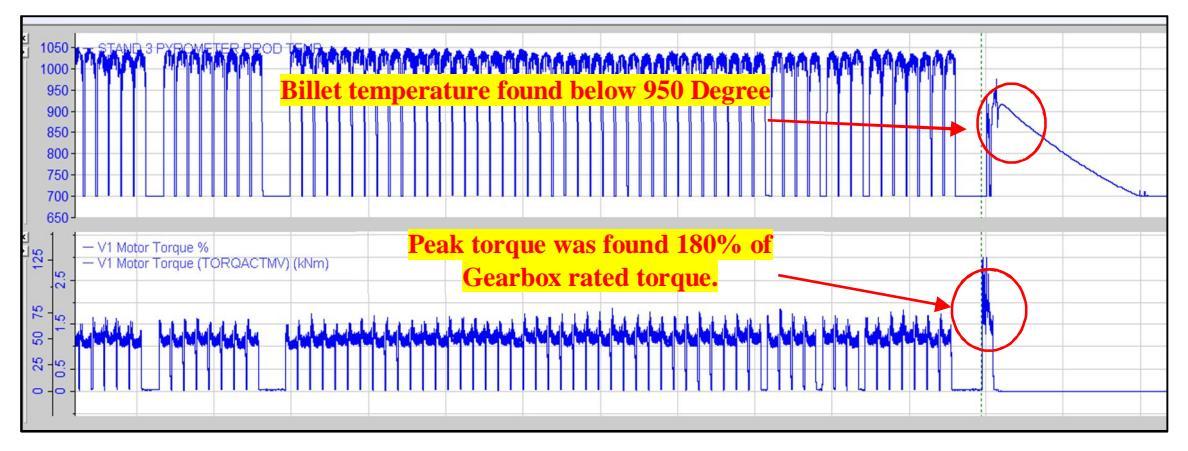
Fig.9 IBA data Analysis on 25th July'20

Such high impact torque load is detrimental for bearings cages & caused initiation of cage breakage.
