Road Safety Audit: A Detailed Analysis of Dhandhuka to Dholera (SH-20) in Gujrat State

Mateen Ahemed¹, Dr. Sunil Sugandhi² Jawaharlal Institute of Technology, Borawan, Khargone

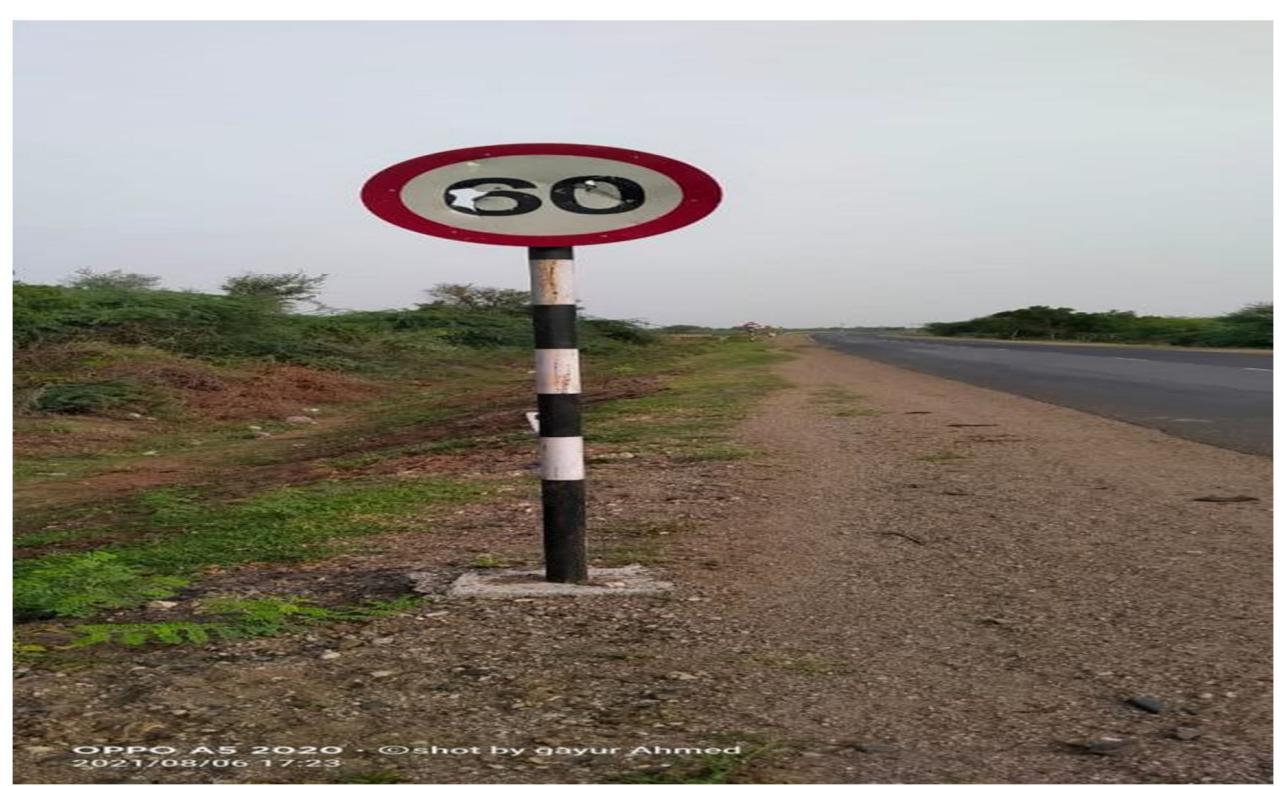
Ch. 26+500 Damaged speed limit sign board

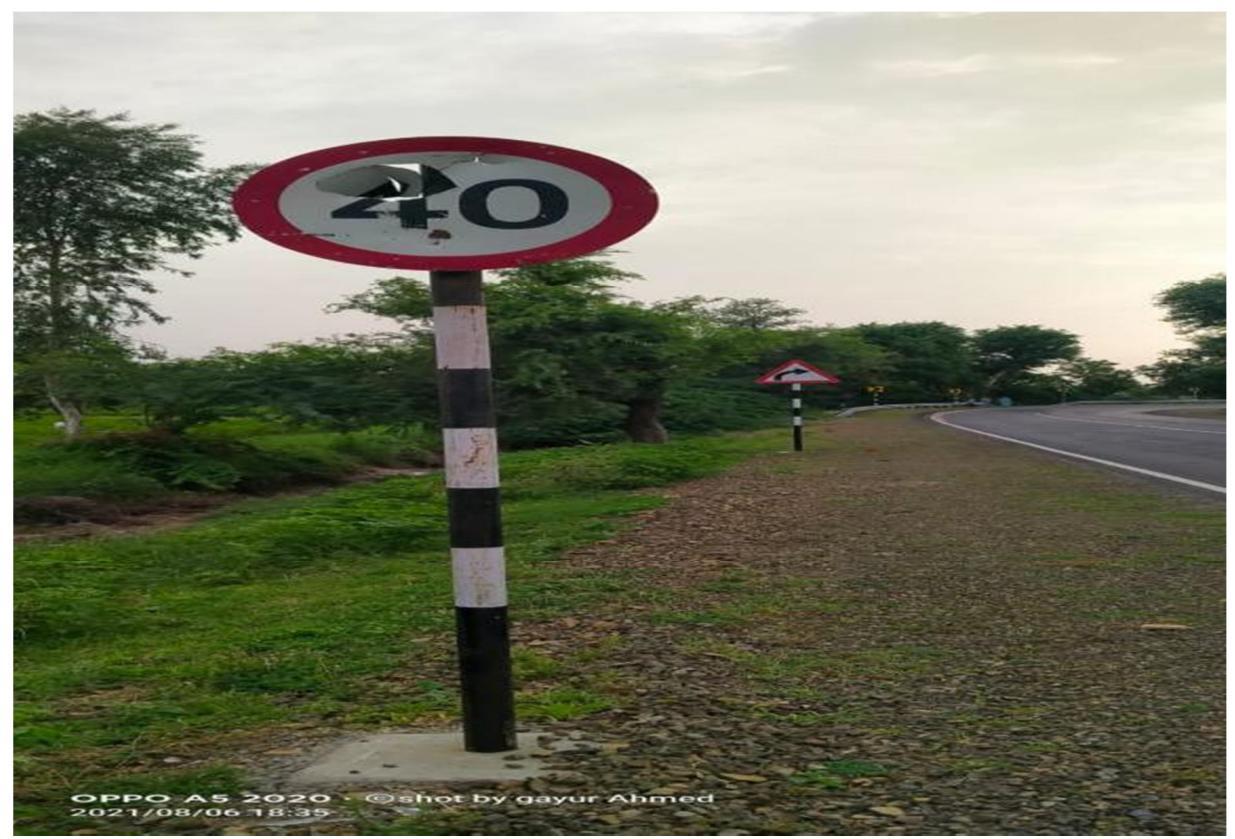
Ch. 16+485 Speed Limit sign board found in damaged condition

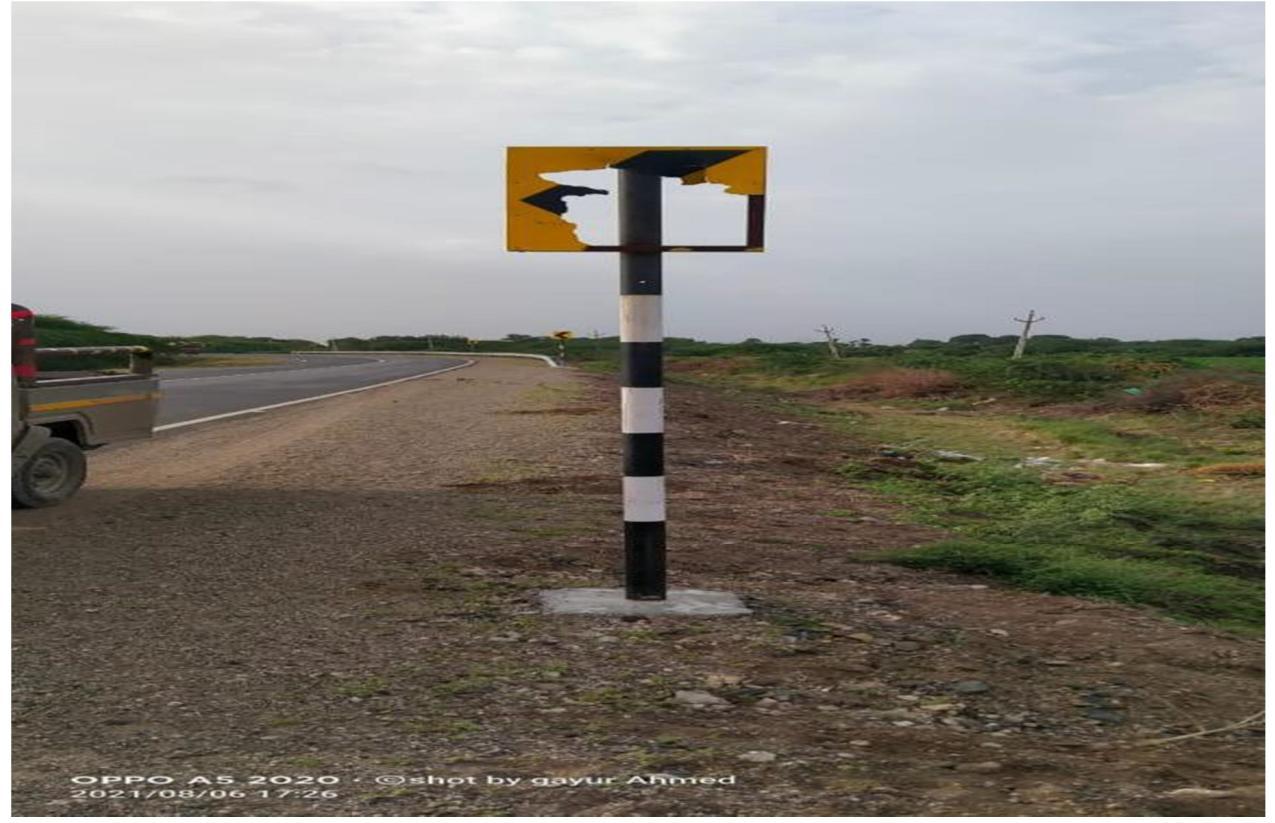
22+300 Left turn chevron sign board found in damaged condition

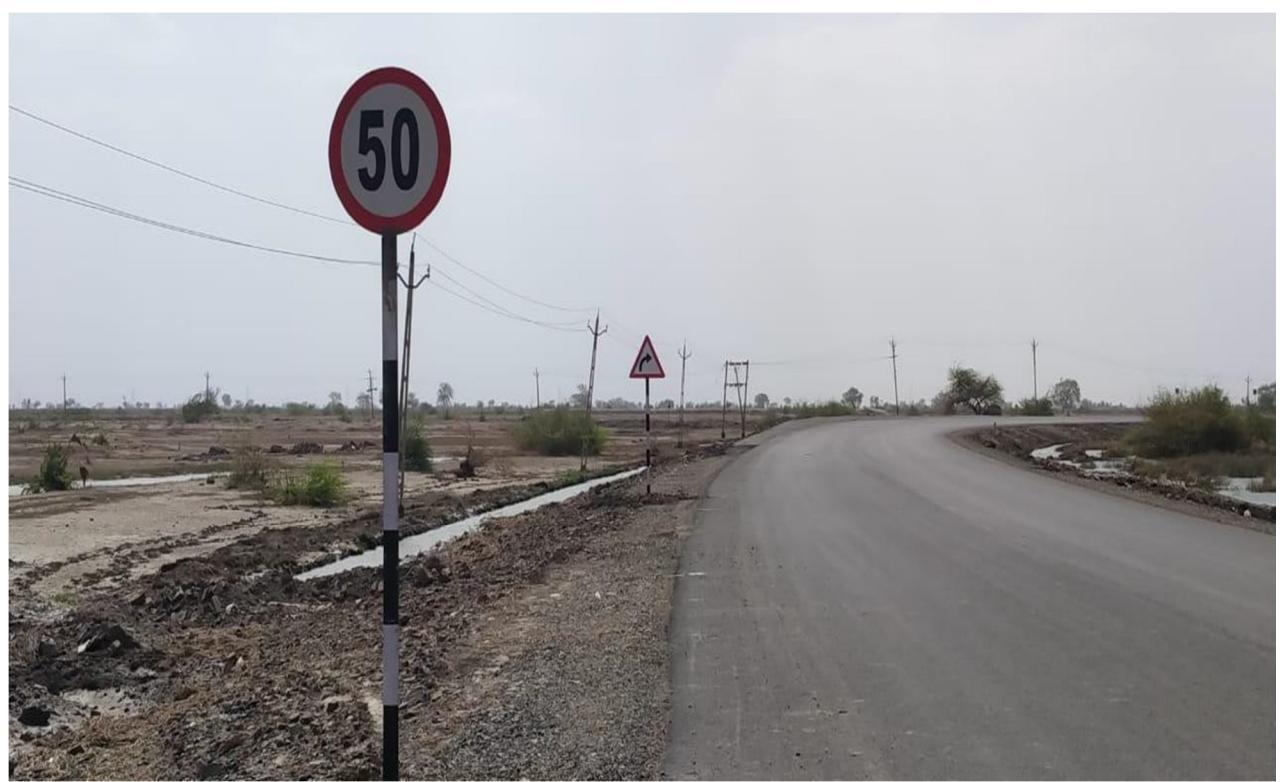
Ch. 20+900 Missing road marking & rain cuts observed near earthen shoulder

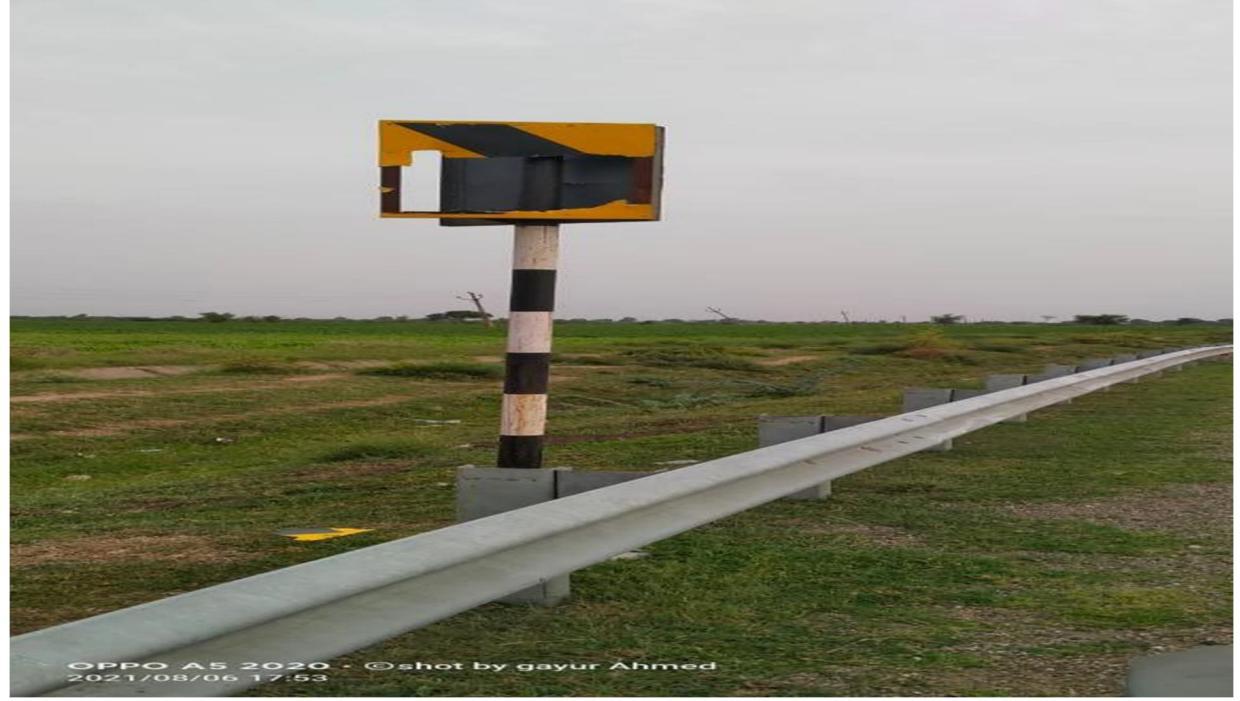
Ch. 16+440 Right hand chevron sign board found in damaged condition

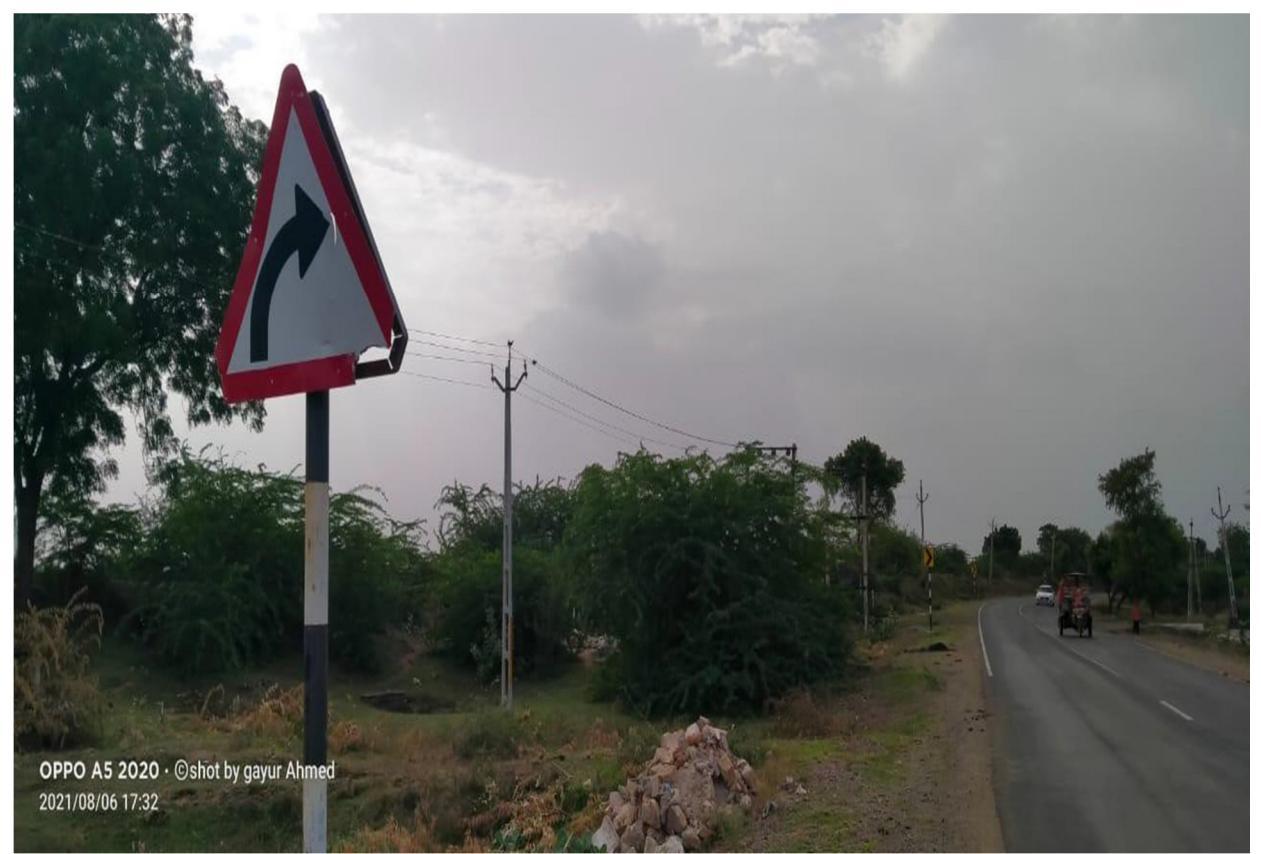
Ch. 3+635 Left turn sign board found in damaged condition & construction material dumped near shoulder

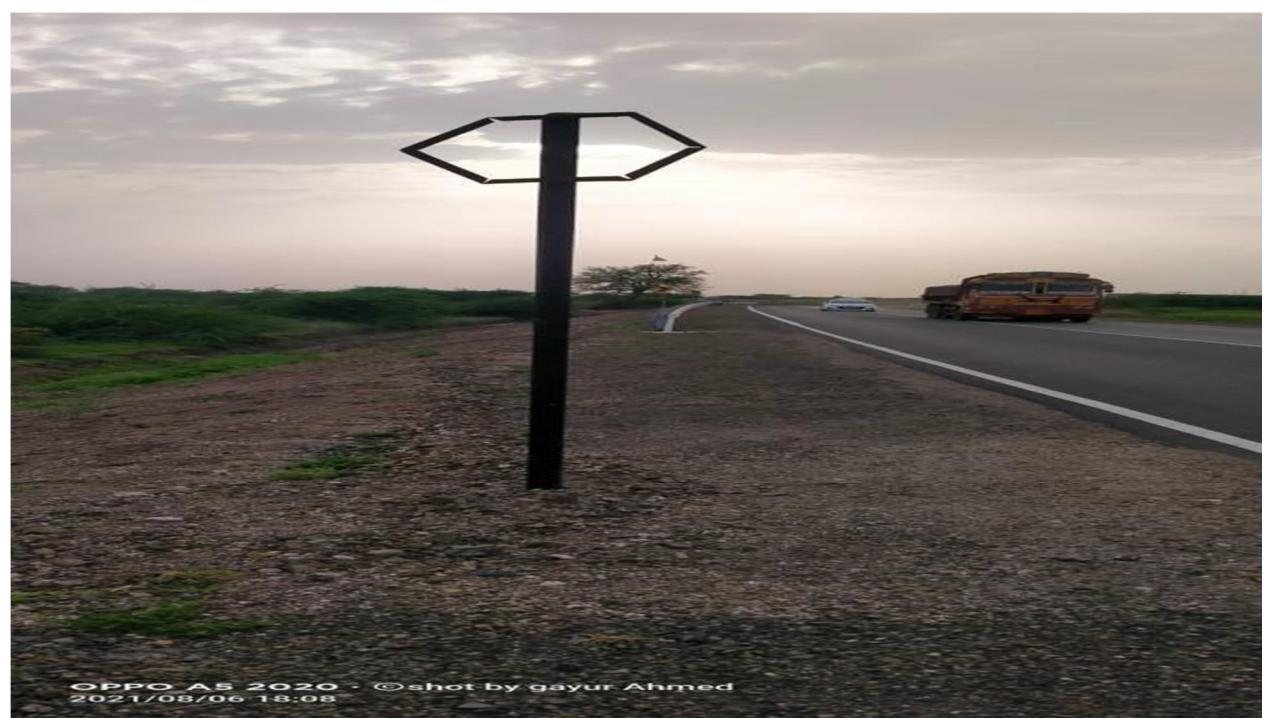
Sign board found damaged at Ch. 7+290

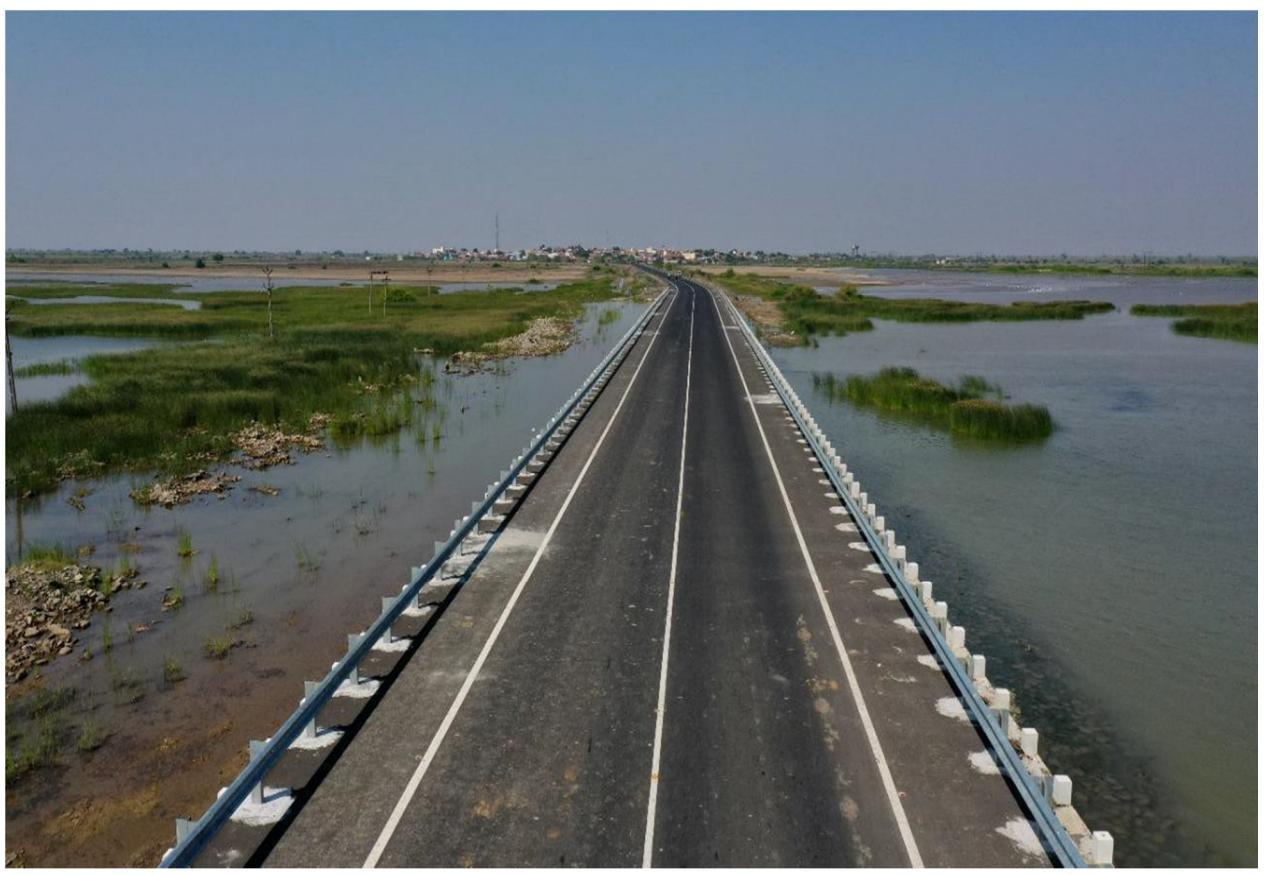
24+260 Left turn chevron sign are missing & protection wall has been suggested in place of W-Beam cross barrier

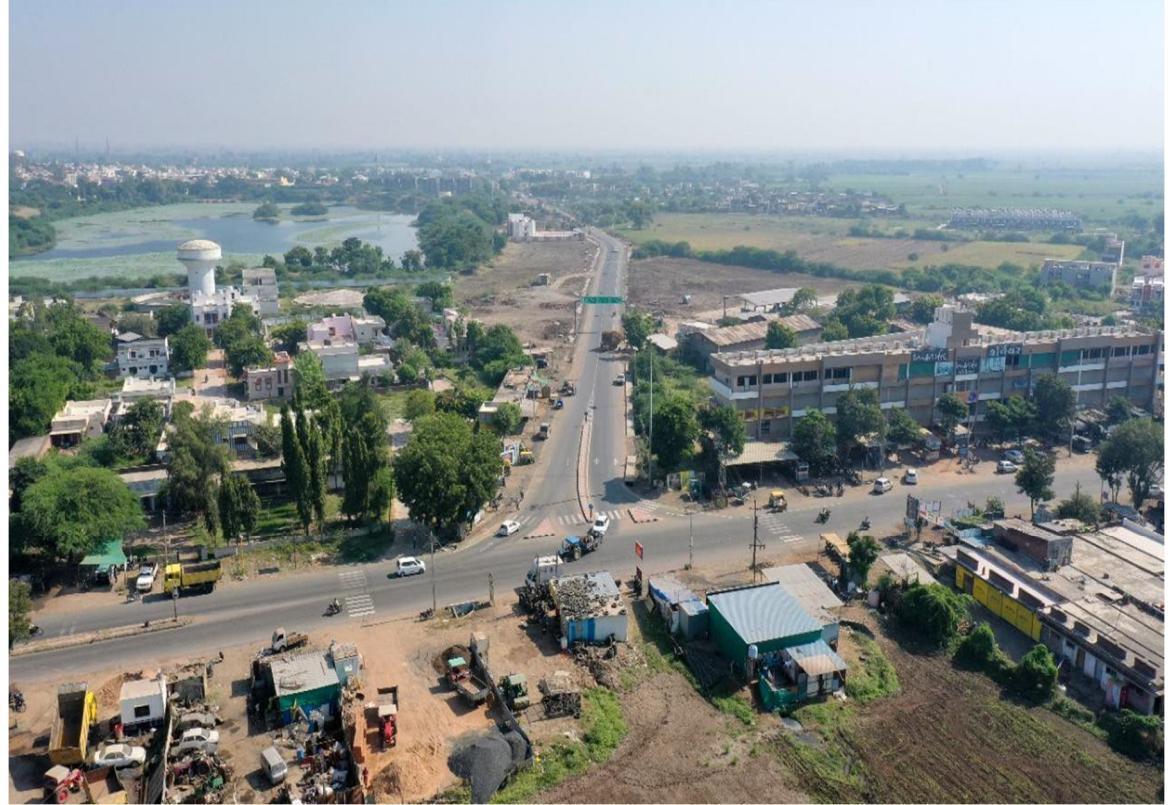
Ch. 0+000 Black Spot point Observed

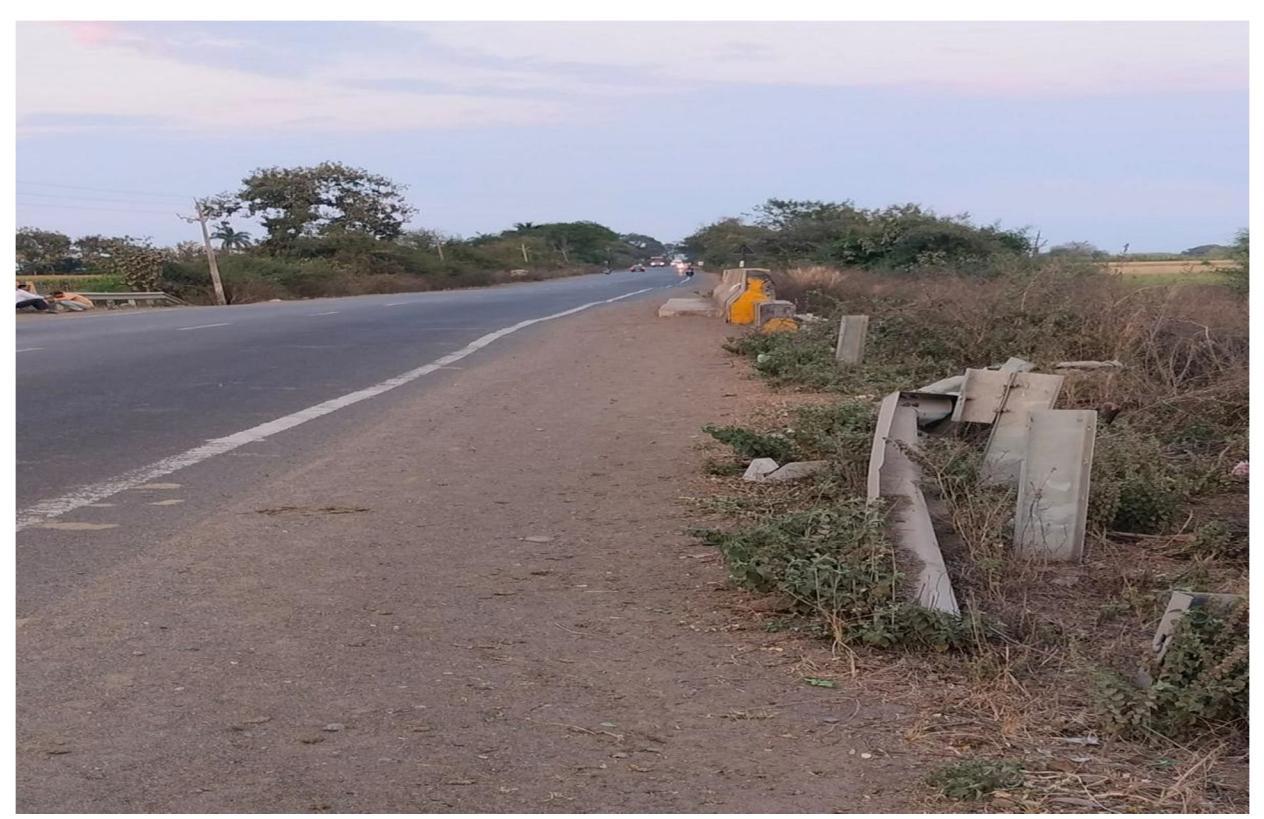
Ch. 15+750 Metal Beam Crush Barrier (MBCB) damaged must be repaired

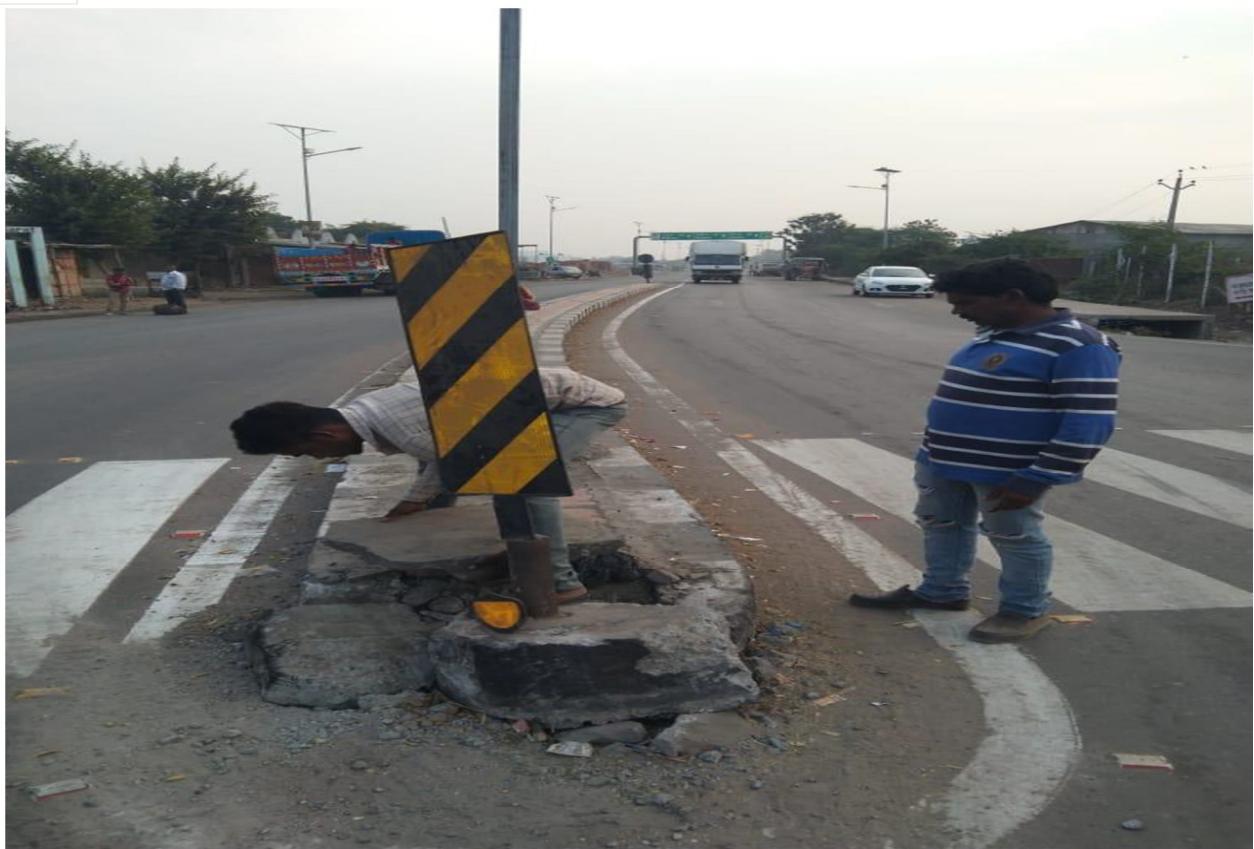
Ch. 0+010 Damaged delineator sign board should be changed & median side kerb should be repaired.

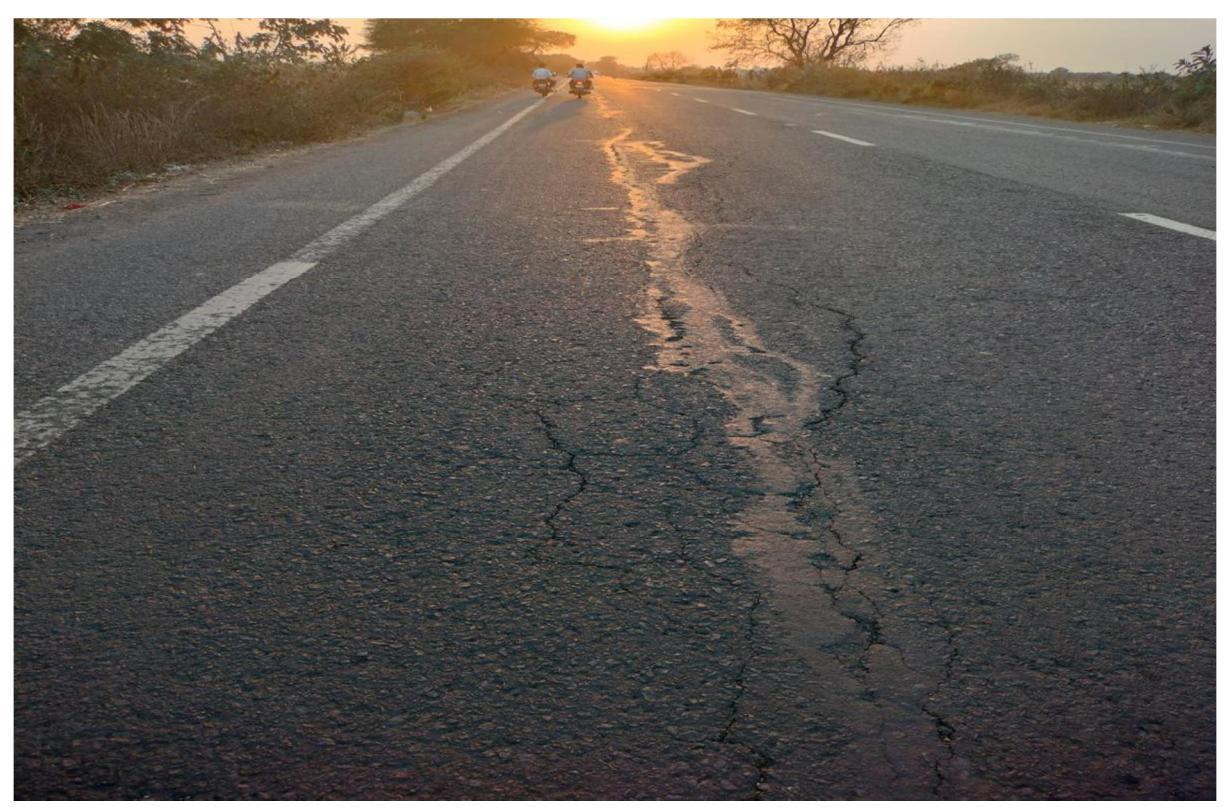
Ch. 3+530 Alligator cracking is observed on Pavement Surface

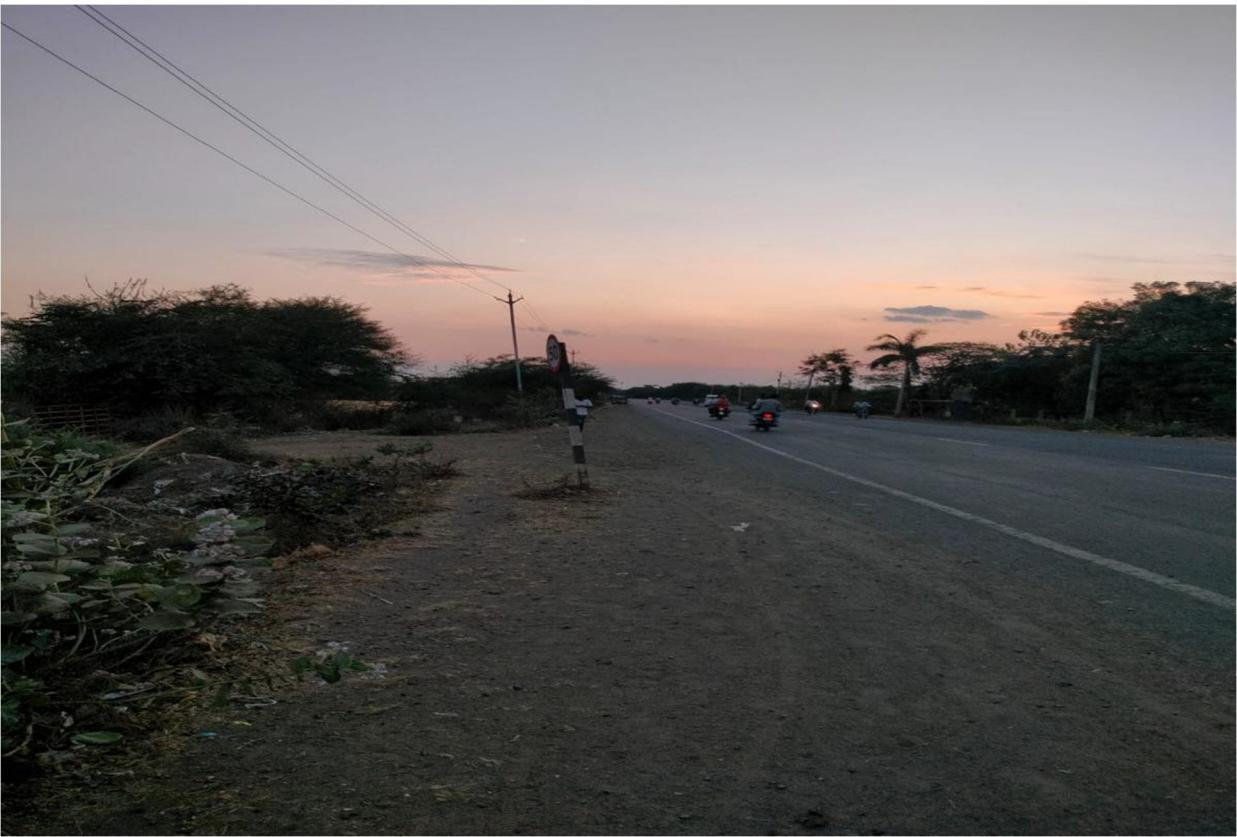
Ch. 20+560 Damaged Speed Limit Sign Must be repaired

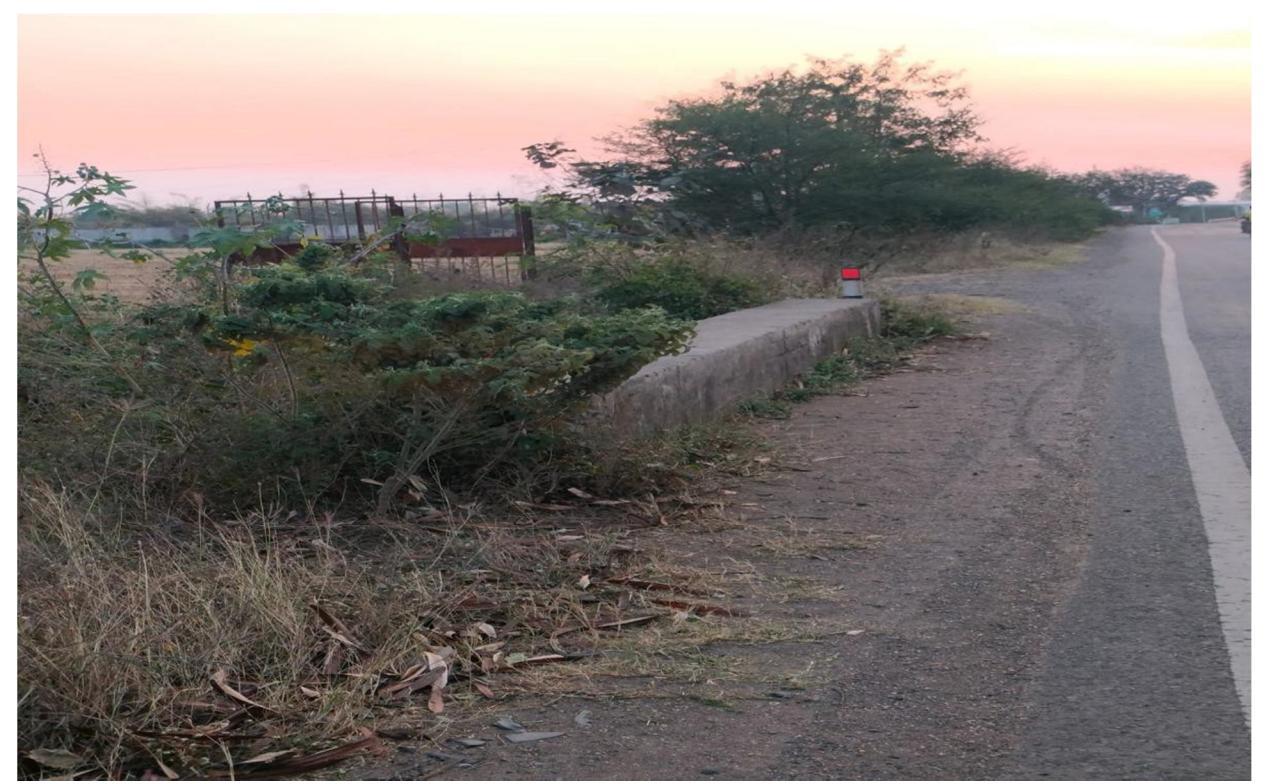
Ch. 17+574 Pipe Culvert Should be painted as per specification
