# Seismic Assessment of Unreinforced Concrete Block Masonry Buildings Before and After Retrofitting: A Case Study

Abstract: This article presents the results of a case study on the performance of unreinforced concrete block masonry building system. The configuration and materials used for the single-story building are typical of those found in the northern areas of 2005 Kashmir earthquake. The retrofitting of the building was done using Ferro-cement overlay and cement based grout injection. Combined shear and flexure failure was observed during the test before retrofitting. The lateral load capacity of the retrofitted building was significantly improved and the damage mechanism was transformed from mixed compression-flexure-shear to a more stable flexural rocking mode. Damage patterns and deformation behavior of the retrofitted structure are compared to the intact structure to quantify the benefits of retrofitting scheme, which is proposed as an efficient approach for the rehabilitation of the existing buildings. Study data were analyzed and presented in the form of force-deformation loops and envelope curves. Based on the measured data, different performance levels before and aft

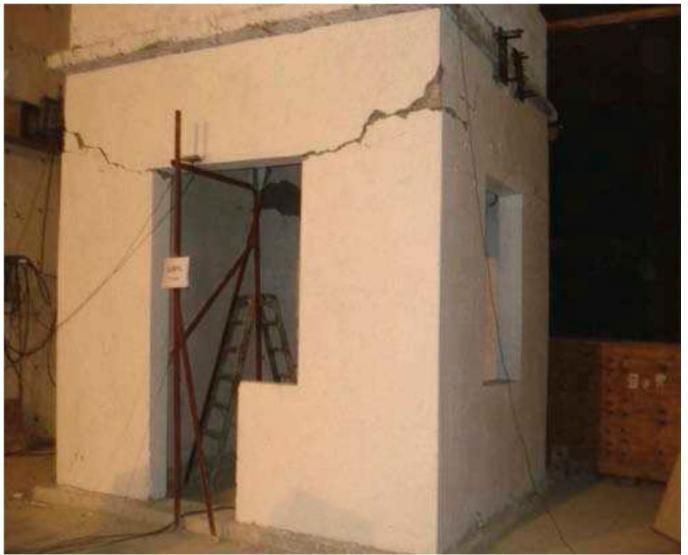
The cracking pattern of the structure after retrofitting is shown observed damage at the in-plane north wall and out-of-plane east wall are provided. A spiral cracking pattern rather than stair stepped pattern was observed for the retrofitted building. The increase in the thickness of the walls due to the application of the ferro-cement overlay caused a reduction in the aspect ratio, which resulted in a stable rocking mode of failure rather than a mixed compression-shear failure.

Fig. Final damage pattern for the retrofitted building

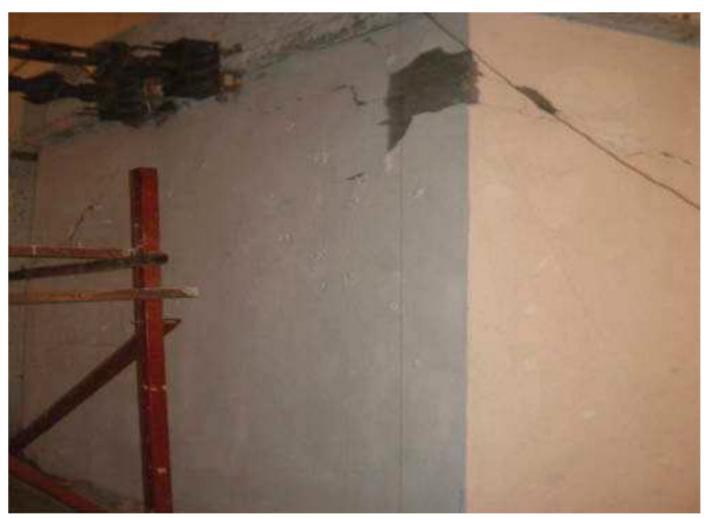
Fig. Falling of plaster observed on retrofitted building.
