Improvisations in Traditional Lime Work, Punjab, India

The case for study is a traditional historic Havelli (Mansion) in Punjab restored by the author as site Conservation Architect under the guidance of CRCI, New Delhi. The project was completed in a span of 6 months in 2008. Many a restorative techniques used are non-conventional and help in giving a new direction to the traditional processes of restoration.

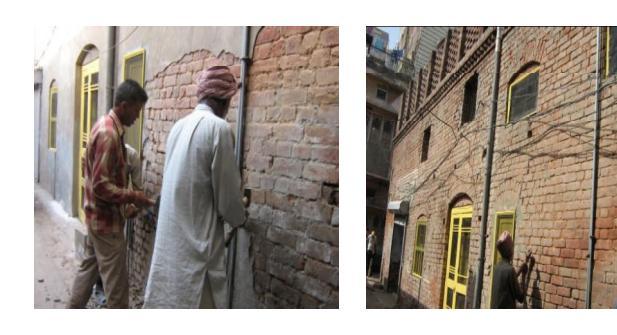
Cement Plaster removal

- 1) Plaster removal: The very first step taken was to expose all the wall surfaces and get rid of the multiple layers of white wash and cement plaster. The complete external wall was exposed to check the status of the masonry beneath; the condition of the brick and the mortar joints. Salt of crystallisation was observed on the wall surfaces due to rising damp. The plaster on the internal wall surface was removed till the height of 2ft. the thus exposed wall surface was left to dry and the trapped moisture in the walls to evaporate due to aeration. This process of drying can take days and months together depending upon the extent of moisture content. Processes in restoration are time taking and need a lot of patience to be dealt with for best results as against the tendency of fast production in contemporary construction.

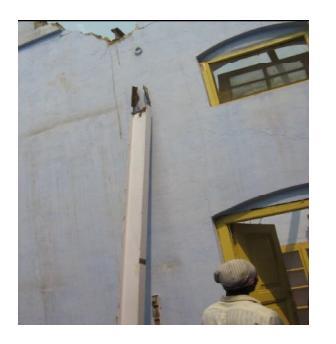
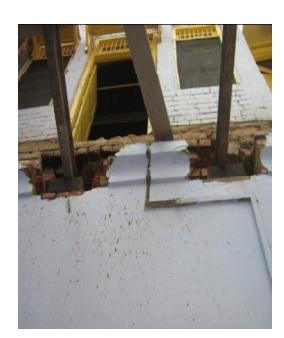
Corroded iron girder end

- C. Checking of Iron Girder Ends and structural strengthening
- 1) Iron girder ends: The iron girders in one room seemed to be sagging while in rest of the rooms the girders on visual inspection seemed stable before removal of the roofing. Once the roofing layers were removed, the ends of these girders embedded in wall were exposed. This brought to light the most precarious condition of the girders, unimaginable during visual inspection. In the past it seems that the original wooden purlins were replaced by iron girders, during which time a blunder was committed by the masons. The iron girder was embedded in masonry with lime mortar joints. Lime has a highly corrosive effect on iron, hence they should never be placed in close proximity to each other, this was not taken into cognizance by the earlier masons, due to which the iron girder ends in contact with lime mortar corroded over the years. The girders would have collapsed any moment if not checked and replaced. The masonry in immediate contact with iron girders were laid in cement mortar 1:2, while rest of the wall was restored in lime mortar 1:2.

- *3) Structural strengthening*: As per the advice of structural engineer the iron girders were structurally strengthened by stiffening of ends. This was achieved by welding iron hollow pipe sections 32mm nominal bore size, 2.60mm thick weighting 2.54kg/m at the ends of iron girders.

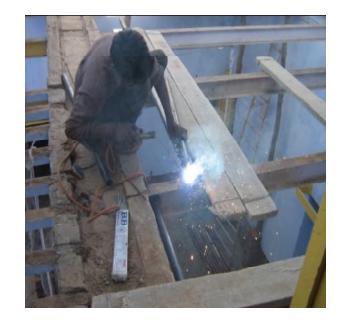
Welding of hollow steel pipes

Insertion of wall pad

- 2) 2. Wall pad insertion: The cracks in masonry due to point load of girders positioned directly over wall surface were a cause for concern. Thus, a wall pad of deodar wood, 450mm x 200mm x 300mm treated with anti-termite portion was inserted as a wall pad over which the iron girders were made to rest at the centre. This would ensure that load of the girders gets evenly distributed over the wall and cracks would not develop due to point load.

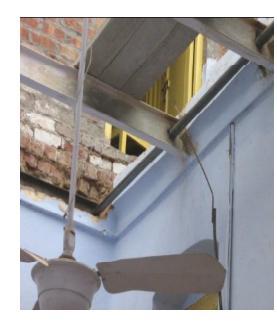
Strengthened beams

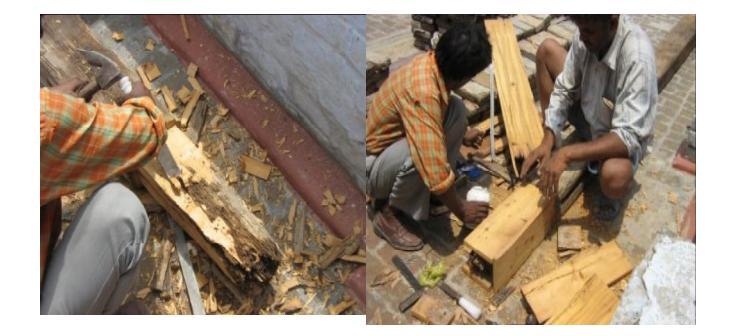
Removal of wood end

Deodar wood planks

The original wooden beam in one of the rooms was in a good state but the ends were deteriorated due to moisture content in wall. This end section of the wooden beam was consolidated. The weathered part of the beam was chiselled and removed. The end was encased within new planks of deodar wood 20mm thk. and the gap was filled with wood shavings mixed with resin of industrial bonding. This beam was then rested upon wooden wall pad.

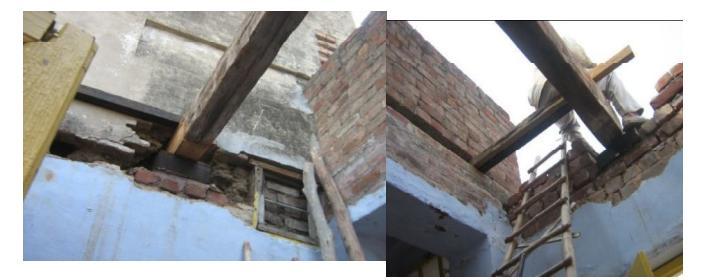
Insertion of wood pad

Wooden purlins laid

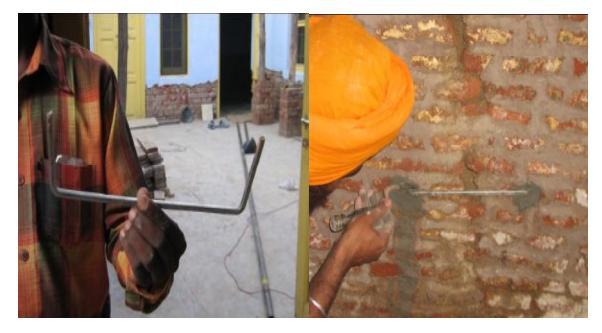
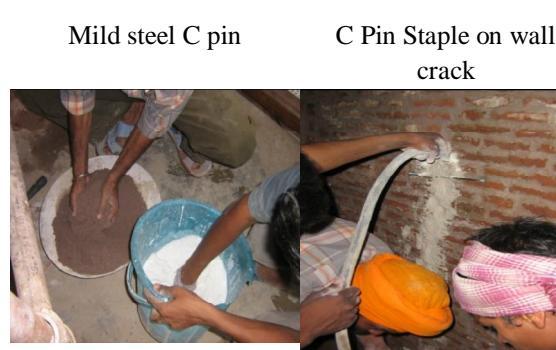
Lime grouting mixture

3) Lime grouting: lime pressure grouting was undertaken for consolidating a crack in masonry. The crack was first stitched with mild steel C Pins of 10mm dia. Thereafter, the crack was filled with lime grout forced into the fissures of the masonry through a grouting machine. The lime forced with pressure reaches the internal fissures of the masonry and fills in the gap. This operation though proved to be a failure in the said case and the wall in 24hrs time bulged out. After further investigation into the cause of the same, it was learnt that the wall so treated has internal mud mortar layer and the thus the mud after absorption of moisture from lime grout swelled up causing the bulging effect in the wall.

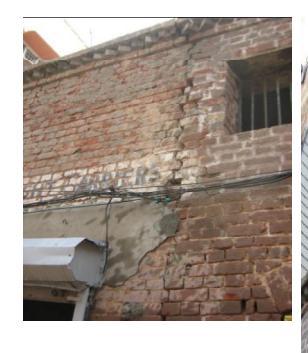
Crack in masonry

Crack masonry opened up

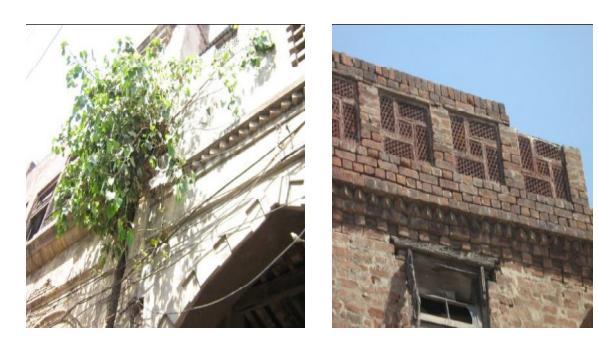
Vegetation in wall joints

Parapet in distress

A Peepal plant had taken roots into the masonry of the Havelli, this could cause collapse of the wall if the plant was not removed. Plants if not carefully and completely removed have a tendency to regrow. The plant was injected with chemical compound which slowly dried up the plant. The masonry along the roots was removed to pull out the entire vegetation growth. Terracotta jaalis from the adjacent property belonging to the client were carefully removed and cleaned. These jaalis are rare as they are not casted anymore and have been replaced steadily be cement jaalis in the market.

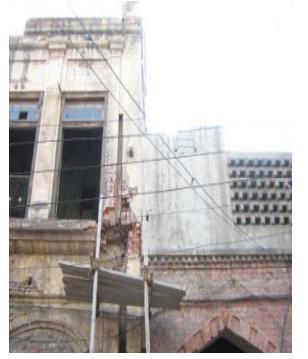
Vegetation removed

Terracotta tile restored
