## International Journal for Research in Applied Science & Engineering Technology (IJRASET) Review of Failure Analysis of Ground Level Reservoir and Remedial measures

T.Vijila<sup>1</sup>, N.Sakthieswaran<sup>2</sup>, G.Shiny Brintha<sup>3</sup>, O.Ganesh Babu<sup>4</sup> <sup>1,2,3,4</sup>Department of Civil Engineering <sup>1,2,3,4</sup>Anna University Regional Campus, Tirunelveli, TN, India.

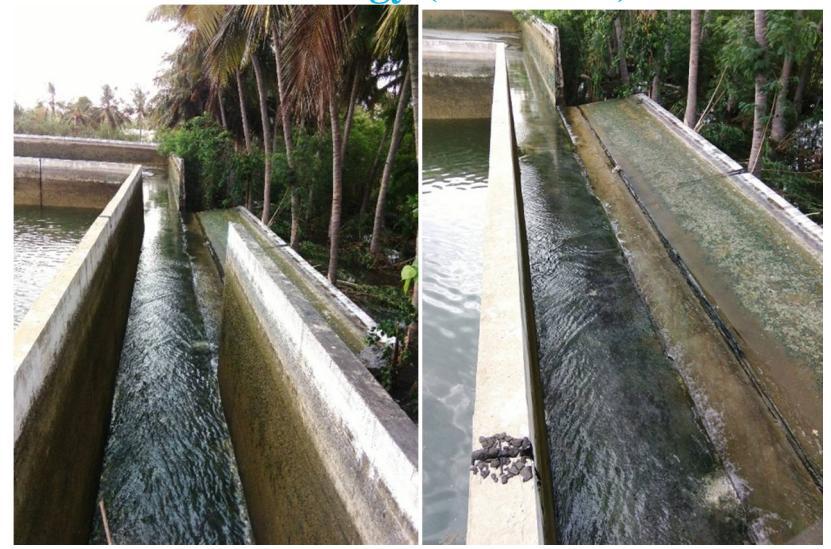
On 12.07.2015, a portion of the wall toppled as a rigid body near the beginning of diversion channel. The separation occurred at the raft and side wall connection. At the time of collapse, the level of water is approximately 90% of its capacity.

This indicates that the pressure all along the wall is higher than the design pressure at the time of failure. The higher pressure causes the shear failure of rods and the wall was collapsed. The photograph shows the collapsed wall and three places where the concrete and rod samples collected. The higher dynamic pressure may be due to the sudden drawl of water from the compartment.

Figure 1 : Collapsed Ground level reservoir Photos
