A Case Study on Blue Algae in Malampuzha Dam

Hanna K¹, Mohammed Jabir CK², Sana Parvin PK³, Shamil VM⁴

Department of Civil Engineering, APJ KTU

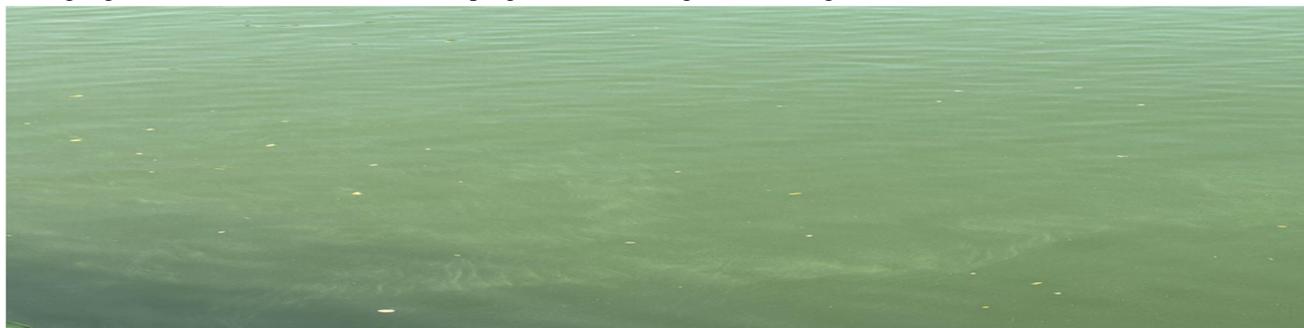
Fig 1 : site visit

Malampuzha Dam: A detailed inspection of the dam reservoir area should be carried out, including the water inlet and outlet points, as well as regions of stagnant water where algal blooms typically concentrate. These stagnant zones often provide favourable conditions for the rapid growth of algae. The surrounding catchment areas must also be surveyed to identify sources of agricultural runoff, soil erosion, and inflow streams that may carry excess nutrients such as nitrogen and phosphorus into the reservoir. In addition, observations should be collected regarding recreational activities, boating, and tourism around the dam, as these human activities can contribute to pollution and nutrient loading. It is also important to assess the depth profile of the reservoir, flow regimes, and seasonal fluctuations in water levels. Variations in water depth, temperature, and circulation patterns during different seasons can create ideal conditions for algal proliferation. Conducting these assessments will help in understanding the factors influencing algal bloom formation and in developing effective management strategies.

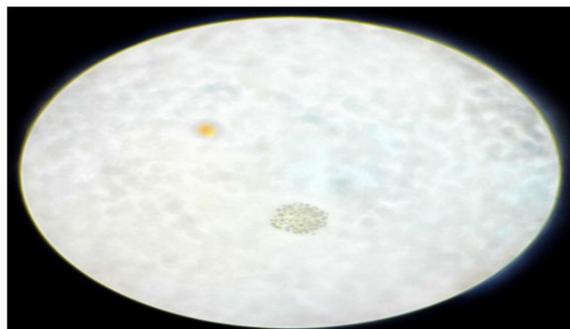
Fig 2 : microscopic view of collected sample

Microscopic examination confirmed the dominance of *Microcystis*.

Microcystis is a type of blue green algae (cyanobacteria) common in eutrophic water bodies produces toxins called microcystins harmful to liver and human health and makes water unsafe for drinking

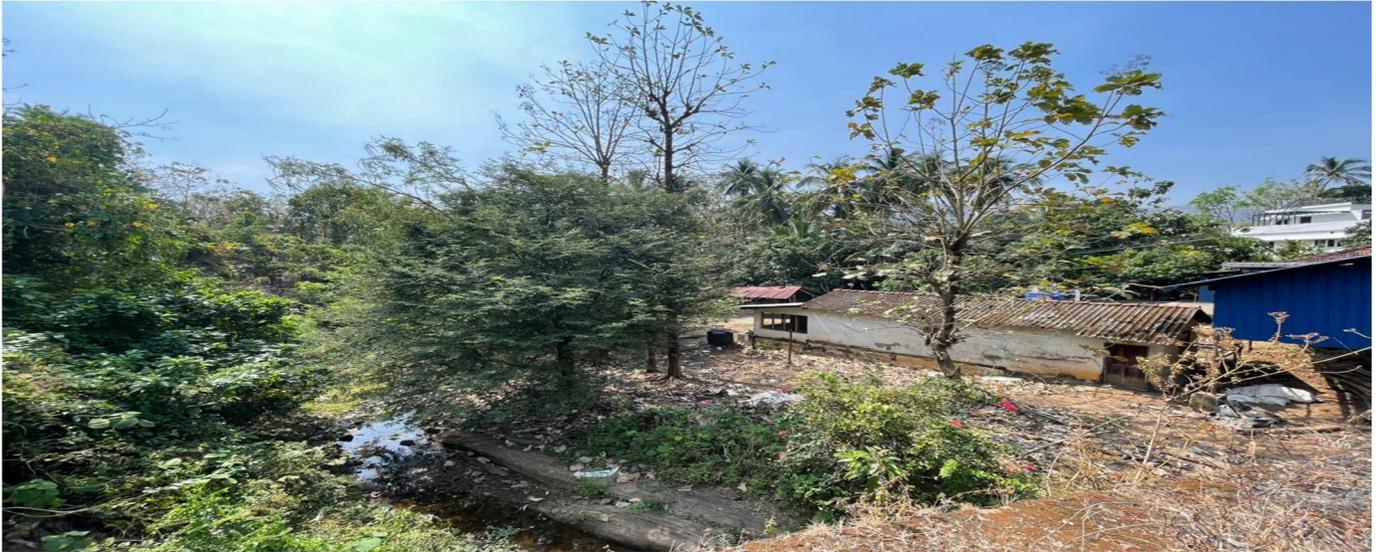
Fig 7 : Dairy farm

In addition to agricultural activities, dairy farming plays an important role in influencing algal growth in the reservoir, as identified through the study. Dairy farms located within the catchment area generate significant quantities of animal waste, including cow dung and urine, which are rich in nutrients such as nitrogen and phosphorus.

When dairy farm waste is improperly managed or discharged into open land and nearby drains, these nutrients are carried into the reservoir through surface runoff, especially during the monsoon season. This nutrient inflow accelerates the process of eutrophication, thereby promoting the excessive growth of blue-green algae (cyanobacteria).

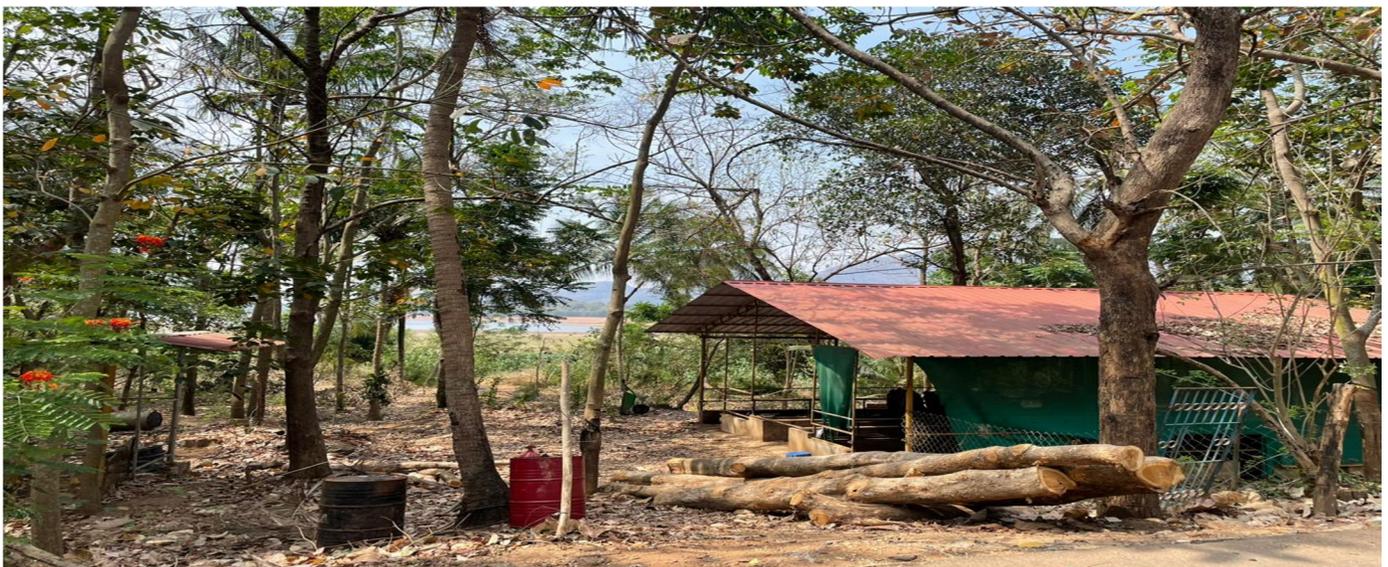
Fig 8 : Dairy farm near the dam

Field observations and water quality analysis indicate that areas closer to dairy farming zones show relatively higher nutrient concentrations, correlating with increased algal density. This confirms that dairy farming, along with agricultural runoff, significantly contributes to nutrient loading and algal bloom formation in Malampuzha Dam.
