A Case Study on Blue Algae in Malampuzha Dam

Hanna K¹, Mohammed Jabir CK², Sana Parvin PK³, Shamil VM⁴

Department of Civil Engineering, APJ KTU

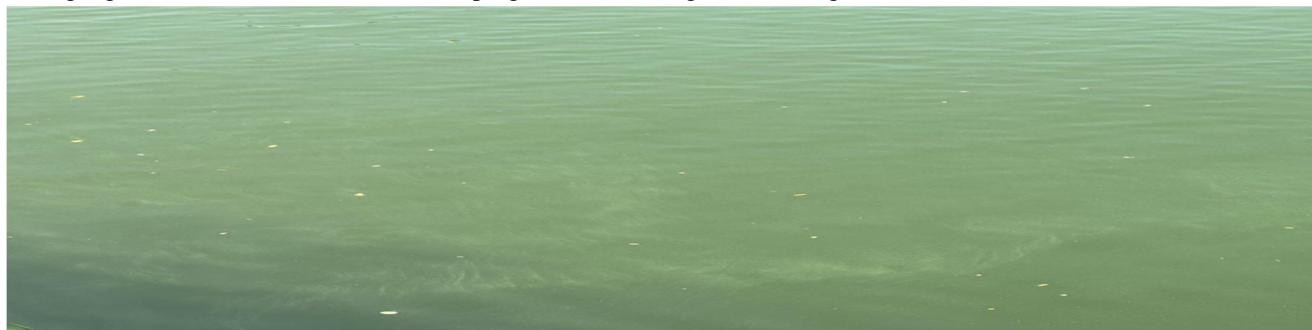
Fig 1 : site visit

Malampuzha Dam: A detailed inspection of the dam reservoir area should be carried out, including the water inlet and outlet points, as well as regions of stagnant water where algal blooms typically concentrate. These stagnant zones often provide favourable conditions for the rapid growth of algae. The surrounding catchment areas must also be surveyed to identify sources of agricultural runoff, soil erosion, and inflow streams that may carry excess nutrients such as nitrogen and phosphorus into the reservoir. In addition, observations should be collected regarding recreational activities, boating, and tourism around the dam, as these human activities can contribute to pollution and nutrient loading. It is also important to assess the depth profile of the reservoir, flow regimes, and seasonal fluctuations in water levels. Variations in water depth, temperature, and circulation patterns during different seasons can create ideal conditions for algal proliferation. Conducting these assessments will help in understanding the factors influencing algal bloom formation and in developing effective management strategies.

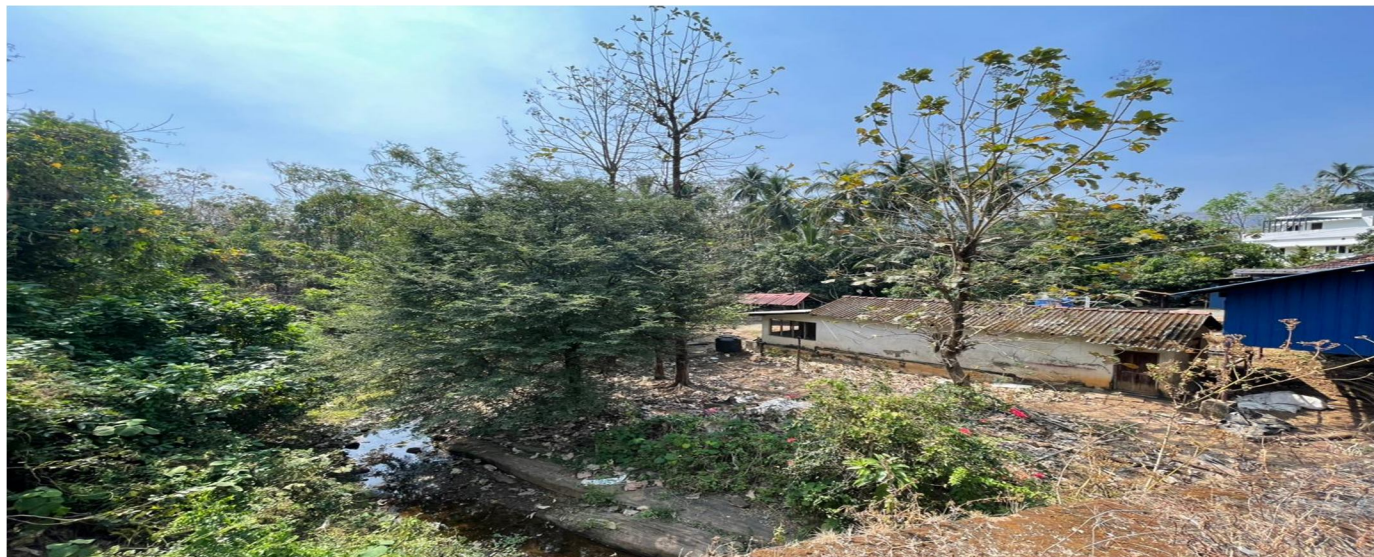
Fig 7 : Dairy farm

In addition to agricultural activities, dairy farming plays an important role in influencing algal growth in the reservoir, as identified through the study. Dairy farms located within the catchment area generate significant quantities of animal waste, including cow dung and urine, which are rich in nutrients such as nitrogen and phosphorus.

When dairy farm waste is improperly managed or discharged into open land and nearby drains, these nutrients are carried into the reservoir through surface runoff, especially during the monsoon season. This nutrient inflow accelerates the process of eutrophication, thereby promoting the excessive growth of blue-green algae (cyanobacteria).

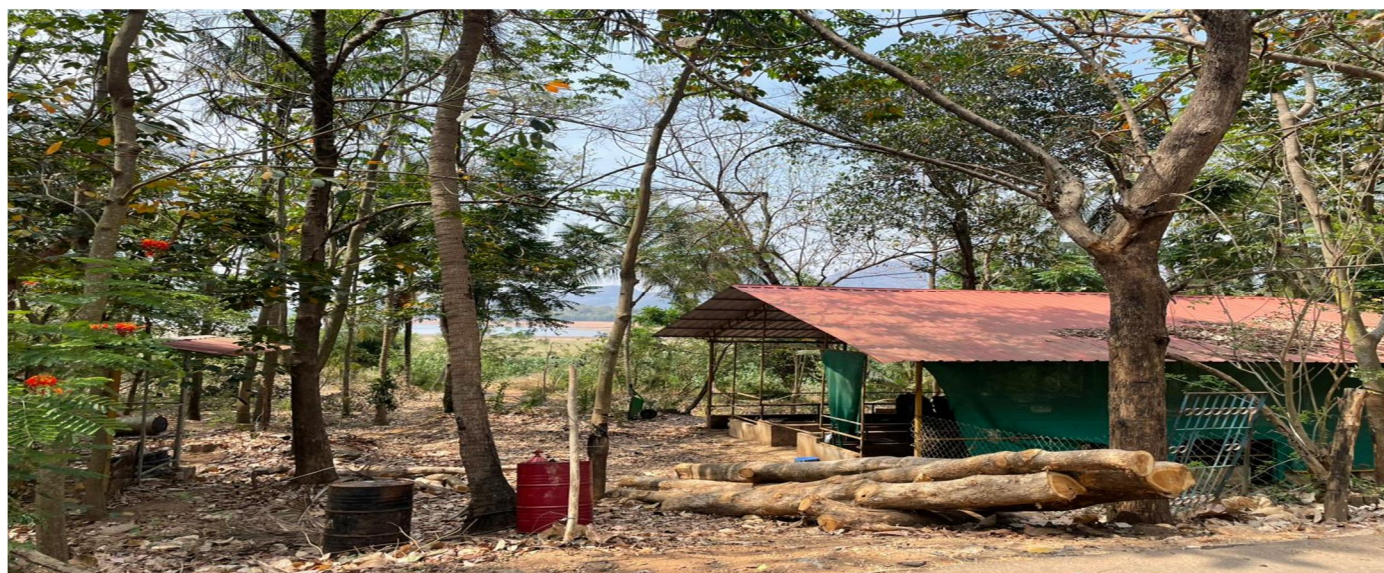
Fig 8 : Dairy farm near the dam

Field observations and water quality analysis indicate that areas closer to dairy farming zones show relatively higher nutrient concentrations, correlating with increased algal density. This confirms that dairy farming, along with agricultural runoff, significantly contributes to nutrient loading and algal bloom formation in Malampuzha Dam.
