A Data-Driven Approach to Comprehensive Pothole Management Using GIS for NH-848 from Trimbakeshwar to Nashik

Rohan Ahire¹, Prof. Tejas Bansode², Prof. Sourabh Joshi³

¹P.G. Student, Government College of Engineering, Karad, Satara, Maharashtra, India

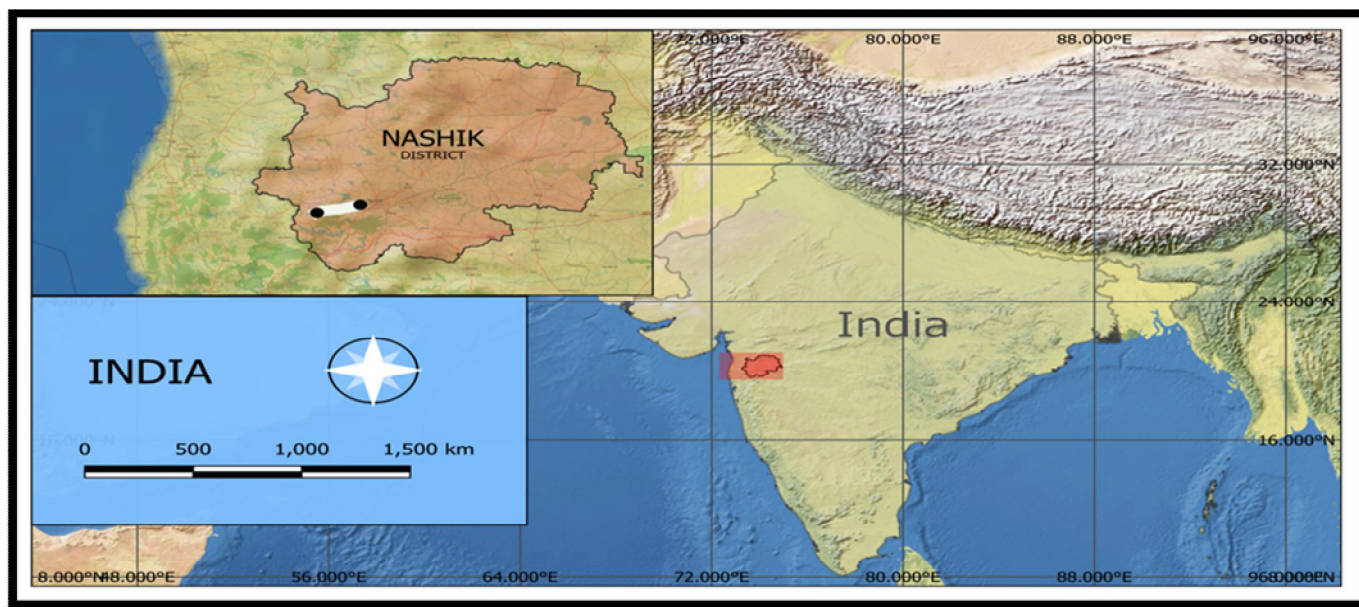
Fig. 1 Study Area

The study area is located in Maharashtra, western India, along National Highway 848 (NH-848), which stretches from Nashik to Trimbakeshwar. This corridor is situated in the Nashik district, known for its diverse topography, religious significance, and rapidly developing urban infrastructure. The route traverses various urban areas, peri-urban towns, agricultural fields, and steep terrains, making it important for socioeconomic and geospatial research. The Godavari River originates at Trimbakeshwar, a renowned pilgrimage site nestled in the foothills of the Brahmagiri range. To help international visitors better understand the study region within India's natural and cultural landscapes, the following maps provide both a district-level perspective and a broader national context.

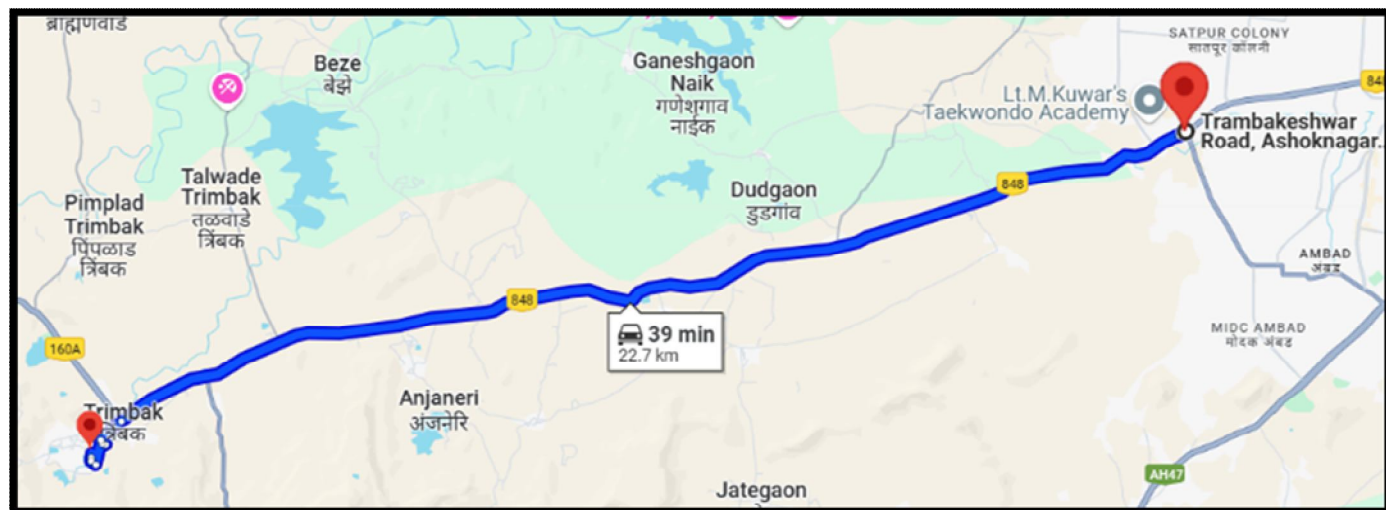
Fig -2: Case Study

For the case study, a 22.7 kilometer road from Nashik to Trimbakeshwar via Gangapur Road via NH 848 was chosen.

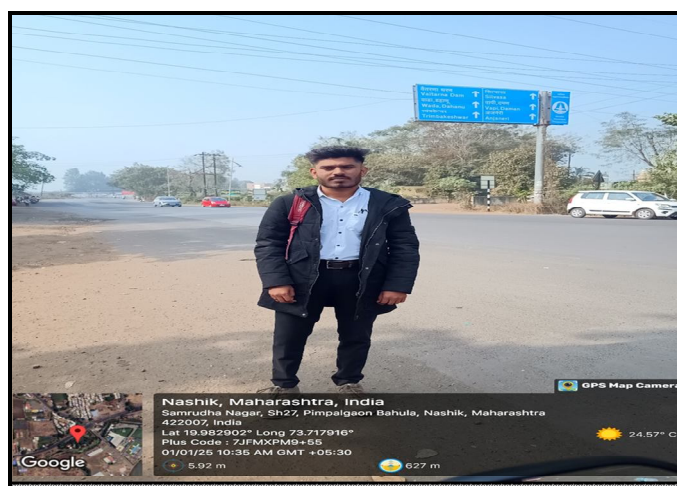
Fig -3 : Site visit Image

As we start our site tour, I'm standing next to NH 848. I'm evaluating the state of the road and the area around it. As seen in this picture, this is the start of our site survey, which aims to identify and record the state of the roads along NH 848, which connects Nashik and Trimbakeshwar.

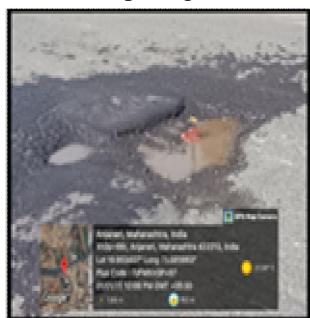
Fig -8: Recurring_Anjaneri

It seems that due to persistent issues like waterlogging, unstable soil conditions, heavy traffic loads, and the use of subpar construction materials, several potholes on NH-848 have reappeared despite previous repair efforts. The situation has only worsened over time, largely due to ineffective and temporary repair methods that fail to address the root causes. This recurring damage not only disrupts road safety and mobility but also leads to increased maintenance costs and public inconvenience. The scenario underscores an urgent need for durable, location-specific, and scientifically backed repair strategies to ensure long-term stability and resilience of the highway infrastructure.

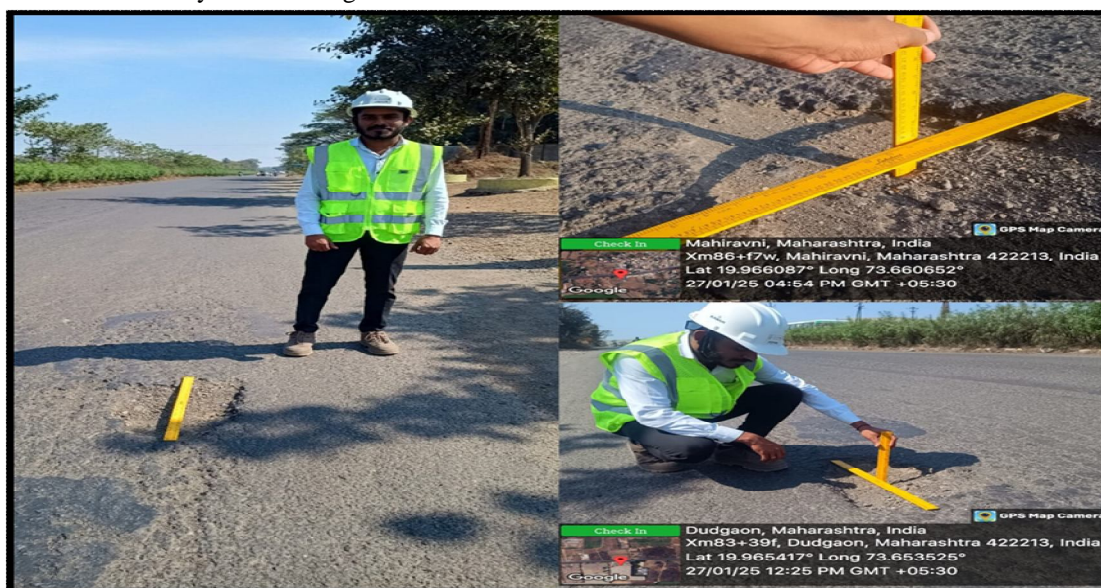
Fig -18: Pothole Measurement Safety

During a site survey along NH-848 from Nashik to Trimbakeshwar, significant pothole issues that jeopardize road safety and travel efficiency were identified. The primary causes of these problems, which lead to more frequent accidents, vehicle damage, and longer travel times, include heavy traffic, inadequate drainage, and delayed repairs.

While larger potholes require long-term solutions such as improved drainage systems, high-quality resurfacing, and ongoing maintenance, minor potholes can be addressed more easily. Field observations of pothole depth and diameter were combined with GIS techniques for geographical mapping. One particularly large pothole near Trimbakeshwar, characterized by deep, crumbling edges and exacerbated by waterlogging and heavy traffic, poses a serious risk to vehicles, especially two-wheelers. This pothole prompts rapid lane changes by drivers, increasing the likelihood of collisions and skidding. To prevent further deterioration, rising accident rates, and increased costs, immediate repairs and drainage upgrades are necessary.

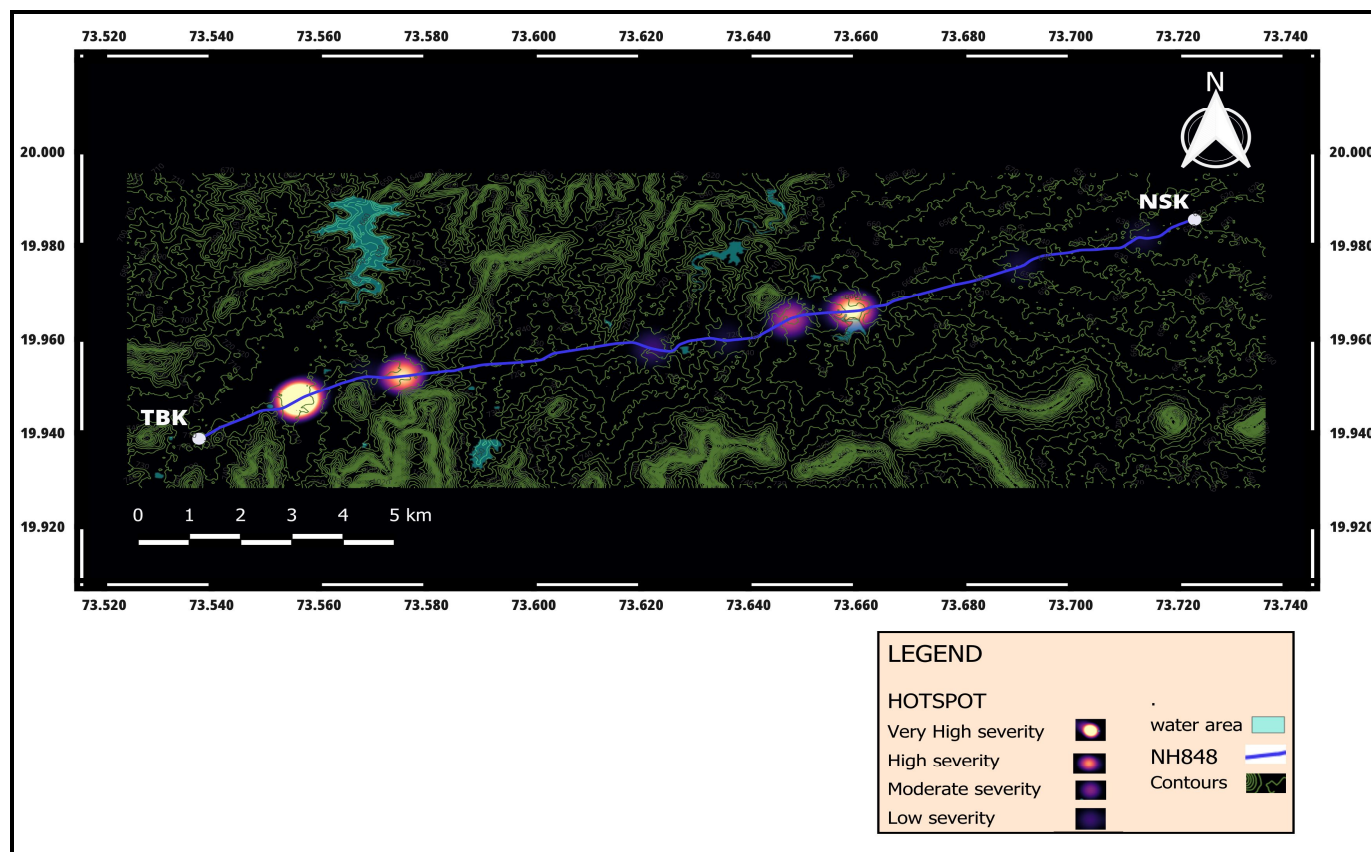
Fig -22 : Pothole Hotspot Analysis

A QGIS-based study reveals that the NH-848 stretch between Nashik and Trimbakeshwar has experienced significant degradation. Potholes have become a major cause of traffic accidents, particularly in areas with heavy traffic. The most hazardous locations are highlighted in red zones on the heatmaps, indicating severe surface distress and an increased risk of accidents. Approximately 10,000 daily commuters are directly affected by these high-risk areas, which pose threats to their safety and mobility. The findings underscore the urgent need for targeted maintenance, improved road engineering measures, and the swift implementation of safety initiatives to prevent further loss and inconvenience.

This steep and winding stretch is dangerous, especially when it rains. Potholes frequently form near sharp curves, causing drivers to lose control, especially on two-wheelers. Water gathers in low areas, causing vehicles to skid.

While this section has fewer potholes and less traffic, it still needs regular maintenance to prevent minor damage from developing into more serious issues. Conducting regular inspections during the monsoon season and making prompt surface repairs will help keep the road safe and reduce future repair costs.

This route, which is located in an academic zone, is always congested with students and personnel riding bikes or walking. Potholes near the entrance and shady places are difficult to see, particularly in the morning and evening.

This is a popular religious route with strong inclines. Heavy cars and numerous visits exacerbate road degradation rapidly. During festivals or holidays, the hazard increases dramatically. Potholes here can lead to serious accidents.
