# Identification and Mitigation of Blackspots and Implementation of An Advanced Traffic Management System on NH-216A (A Spur of National Highway-16)

Maanyam Ramakrishna<sup>1</sup>, Bandaru Ramesh<sup>2</sup>

<sup>1</sup>M.Tech Student, Transportation Engineering, Department of Civil Engineering, Pydah College of Engineering, Kakinada, Andhra Pradesh

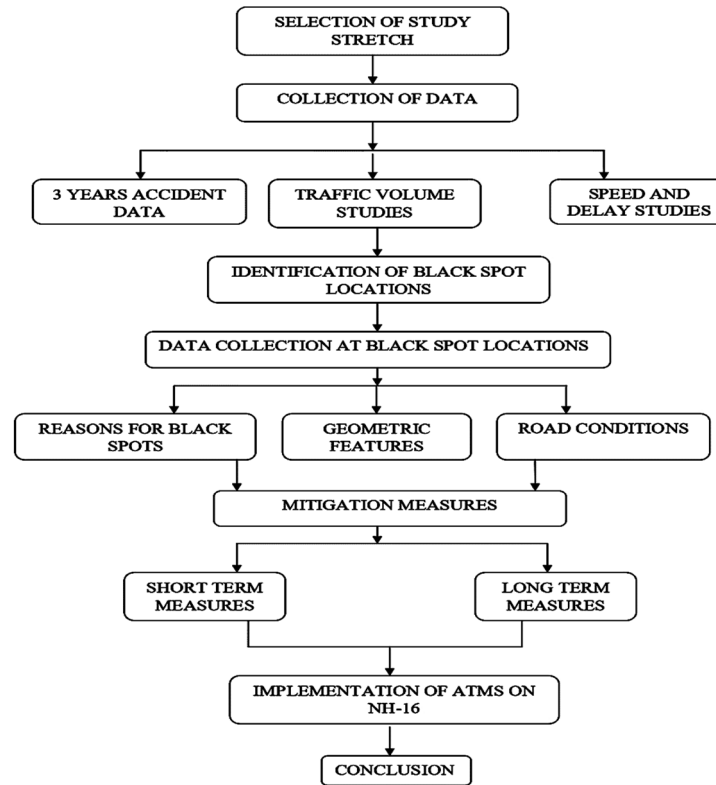
Fig.1 Methodology

The methodology of the project is shown in the flowchart given below.

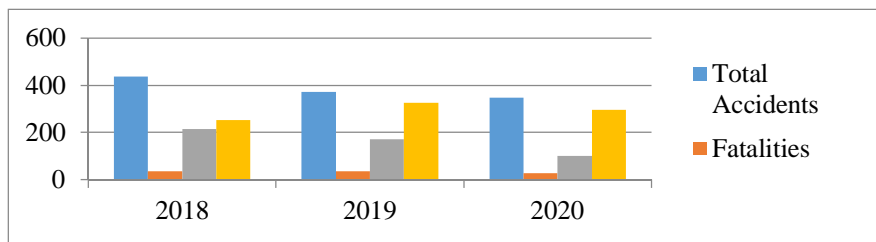
Fig. 3 Road Accidents on NH-16 for the section of Diwancheruvu to Siddantham

- 1) **Accident Data Collection:** The past 3 years (2018 To 2020) accident data is collected from the National Highways Authority of India for the section of Diwancheruvu to Siddantham section (from Km. 901+500 to Km. 950+542). The analysed accident data is represented in table 1:

Year	Total Accidents	Fatalities	Major Injured	Minor Injured
2018	438	36	215	254
2019	371	35	171	325
2020	348	27	101	295

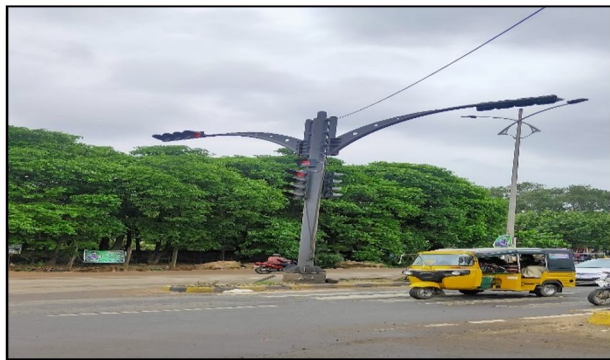
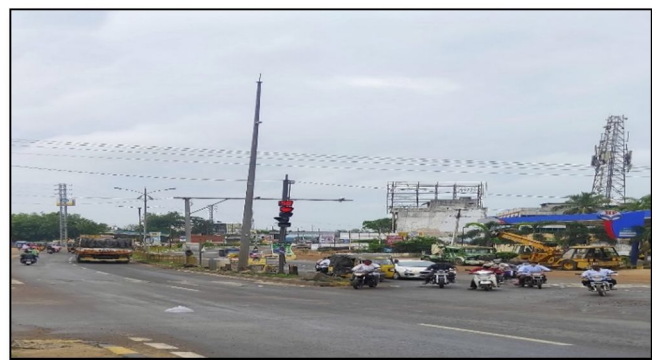
Fig. 4 Traffic Signal at Lalacheruvu Junction

Stretch	Average Delay Time	Reason for Delay
Diwancheruvu to Siddantham	192 Seconds	Traffic Signals at 1. Lalacheruvu Junction(62 Sec) 2. Morampudi Junction(130 Sec)
Siddantham to Diwancheuvu	188 Seconds	Traffic Signals at 1. Lalacheruvu Junction(62 Sec) 2. Morampudi Junction(126 Sec)

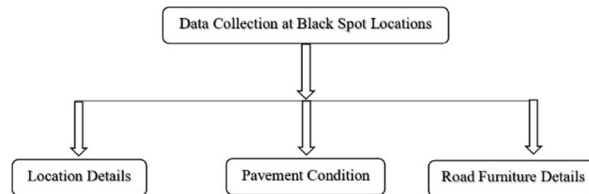
Fig. 6 Flowchart of Data Collection at Black Spot Location

The data collection at the black spot located in the present study is detailed in the below figure.

- 1) The data collection involves Location details Road Features, Median opening details, Approach Road conditions, Intersection details, and Pavement cross-sections.
- 2) Pavement condition involves Alligator cracking, Bleeding, Block cracking, Bumps and sags, Corrugations, Depressions, Edge cracking, Joint reflections, Lane/shoulder drop-off, Longitudinal, and transverse cracking, Potholes, Rutting, Shoving, Slippage cracking, Swelling, Ravelling.
- 3) Road Furniture condition involves the condition of Road Markings, Road Signs, Road Studs, Safety Barriers, Guard Posts, Traffic Delineators, and Highway Lighting.
