# Identification and Mitigation of Blackspots and Implementation of An Advanced Traffic Management System on NH-216A (A Spur of National Highway-16)

Maanyam Ramakrishna<sup>1</sup>, Bandaru Ramesh<sup>2</sup>

<sup>1</sup>M.Tech Student, Transportation Engineering, Department of Civil Engineering, Pydah College of Engineering, Kakinada, Andhra Pradesh

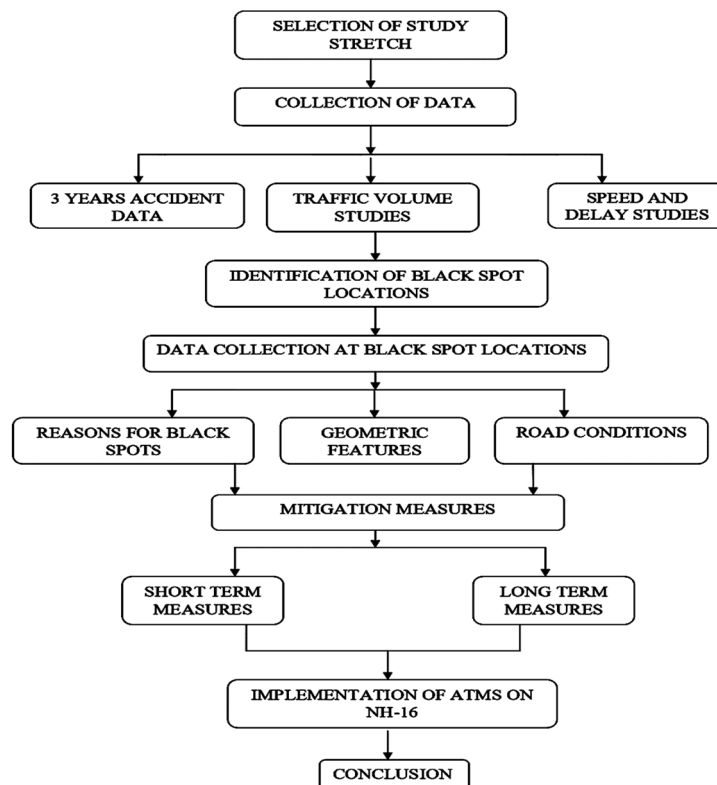
Fig.1 Methodology

The methodology of the project is shown in the flowchart given below.

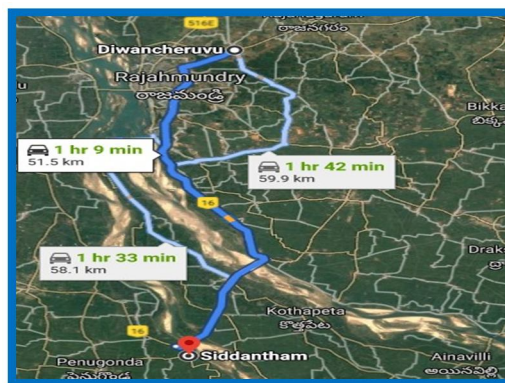
Fig. 2 Map of Study Stretch (Diwancheruvu to Siddantham)

The area which is selected for accident studies is 49 km long National Highway-216A (a spur road of National Highway-16) section between Diwancheruvu to Siddantham from Km. 901+500 to Km. 950+542, Andhra Pradesh.

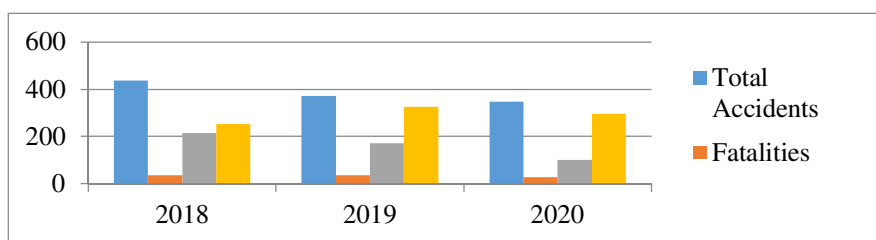
Fig. 3 Road Accidents on NH-16 for the section of Diwancheruvu to Siddantham

- 1) **Accident Data Collection:** The past 3 years (2018 To 2020) accident data is collected from the National Highways Authority of India for the section of Diwancheruvu to Siddantham section (from Km. 901+500 to Km. 950+542). The analysed accident data is represented in table 1:

Year	Total Accidents	Fatalities	Major Injured	Minor Injured
2018	438	36	215	254
2019	371	35	171	325
2020	348	27	101	295

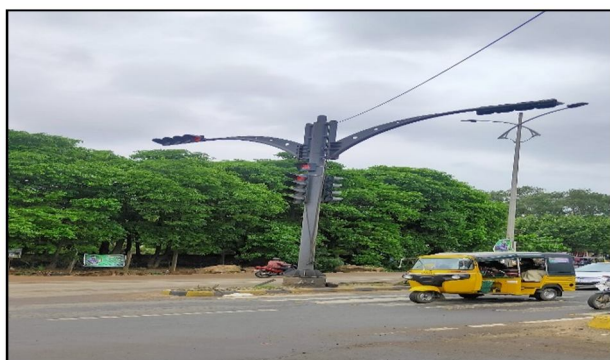
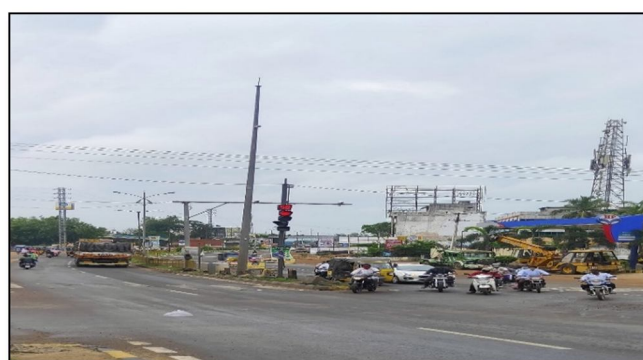
Fig. 4 Traffic Signal at Lalacheruvu Junction

Stretch	Average Delay Time	Reason for Delay
Diwancheruvu to Siddantham	192 Seconds	Traffic Signals at 1. Lalacheruvu Junction(62 Sec) 2. Morampudi Junction(130 Sec)
Siddantham to Diwancheruvu	188 Seconds	Traffic Signals at 1. Lalacheruvu Junction(62 Sec) 2. Morampudi Junction(126 Sec)

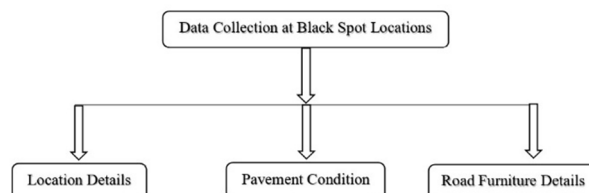
Fig. 6 Flowchart of Data Collection at Black Spot Location

The data collection at the black spot located in the present study is detailed in the below figure.

- 1) The data collection involves Location details Road Features, Median opening details, Approach Road conditions, Intersection details, and Pavement cross-sections.
- 2) Pavement condition involves Alligator cracking, Bleeding, Block cracking, Bumps and sags, Corrugations, Depressions, Edge cracking, Joint reflections, Lane/shoulder drop-off, Longitudinal, and transverse cracking, Potholes, Rutting, Shoving, Slippage cracking, Swelling, Ravelling.
- 3) Road Furniture condition involves the condition of Road Markings, Road Signs, Road Studs, Safety Barriers, Guard Posts, Traffic Delineators, and Highway Lighting.
