AI Based Fabric Inspection System

Abstract: *Textile industry continues to face challenges in ensuring consistent fabric quality due to its reliance on manual inspection processes. This study introduces an AI-driven automated fabric inspection system designed to detect surface defects in real time using deep learning and computer vision techniques. The system is built around a Raspberry Pi 5 platform integrated with TensorFlow and a Pi Camera module. A convolutional neural network (CNN) model processes captured images to identify defects, prompting the system to halt fabric movement and activate a pump-based liquid applicator for marking the flawed regions. The proposed solution is portable, cost-effective, and offers high detection accuracy, making it particularly advantageous for small and medium-sized textile enterprises seeking to modernize their quality control operations. This approach reduces inspection time and improves accuracy in textile manufacturing environments. Experimental validation achieved 92% detection accuracy across multiple fabric types.*

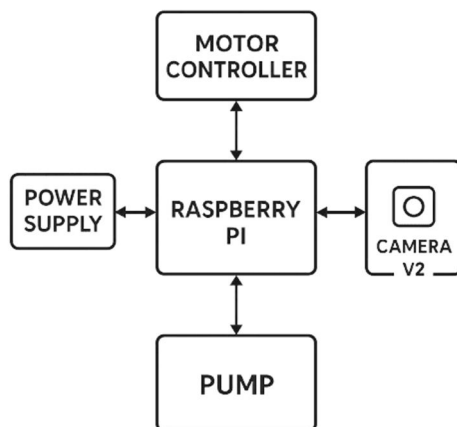
Fig. 3 Hardware Architecture

The hardware architecture of the proposed fabric inspection system is designed to provide a compact, efficient, and reliable platform for autonomous defect detection and marking. The central unit is a Raspberry Pi 5, chosen for its balance of computational capabilities, GPIO interface availability, and energy efficiency. It serves as the processing and decision-making brain of the system, hosting both the AI inference model and the GPIO-based control logic.

Connected directly to the Raspberry Pi is the Pi Camera V2, an 8MP image sensor mounted above a motor-driven fabric roller mechanism. As the fabric moves, the camera continuously captures high-resolution frames, which are fed into the AI pipeline. The fabric is advanced using a NEMA 23 stepper motor, controlled via a TB6600 motor driver, which receives precise PWM pulses from the Pi's GPIO pins to regulate speed and movement accuracy.

Once a defect is detected, the motor is stopped, and a 12V diaphragm pump, driven via an L298N H-Bridge motor driver, is activated to mark the defective section. All actuators and sensors are powered by a dual-voltage regulated SMPS, supplying 5V for logic-level electronics and 12V for high-power components like motors and pumps. The architecture ensures electrical isolation, modular expansion, and robust operation in factory environments.
