AI Based Fabric Inspection System

Sujatha D.¹, Swaraj R.S.², Atitya Ram S.³, Adhith S.⁴, Girishwaran S.⁵, Athiyavan Snovas⁶

Third Mechatronics, PSG Polytechnic College

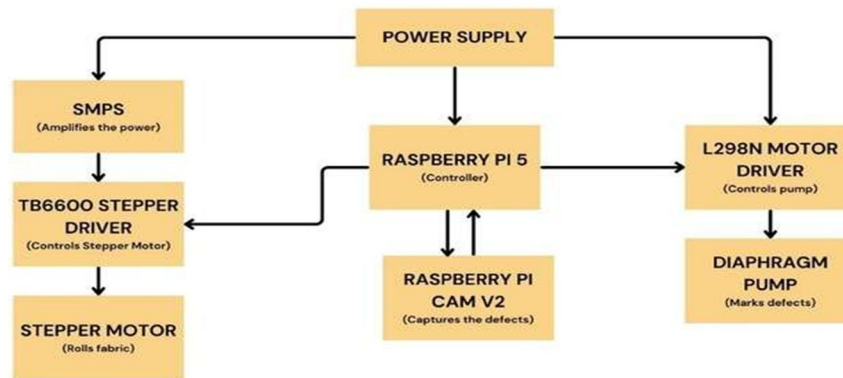
Fig. 1 System Block Diagram

The complete data flow and process logic are depicted in the system block diagram (Fig. 1) and the control flowchart (Fig. 2). The block diagram outlines the relationships between the camera, Raspberry Pi, motor driver, and pump mechanism, while the flowchart illustrates the sequential steps of image acquisition, analysis, defect decision-making, motor halt, and defect marking.

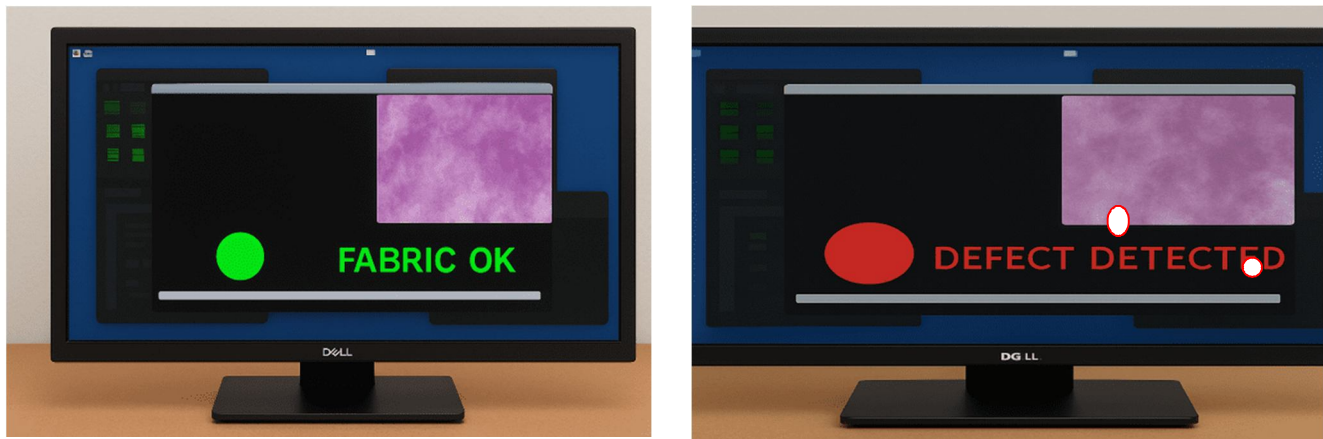
Fig. 12 Graphical User Interface for Machine Control and Defect Tracking with Live Camera Feed and Instant Alert Notifications

To demonstrate visual results, screenshots of actual defect detections and marked fabric outputs were captured during testing. These images show bounding boxes drawn by the software and the corresponding physical markings on the fabric using the nozzle system. Furthermore, Table 1 presents a comparative summary of detection rates, inspection times, and error margins between manual and automated systems.
