**Volume: 13    Issue: V    Month of publication: May 2025**

# AI Based Fabric Inspection System

Third Mechatronics, PSG Polytechnic College

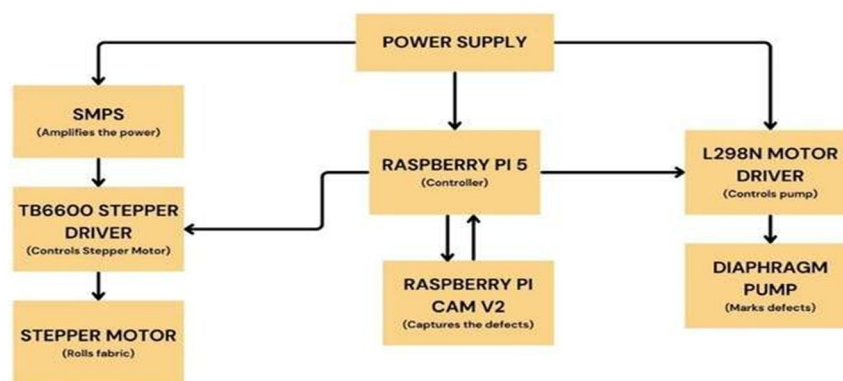
Fig. 1 System Block Diagram

The complete data flow and process logic are depicted in the system block diagram (Fig. 1) and the control flowchart (Fig. 2). The block diagram outlines the relationships between the camera, Raspberry Pi, motor driver, and pump mechanism, while the flowchart illustrates the sequential steps of image acquisition, analysis, defect decision-making, motor halt, and defect marking.

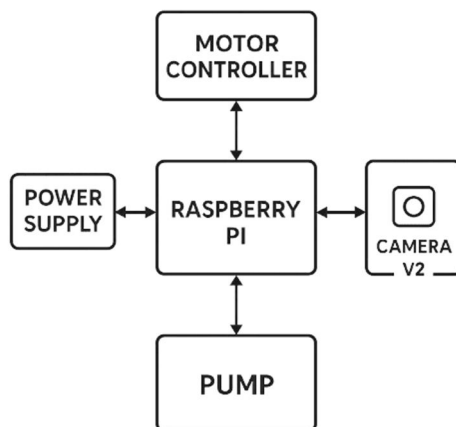
Fig. 3 Hardware Architecture

The hardware architecture of the proposed fabric inspection system is designed to provide a compact, efficient, and reliable platform for autonomous defect detection and marking. The central unit is a Raspberry Pi 5, chosen for its balance of computational capabilities, GPIO interface availability, and energy efficiency. It serves as the processing and decision-making brain of the system, hosting both the AI inference model and the GPIO-based control logic.

Connected directly to the Raspberry Pi is the Pi Camera V2, an 8MP image sensor mounted above a motor-driven fabric roller mechanism. As the fabric moves, the camera continuously captures high-resolution frames, which are fed into the AI pipeline. The fabric is advanced using a NEMA 23 stepper motor, controlled via a TB6600 motor driver, which receives precise PWM pulses from the Pi's GPIO pins to regulate speed and movement accuracy.

Once a defect is detected, the motor is stopped, and a 12V diaphragm pump, driven via an L298N H-Bridge motor driver, is activated to mark the defective section. All actuators and sensors are powered by a dual-voltage regulated SMPS, supplying 5V for logic-level electronics and 12V for high-power components like motors and pumps. The architecture ensures electrical isolation, modular expansion, and robust operation in factory environments.

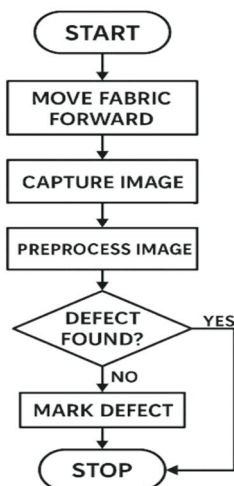
Fig. 4 Software Control Logic

The software control logic forms the core intelligence layer of the fabric inspection system. It manages data flow, decision-making, and hardware actuation using an event-driven Python-based program running on Raspberry Pi OS. The software stack uses OpenCV for image preprocessing, TensorFlow Lite for defect detection inference, and RPi.GPIO or lgpio libraries for GPIO pin management.

At system startup, the fabric feeding motor is initialized and image acquisition begins. Each frame captured by the Pi Camera is preprocessed (resized, grayscale conversion, noise filtering) and then passed to the CNN model for defect analysis. If a defect is detected, the software immediately halts the stepper motor by sending a stop signal to the TB6600 driver. It then triggers the L298N-controlled pump to dispense a brief burst of marking liquid.

To maintain real-time performance, multithreading is used for motor control, image processing, and pump activation. A synchronization flag ensures that marking only occurs when the fabric is stationary. Additionally, a lightweight GUI displays live detection results, logs detected defects, and provides manual override options for operators. The control logic is also equipped with error handling routines that manage sensor disconnects, motor stalls, or AI model delay.

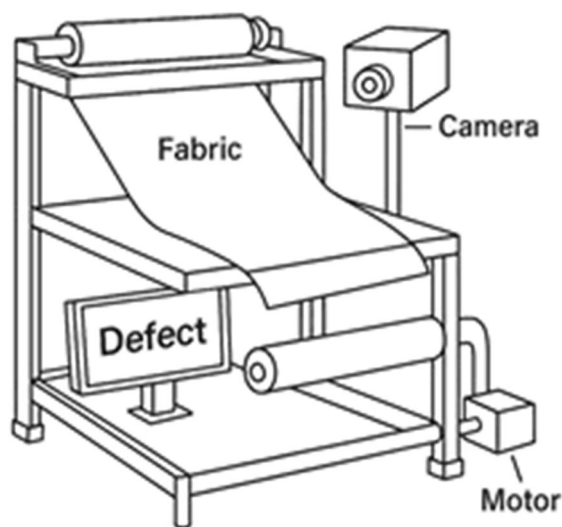
Fig. 6 Hardware Setup

Above this fabric path, the Raspberry Pi Camera V2 is mounted vertically on an adjustable bracket to maintain a constant height and field of view. The camera angle and lighting are calibrated to minimize glare and enhance defect visibility. The Raspberry Pi 5 is housed in a ventilated enclosure on one side of the frame, along with the TB6600 motor driver and L298N pump driver, both fixed on a component board with heat-dissipation considerations. The diaphragm pump, connected to a precision nozzle, is mounted on a pivot arm that moves vertically, ensuring accurate marking at the detected location.

The entire hardware is powered through a dual-output SMPS (5V and 12V). Wiring is managed using cable ducts and sleeves to prevent interference or damage during operation. The design ensures modularity, allowing easy replacement or upgrading of individual components.

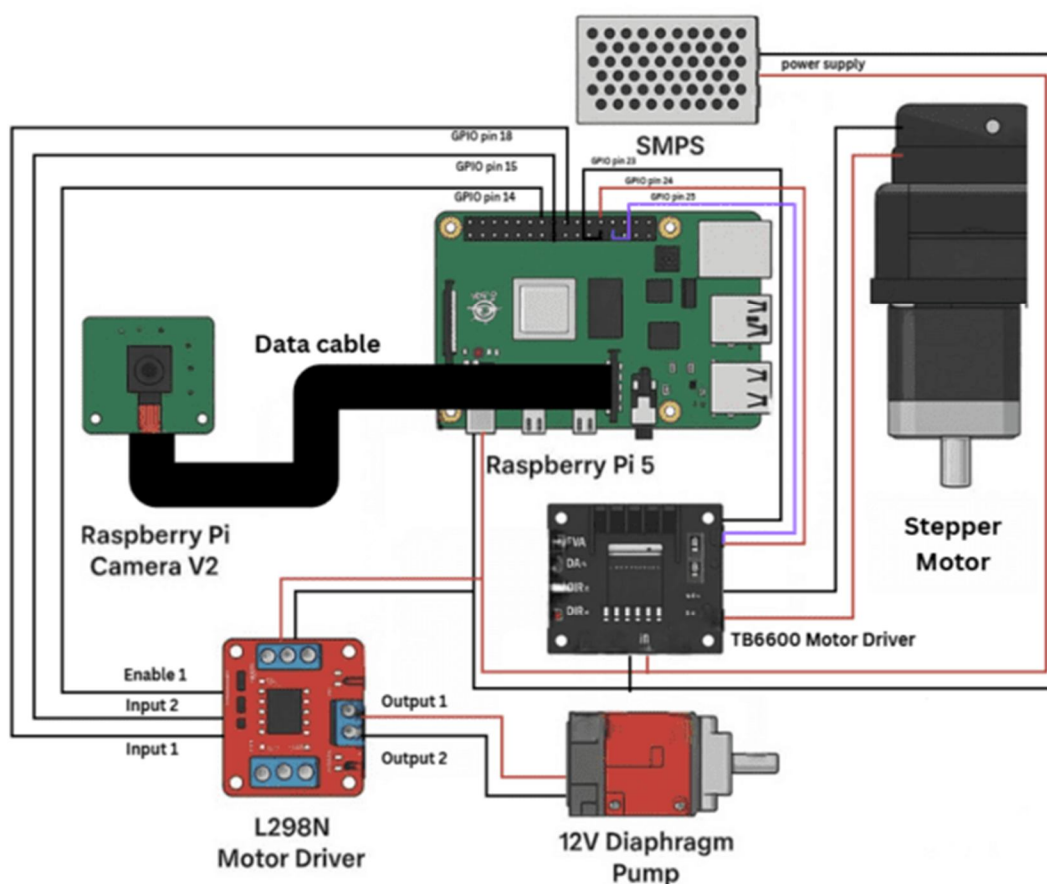
Fig. 7 Layout Connection Diagram

The final system layout represents a holistic view of the fully integrated hardware and control ecosystem designed for real-time fabric inspection. It consolidates the camera module, Raspberry Pi, roller mechanism, defect marking unit, and associated drivers into a structured configuration optimized for functionality, accessibility, and maintainability. The Pi Camera V2 is aligned vertically above the fabric path to ensure a stable field of view, while the fabric is fed forward using a stepper motor-driven roller mounted with precision using bearing supports.

The Raspberry Pi 5, acting as the central controller, is housed in an enclosure beside the fabric path, interfacing directly with the TB6600 driver for motor control and the L298N driver for actuating the 12V diaphragm pump. These drivers are mounted on an insulated control board along with the power regulation circuit that separates logic-level (5V) and motor-level (12V) operations. The marking nozzle is placed downstream of the camera's field of view and is precisely aligned through calibration so it can mark defects exactly where they occur.

This complete layout reflects a compact, portable, and production-ready design. It also includes provisions for cable management, ventilation, and future upgrades such as touchscreen GUI support or wireless connectivity. The layout diagram (as shown in Fig. 7) provides a clear spatial understanding of all integrated components and their interactions, bridging the gap between theoretical design and physical implementation.

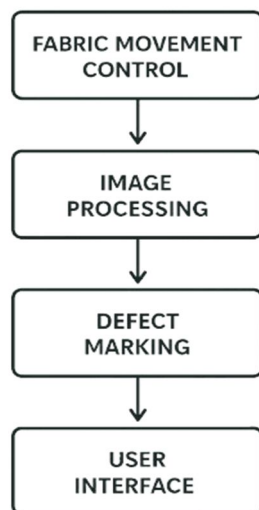
Fig.8 Software Module Integration

The software pipeline is written in Python and deployed on Raspberry Pi OS. It uses OpenCV for real-time image acquisition and preprocessing and TensorFlow Lite for AI-based defect detection. When the system starts, the Raspberry Pi initiates camera streaming, and each captured frame is processed in the following stages: grayscale conversion, Gaussian blur, image resizing (to match CNN input dimensions), and pixel normalization. These steps enhance image quality and ensure consistent input to the detection model.

Once preprocessing is complete, the frame is passed to a Convolutional Neural Network (CNN) model converted into TensorFlow Lite format for edge inference. The model returns a probability score and bounding box coordinates if a defect is detected. Post-inference, the bounding box data is used to map defect locations on the fabric for targeted marking.

To achieve low-latency processing, frame handling and model inference are run in parallel threads, preventing pipeline bottlenecks. The software also logs the number and type of detected defects, enabling later quality audits. A minimal GUI or console display provides live feedback to operators.

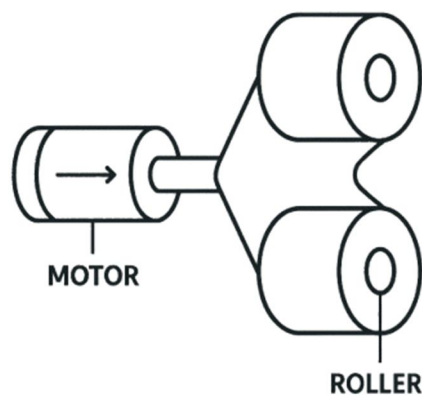
Fig. 9 Motor and Fabric Movement

Precise control of fabric motion is critical for defect localization. The fabric is fed using a stepper motor (NEMA 23) connected to a roller, with speed regulated via the TB6600 driver receiving signals from the Raspberry Pi. The system is programmed such that the roller advances at a constant speed under normal operation, ensuring synchronized image capture and fabric movement.

Upon detection of a defect, the software sends a signal to halt the motor, thereby fixing the fabric in place. This pause enables the marking system to accurately align with the defective region. A delay timer or interrupt-based logic is used to ensure that the pump activates only after motion is fully stopped.

PWM enables dynamic control of motor speed by varying the width of electrical pulses sent to the motor driver. This allows the software to finely tune the motor's rotation, ensuring a steady and consistent fabric flow. As the AI model processes images in real-time, the fabric must remain stationary during detection to avoid blurring or misalignment. Hence, a stop mechanism is integrated into the logic, which halts the motor instantly when a defect is identified. This prevents the defect from being missed or inaccurately marked.

To ensure smooth operation, the control system also accounts for acceleration and deceleration curves that minimize vibration and mechanical jerk. Sudden starts or stops could damage delicate fabrics or cause misalignment in the inspection process. Therefore, the software includes buffering logic to manage transitions gently and synchronously with camera feedback.

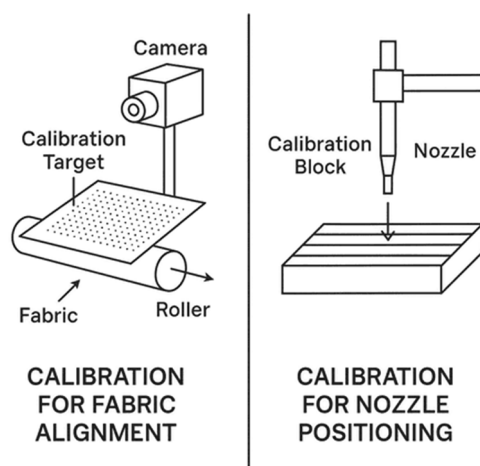
Fig. 10 Calibration and Synchronization

The synchronization mechanism ensures real-time coordination between camera sampling, defect analysis, and mechanical action—making the system reliable for continuous operation without manual intervention.

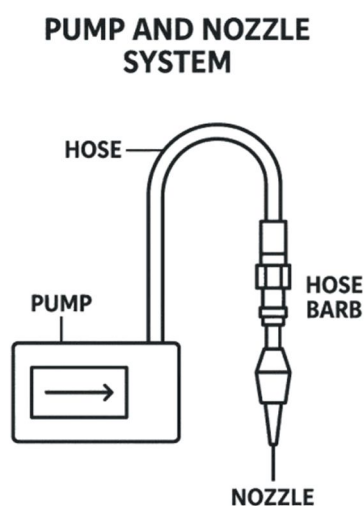
Fig. 11 Marking System Control

The marking system is a key mechanical component tasked with accurately identifying defective zones. It uses a mini diaphragm pump connected to a nozzle through food-grade silicon tubing. The nozzle is mounted above the fabric and fixed to a movable arm that can be manually aligned or servo-actuated for future upgrades.

Marking precision is achieved through accurate calibration of nozzle position relative to the camera's field of view. During system setup, sample defects are used to create a calibration map, matching pixel coordinates with roller displacement distance. The nozzle releases a very small quantity of removable dye using a pulse-based liquid control system. The pump runs for a predefined duration (e.g., 300ms) based on volume requirements and fabric type.

Additionally, the marking fluid is selected to be non-permanent and easily washable during post-processing, ensuring that it serves only as a visual cue during quality checks. The system also allows for a manual override of the marking unit in case of false detections or missed marks.

The marking design is enclosed to avoid splatter, and excess fluid is managed via a small drip tray placed beneath the nozzle to prevent contamination or false impressions on the fabric.

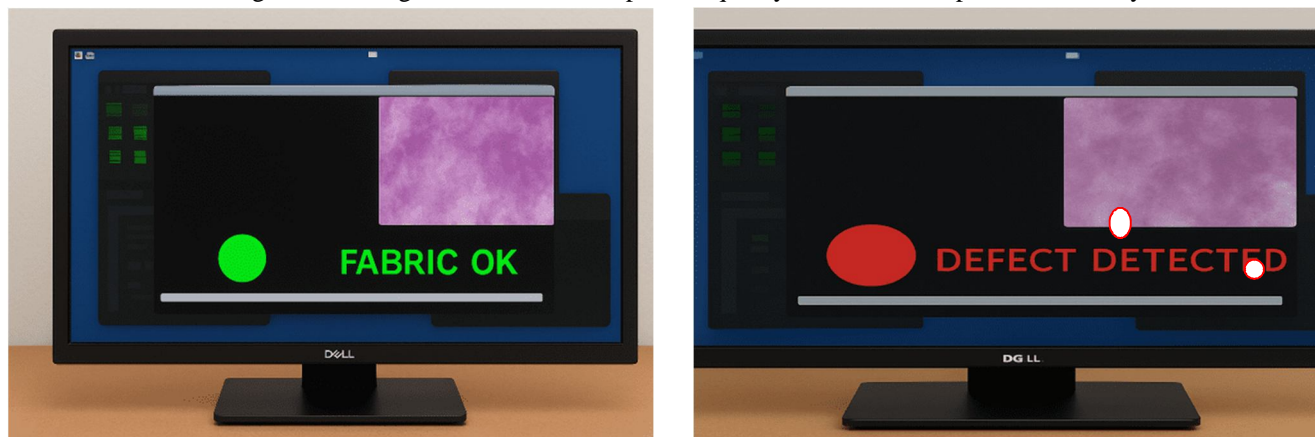
To demonstrate visual results, screenshots of actual defect detections and marked fabric outputs were captured during testing. These images show bounding boxes drawn by the software and the corresponding physical markings on the fabric using the nozzle system. Furthermore, Table 1 presents a comparative summary of detection rates, inspection times, and error margins between manual and automated systems.

Fig. 12 Graphical User Interface for Machine Control and Defect Tracking with Live Camera Feed and Instant Alert Notifications

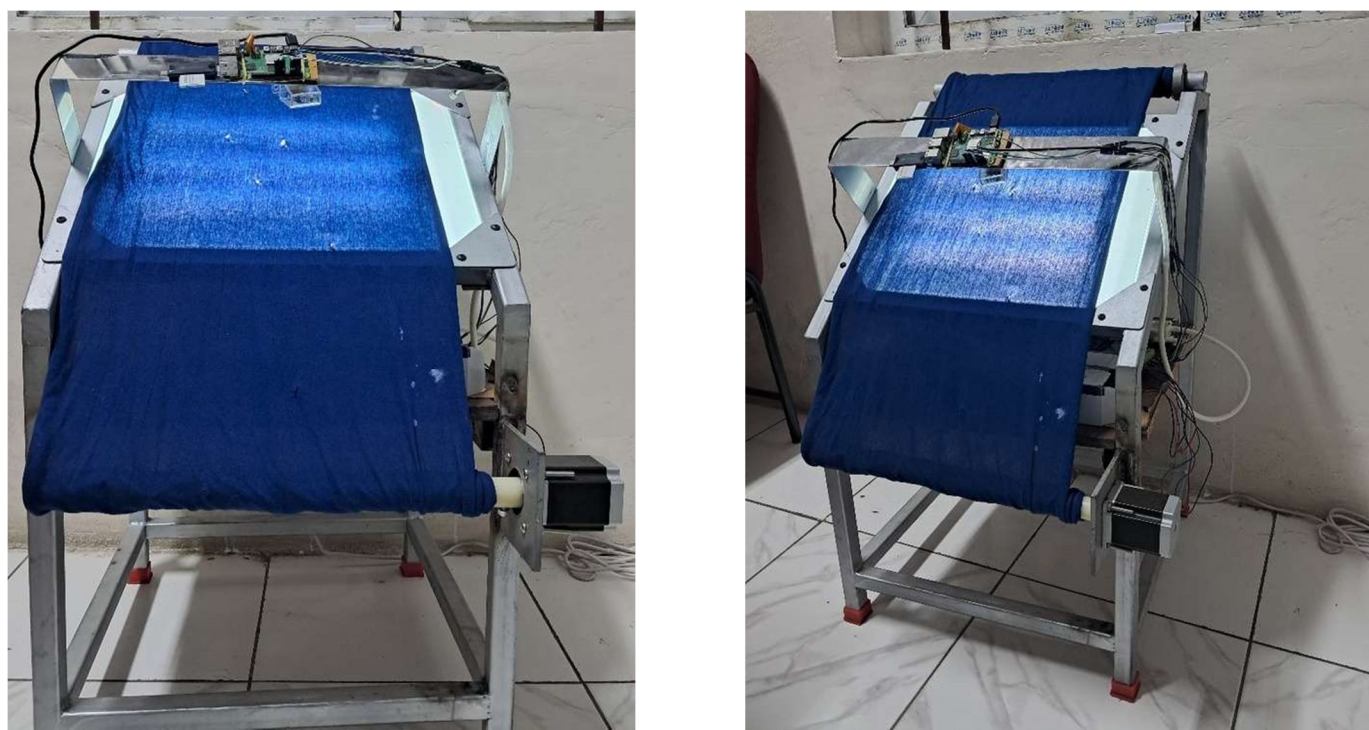
FIG. 12 FINAL PROTOTYPE SETUP OF THE AI-BASED FABRIC DEFECT DETECTION SYSTEM
