An Experimental Work on Rehabilitation Method of Beam Reinforcement by Using Meshing & Stitching Method

Mayuri D. Gaikwad

Student of PG Dept. of Civil Engineering, S.K.N. Sinhgad College of Engineering, Korati Pandharpur, Maharashtra, India

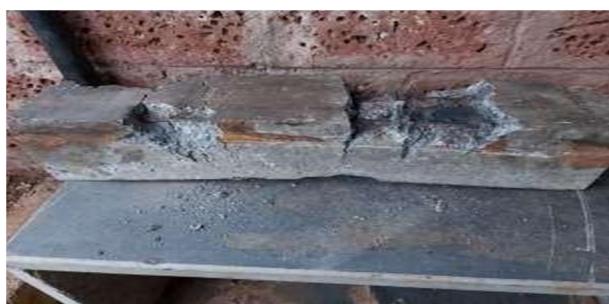
Figure 8.3: Removal of damaged concrete

After testing the corroded beams, the weak concrete or the damaged part was removed with the help of chisel and hammer. The dust is removed completely with the help of wire brush as shown in Figure 8.3.

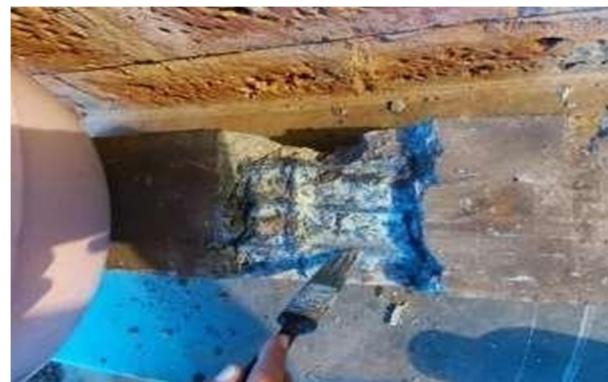
Figure 8.4: Application of Rust remover on the reinforcement

Concrete cover is removed up to steel reinforcement. SP Rustclean, a rust remover is applied as instructed is applied on the bars to break the corrosion process as shown in Figure 8.4.

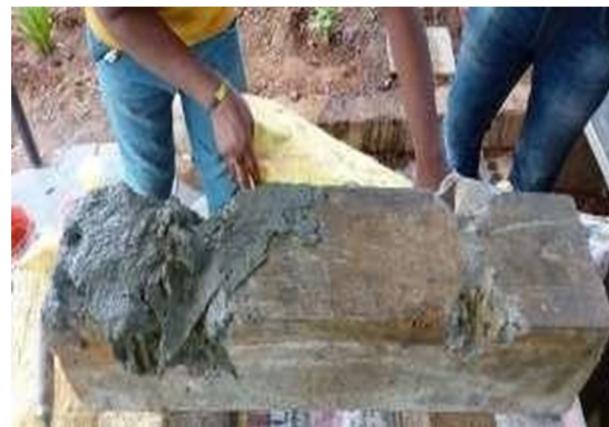
Figure 8.5: Sealing pot holes and spalled portions with repair mortar

Durocon-49 acts as a bonding agent, so there was no need of external bonding chemical. Curing of beams.

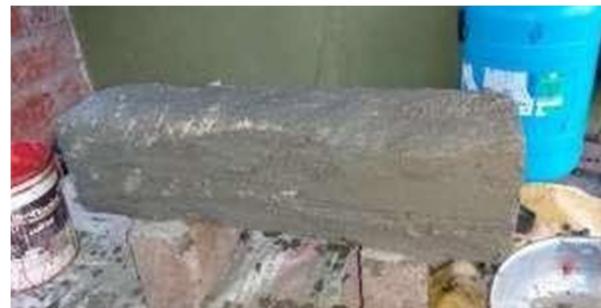
Figure 8.6: Application of repair mortar over three sides of beam

Rehabilitation by this method is comprised of applying an extra thick layer of repair mortar of 25 mm width on bottom three sides of the beam. The thorough procedure for accomplishing this method is as follows.

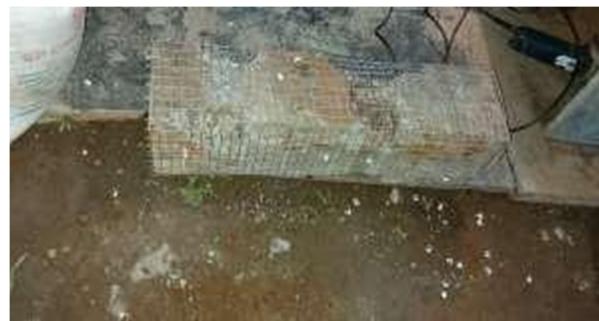
Figure 8.7: Placing of stainless steel mesh on the three sides of beam

Wire Mesh made up of stainless steel was wrapped around the three sides of the beam as shown in Figure 8.7.

Repair mortar of thickness 25 mm was applied over the mesh. Curing of beams after hardening of repair mortar.

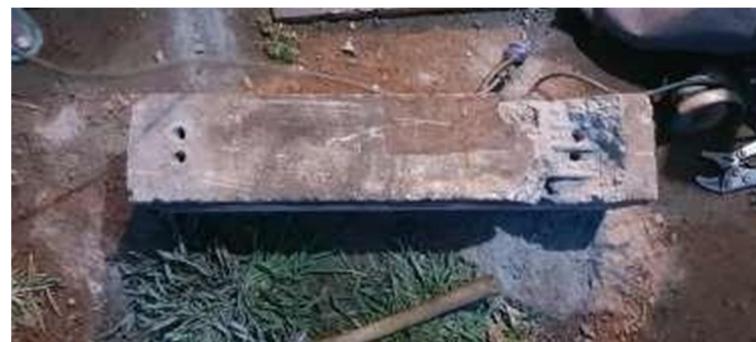
Figure 8.8: Drill pattern of holes for stitching method

SP Rustclean, a rust remover is applied as instructed is applied on the bars to break the corrosion process. The beam is left undisturbed for a day to air dry the Rustclean. Holes of 14 mm diameter are drilled on the tension side of the beams.

Four holes were drilled on the bottom side of the beams at the corner as shown In fig.8.8.

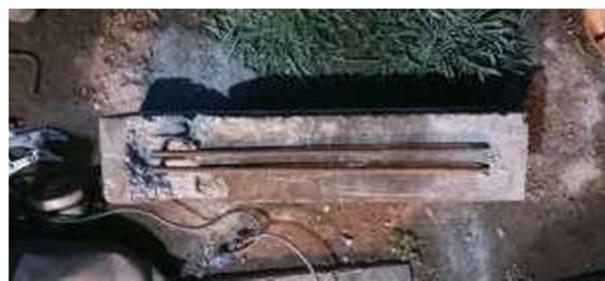
Figure 8.9: Placing of U shape bars into the beam

This method consists of rehabilitating the corrosion damaged beams by providing U-type bars and stitching them into the bottom of beam. The bar is bent at 90° angle at both the ends. The U-type bar is provided as an extra tension reinforcement.

The dust from the holes is removed and kept clean. The holes are filled with grouting material. Two bars of 10 mm dia. in the form of U shape is placed across the flexure crack up to 80 mm depth in to the beam as shown in fig 8.9.

After stitching the reinforcement into the holes of the beam, repair mortar of depth 25 mm was placed throughout the beam. Curing of beams was carried out with the help of wet gunny bags for 28 days.

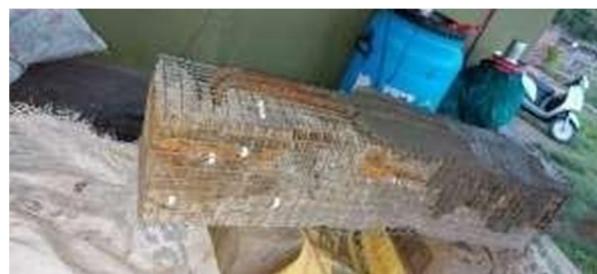
Figure 8.10: Application of repair mortar

The dust from the holes is removed with the help of vacuum pressure. The holes are filled with grouting material. Two U-type bars of 10 mm is placed up to 80 mm depth into the beam. Stainless steel mesh is wrapped around the three sides of the beams as shown in Figure 8.10.

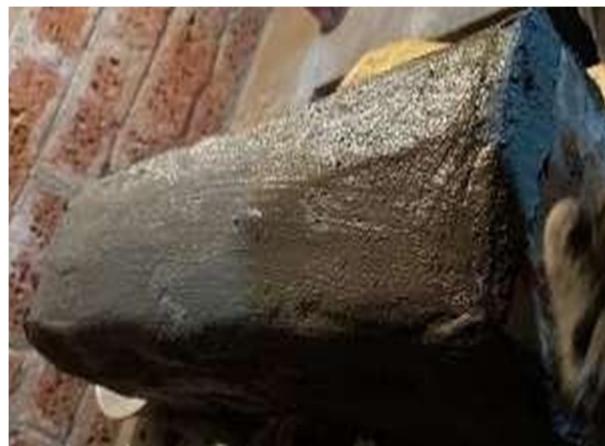
Figure 8.11: After rehabilitation by Meshing + Stitching method

After fixing the reinforcement into the holes and applying mesh, repair mortar of depth 25 mm was placed throughout the beam as shown in Figure 8.11. To achieve strength of the mortar, curing was done for 28 days after the day of repair.

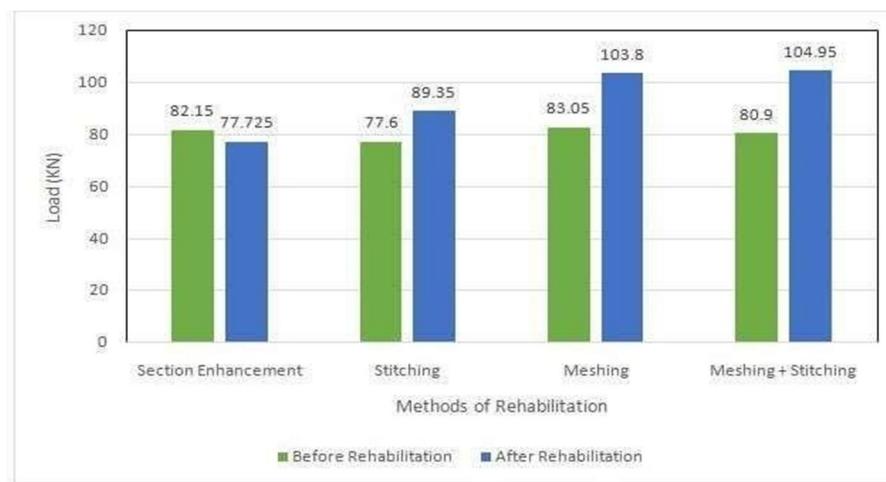
Figure 9.1: Variation of Load of beams BR and AR

Sr. no.	Method of Rehabilitation	Average Load at Failure before Rehabilitation (kN)	Average Load at Failure after Rehabilitation (kN)	% Strength Restored
1.	SEM	82.15	77.725	94.61
2.	SM	77.60	89.35	115.14
3.	MM	83.05	103.80	124.98
4.	MSM	80.90	104.95	129.73

This chapter defines details on experimental outcomes of the corrosion damaged beams and rehabilitated beams. Bending stresses, moment carrying capacity, load carrying capacity, mode of failure, load vs. deflection curves and comparative study of all types of beams before and after rehabilitation are described in Table 9.1 to Table 9.3 and Figure 9.1.

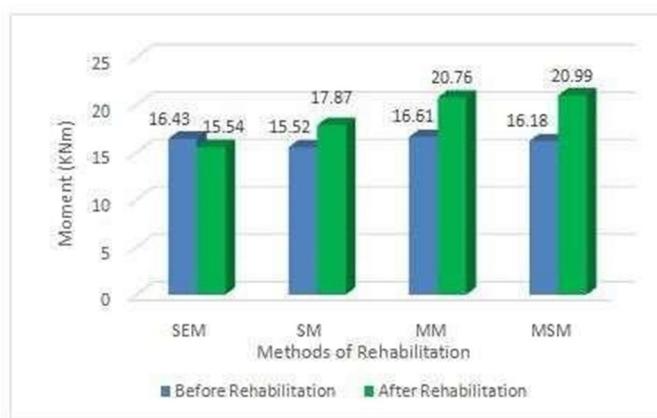
Figure 9.8: Moment capacity of beams BR and AR

Fig. 9.7 and Fig. 9.8 shows the variation of bending stresses and moment carrying capacity of damaged beam before rehabilitation and after rehabilitation. Combination of stitching plus meshing method showed outstanding result in carrying highest bending stress and moment capacity.

Sr. no.	Method of Rehabilitation	Bending Moment (kNm)	
		Before Rehabilitation	After Rehabilitation
1.	SEM	16.43	15.54
2.	SM	15.52	17.87
3.	MM	16.61	20.76
4.	MSM	16.18	20.99
