# Analysis of VFTO and Its Mitigation in a GIS through Additional Earthing Grid

## II. VFTO GIS FLASHOVER AT A 765 KV GIS INSTALLATION

Tripping of a 765 kV transmission line during first-time charging of an ICT in a GIS installation @ 00:19Hrs on 30.12.2023

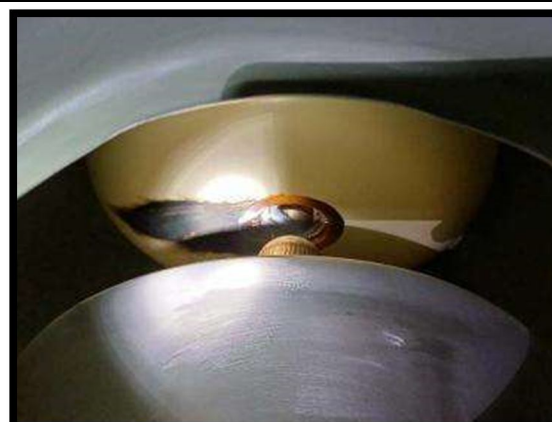
During closing operation of isolators for first time charging of ICT#3, 71152R Phase CB (existing tie CB of 765kV line line#2 and ICT#3 elements) flash over occurred in 711 89A R Ph DS/ES Gas compartment at 00:19hrs on 30.12.2023 and lead to tripping of 765kV line#2 on distance protection.

The fault current was observed to be 13.9kA. SO<sub>2</sub> content was observed in Isolator/DSES 71189A (R Ph), 711CTA (R Ph towards line #2) and 71152 CB (R Ph)

Flash Over or burnt marks appeared in 711 89A R Ph DS/ES Gas compartment (Highlighted in RED color in Gas SLD). Powder remanent was observed inside the DS chamber.

At GIS installation, flashover related concerns and transient stress indications prompted the installation of additional grounding conductors using copper earth flats interconnected with the existing earth mat. Subsequent operation revealed a noticeable improvement with no further flashover occurrence.
