Assessment of Water Quality in Chennai's Urban Lakes: Impacts of Urbanization and Encroachment

Abstract: *This study assesses the 2019 water quality of five major lakes in Chennai—Ambattur, Korattur, Perungudi, Velachery, and Rettai Eri—highlighting significant contamination driven by urbanization and industrial activities. Water samples from these lakes were analyzed for key geo-chemical parameters, including calcium, magnesium, carbonates, bicarbonates, sulfates, sodium, chlorides, total dissolved solids (TDS), pH, electrical conductivity (EC), and potassium. The results revealed substantial contamination due to residential sewage and urban runoff. For instance, Velachery Lake exhibited the most significant contamination, with only 24.78% of its original area remaining and 75.22% encroached upon. The other lakes also showed high levels of pollution, reflecting the severe impact of urban expansion on water quality. These findings emphasize the urgent need for comprehensive water management strategies and targeted interventions to mitigate pollution and restore the ecological balance of these lakes. Effective measures such as strict zoning law enforcement, restoration projects, pu

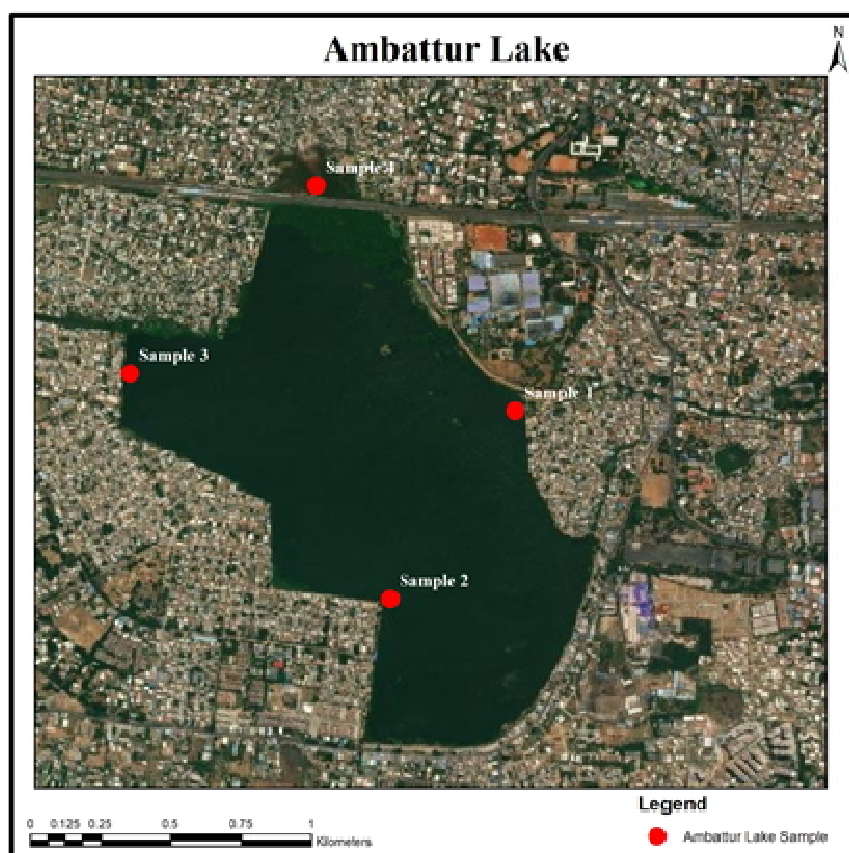
Figure.No.1 Ambattur Lake Water Quality sample

The water quality data for Ambattur Lake in 2019 includes four samples collected from various points around the lake. Situated in a densely populated residential area, Ambattur Lake receives direct sewage discharge from nearby residences, leading to significant contamination. The northern part of the lake, in particular, has been identified as highly polluted, necessitating urgent remediation efforts.

The water quality data for Ambattur Lake in 2019 highlights several key geo-chemical parameters, reflecting significant contamination primarily due to its location in a densely populated residential area. This lake receives direct sewage discharge from nearby homes, particularly affecting the northern part of the lake.

Calcium levels in Ambattur Lake range from 117.25 mg/L to 214.57 mg/L, while magnesium levels vary between 30.36 mg/L and 73.80 mg/L. These elevated levels suggest water hardness, often linked to urban runoff and sewage discharge. The carbonate levels range from 363 mg/L to 784 mg/L, and bicarbonates range from 282 mg/L to 455 mg/L. These high levels indicate substantial buffering capacity but also point to potential pollution from residential sewage.

Sulfate levels in the lake vary between 82.11 mg/L and 144.66 mg/L. Elevated sulfate levels can be associated with industrial discharges and the decomposition of organic matter from sewage. Sodium levels range from 219 mg/L to 327 mg/L, while chloride levels span from 236.23 mg/L to 800.53 mg/L. High concentrations of these ions are typical indicators of urban sewage contamination and road runoff.

TDS levels in Ambattur Lake range from 1242 mg/L to 2159 mg/L. These high values reflect significant contamination from sewage and urban runoff, impacting water quality. The pH of the lake ranges from 7.30 to 8.60, indicating slightly alkaline conditions, consistent with the presence of bicarbonates and carbonates in the water. EC values range from 1856.90 $\mu\text{S}/\text{cm}$ to 3387.50 $\mu\text{S}/\text{cm}$. High electrical conductivity suggests a high ionic concentration in the lake water, indicating substantial contamination.

The northern part of Ambattur Lake is particularly contaminated, as evidenced by Sample 4 data: calcium at 214.57 mg/L, magnesium at 73.80 mg/L, carbonates (CaCO_3) at 784 mg/L, bicarbonates (HCO_3) at 455 mg/L, sulfate at 144.66 mg/L, sodium at 327 mg/L, chloride at 800.53 mg/L, TDS at 2159 mg/L, pH at 8.60, and electrical conductivity at 3387.50 $\mu\text{S}/\text{cm}$. These elevated levels indicate severe contamination, likely from direct sewage discharge and urban runoff.
