Volume: 12 **Issue:** VII **Month of publication:** July 2024

Assessment of Water Quality in Chennai's Urban Lakes: Impacts of Urbanization and Encroachment

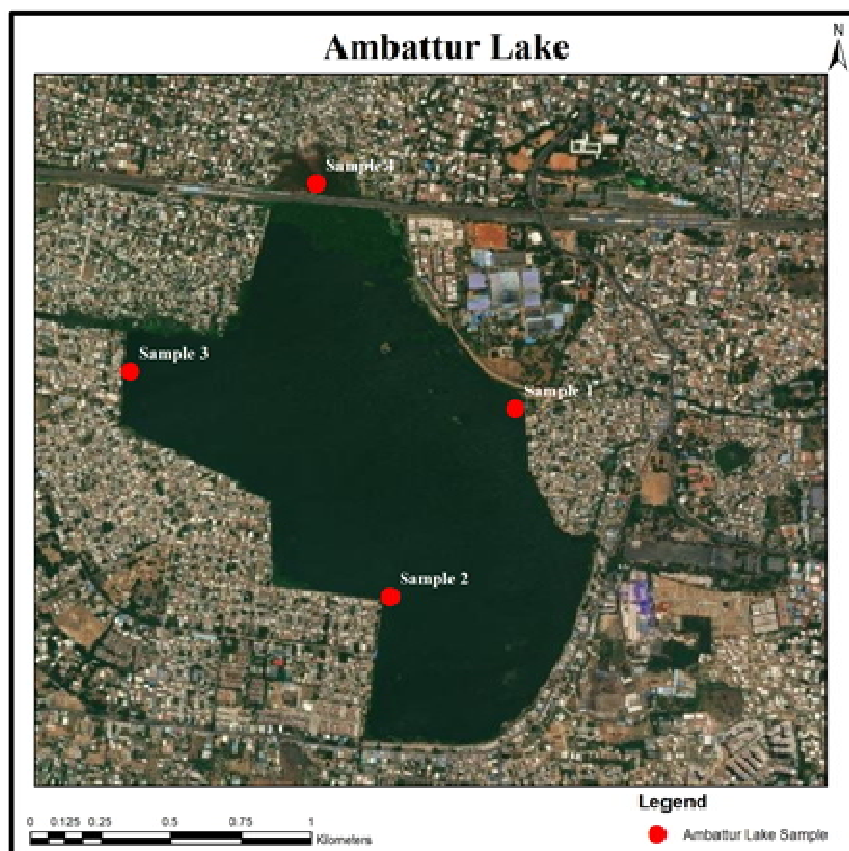
Figure.No.1 Ambattur Lake Water Quality sample

The water quality data for Ambattur Lake in 2019 highlights several key geo-chemical parameters, reflecting significant contamination primarily due to its location in a densely populated residential area. This lake receives direct sewage discharge from nearby homes, particularly affecting the northern part of the lake.

Calcium levels in Ambattur Lake range from 117.25 mg/L to 214.57 mg/L, while magnesium levels vary between 30.36 mg/L and 73.80 mg/L. These elevated levels suggest water hardness, often linked to urban runoff and sewage discharge. The carbonate levels range from 363 mg/L to 784 mg/L, and bicarbonates range from 282 mg/L to 455 mg/L. These high levels indicate substantial buffering capacity but also point to potential pollution from residential sewage.

Sulfate levels in the lake vary between 82.11 mg/L and 144.66 mg/L. Elevated sulfate levels can be associated with industrial discharges and the decomposition of organic matter from sewage. Sodium levels range from 219 mg/L to 327 mg/L, while chloride levels span from 236.23 mg/L to 800.53 mg/L. High concentrations of these ions are typical indicators of urban sewage contamination and road runoff.

TDS levels in Ambattur Lake range from 1242 mg/L to 2159 mg/L. These high values reflect significant contamination from sewage and urban runoff, impacting water quality. The pH of the lake ranges from 7.30 to 8.60, indicating slightly alkaline conditions, consistent with the presence of bicarbonates and carbonates in the water. EC values range from 1856.90 $\mu\text{S}/\text{cm}$ to 3387.50 $\mu\text{S}/\text{cm}$. High electrical conductivity suggests a high ionic concentration in the lake water, indicating substantial contamination.

The northern part of Ambattur Lake is particularly contaminated, as evidenced by Sample 4 data: calcium at 214.57 mg/L, magnesium at 73.80 mg/L, carbonates (CaCO_3) at 784 mg/L, bicarbonates (HCO_3) at 455 mg/L, sulfate at 144.66 mg/L, sodium at 327 mg/L, chloride at 800.53 mg/L, TDS at 2159 mg/L, pH at 8.60, and electrical conductivity at 3387.50 $\mu\text{S}/\text{cm}$. These elevated levels indicate severe contamination, likely from direct sewage discharge and urban runoff.

The 2019 water quality data for Ambattur, Korattur, Perungudi, Velachery, and Rettai Eri Lakes in Chennai highlight significant contamination due to urbanization and industrial activities. High levels of calcium and magnesium in Ambattur Lake indicate significant hardness, attributed to residential sewage and urban runoff, with elevated carbonates and bicarbonates suggesting pollution. Sodium and chloride levels, along with high TDS and EC values, underscore severe pollution.
