Reliability Improvement of EP-UHR Belt Joint

Tata Steel, Jamshedpur-831001, India

I. BACKGROUND

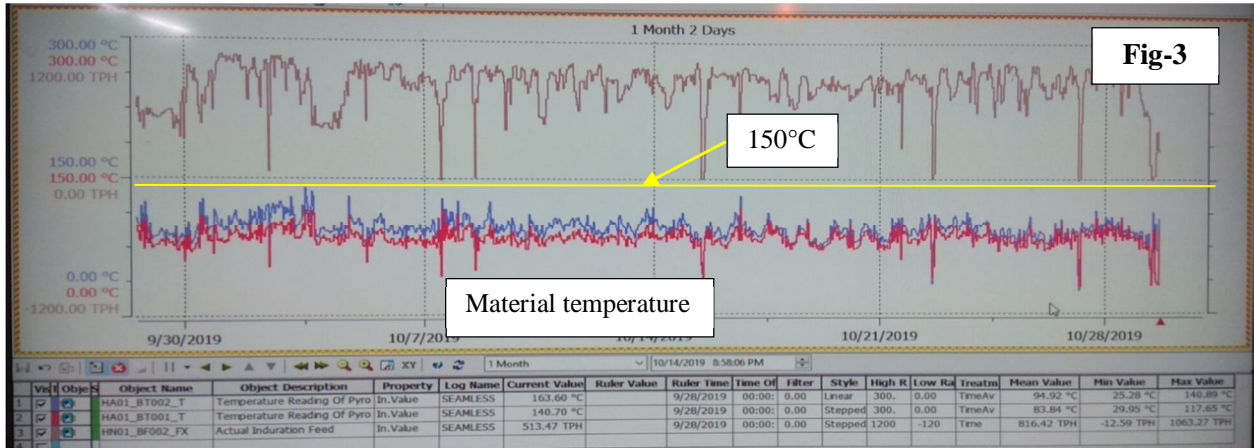
Material temperature of upstream conveyors were found below 150°C in DCS temperature trend (fig-3). The pyrometers (temperature RTD) are installed just after receiving chute and before water spray system. The temperature was found within the belt max surface temperature rating 220°C as per belt datasheet.

- 1) *Low Heat Resistance Cover Rubber:* As based on the belt failure history as per table-1, the failed belts were supplied by the various manufacturers (Indian & Overseas) but the all belts failure mode is almost similar (only joint failure). As per fig-3, the material temperature trend was found below 150°C but as per the central monitoring team thermography report, the material temperature was found max. 230°C however, this belt could have taken care of max. belt surface temperature 220°C as per the belt datasheet. Hence the selection of cover rubber grade (heat resistance) is not inadequate.

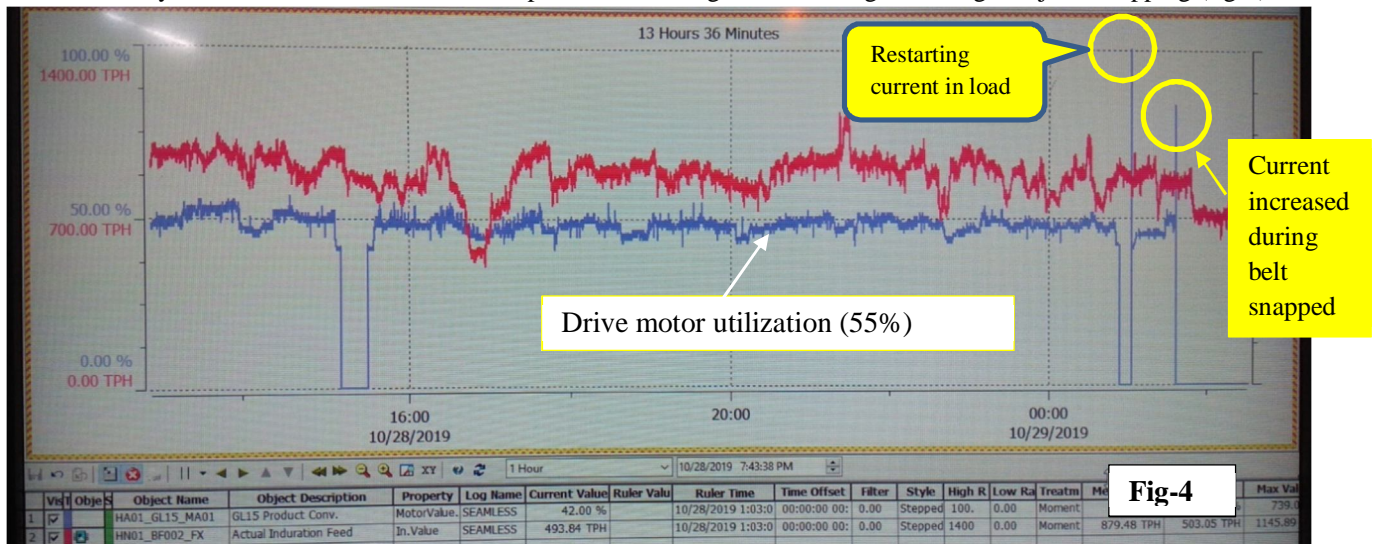
The failed belt conveyor drive motor current was shot up at belt restarting in load and again during belt joint snapping (fig-4).

Motor current spike before belt snapped: The belt was sensed high current during re-starting in load (fig-4). This might be the reason of pile formation at the receiving chute of conveyor.

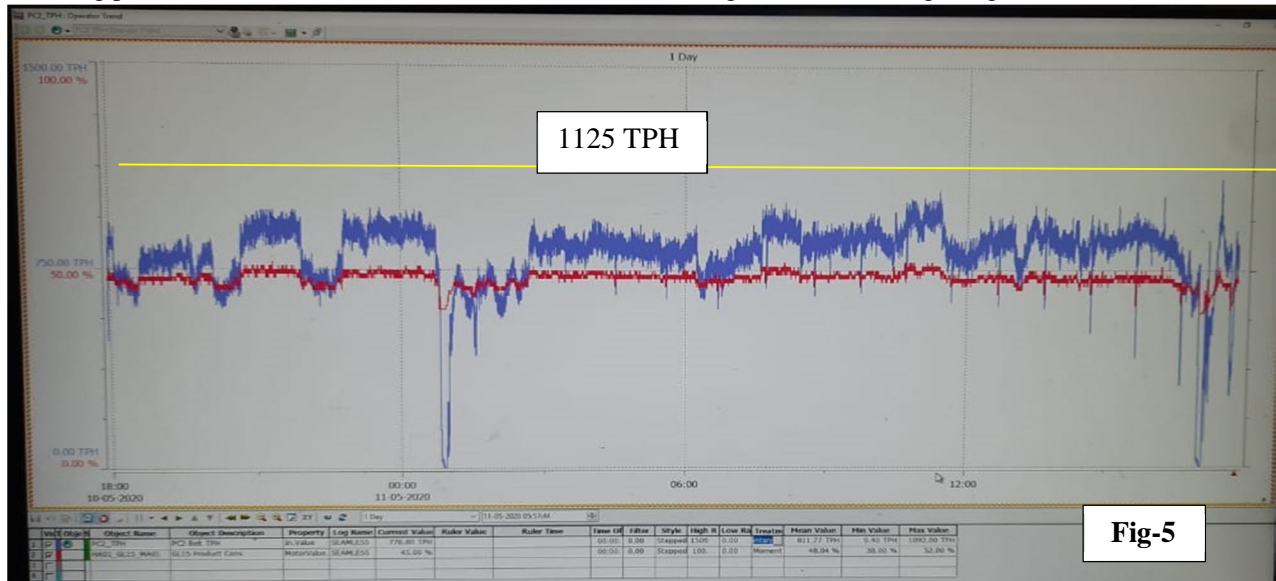
Conveyor loading pattern was taken and found max 1092 TPH & its trending details is showing in fig-5.

This conveyor runs at 1125 TPH which is within the rated capacity (1270 TPH), as per TPH trend (fig-5).

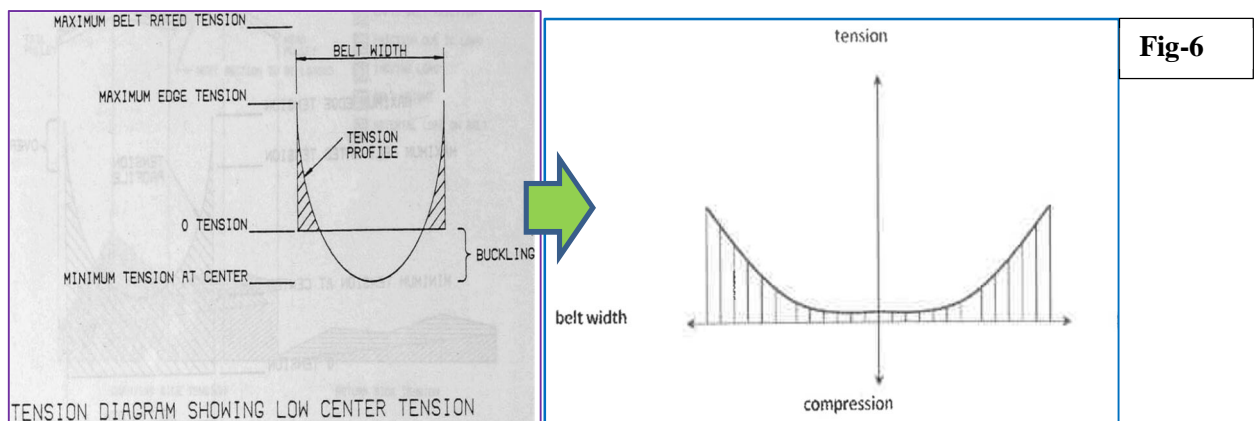
The benefits of 450/4 (500/4) over 630/4 rating belt: Improved edge to centre tension differential & reduced centre tension (fig-6).

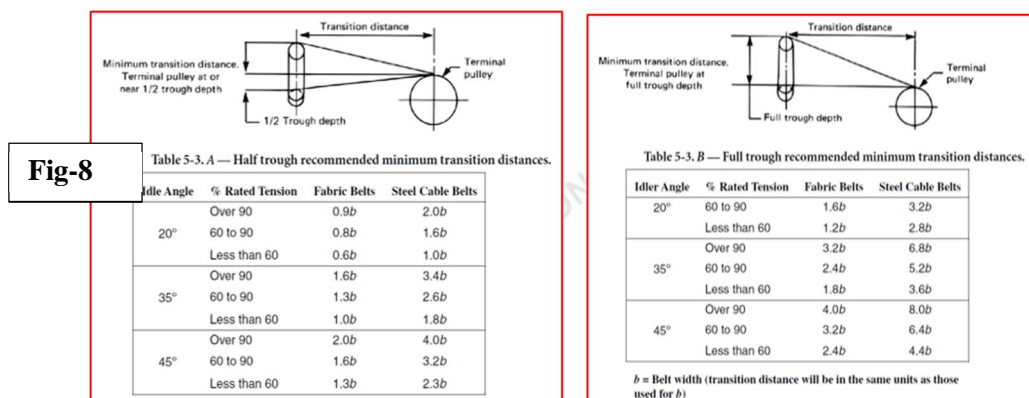
As per standard transition distance of belt (FOS -10 for EP fabric), detail is shown in below figure-8,

Hence recommended tail transition distance = 3.2 x belt width = 3.2 x 1.2 = 3.84 m
