Case Study on Surface and Subsurface Water Ingress of Barog Tunnel in the State of Himachal Pradesh

Deepak Parkash Gupta

Senior Geologist, M/s Lion Engineering Consultants Pvt. Ltd in association with Hadimba Consultants Professionals & Technocrats

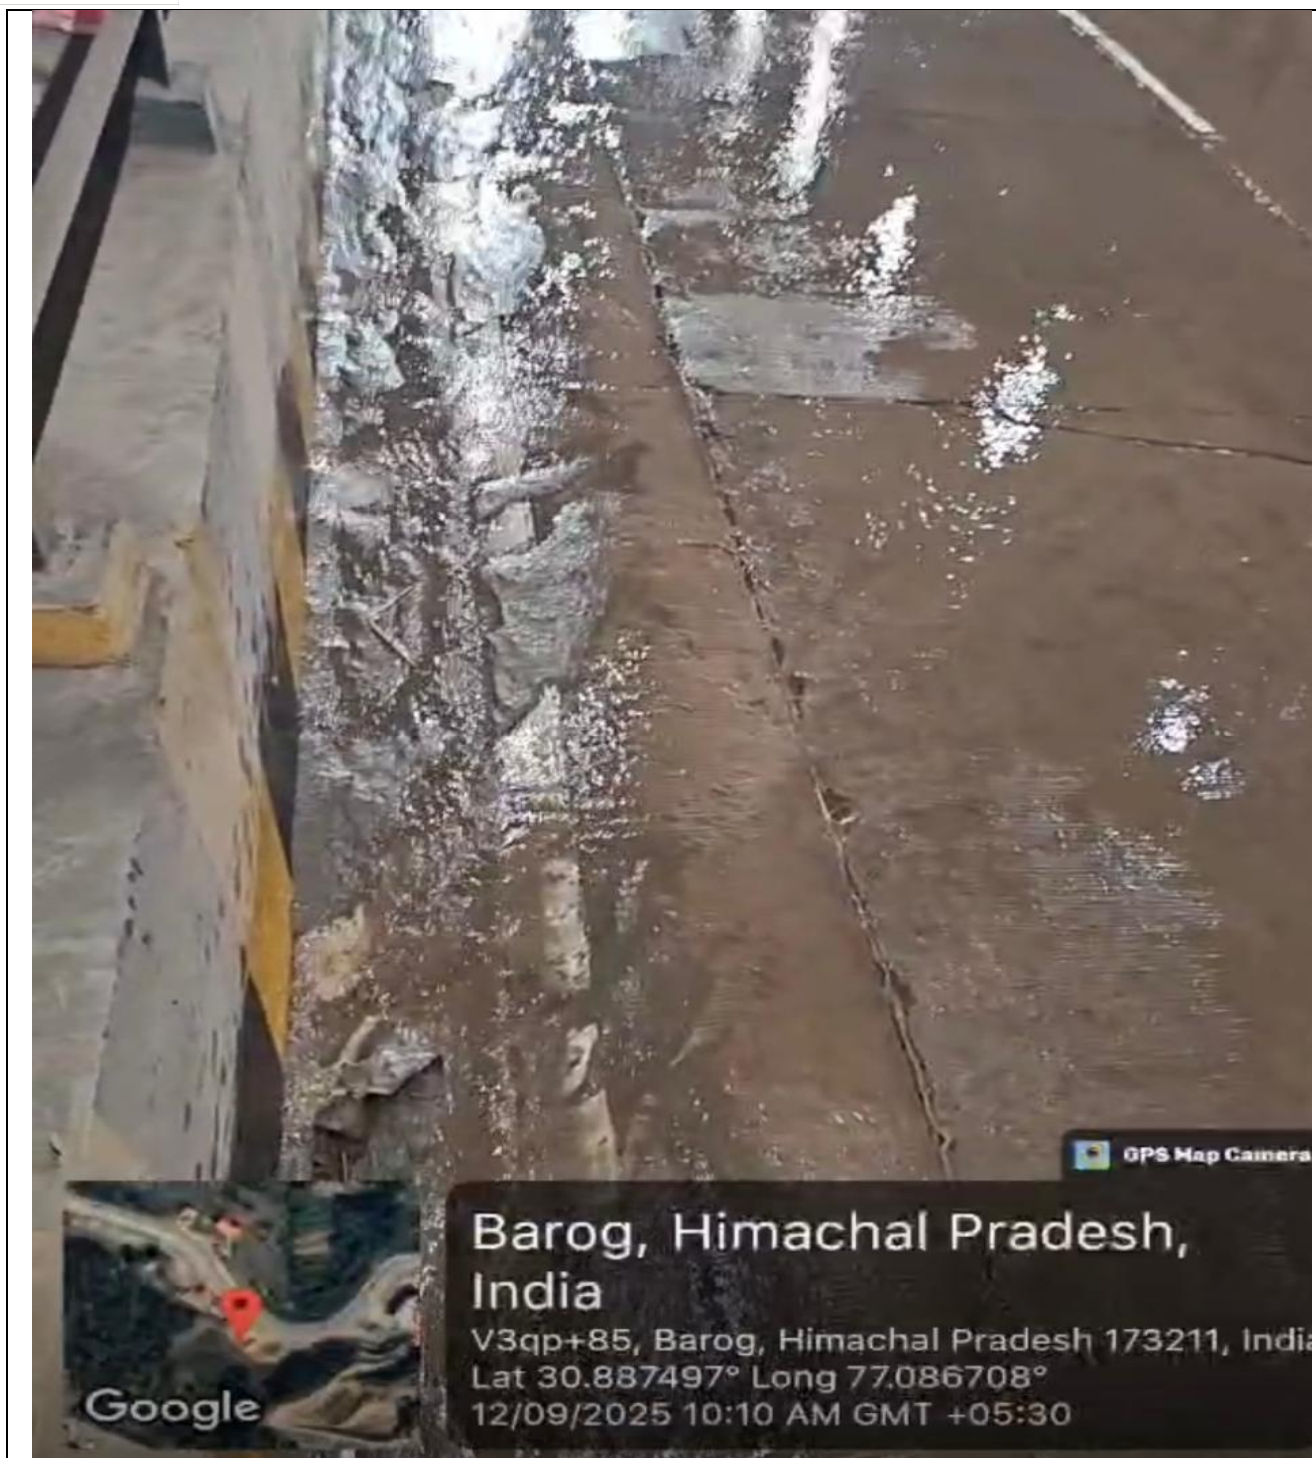
- 2) PQC and pedestal joints: - It is observed that sub surface water is coming out from several locations minimum 5 liter/minute of water especially from grove cutting area and resulting in flowing of water from here and there inside tunnel thereby causing damaging to the PQC part and creating problem for road users.

Seepage of water from construction joints of pedestal and PQC.

- 1) Seepage of water from construction joints in lining part: -Polyurethane (PU) grouting should be used to treat dampness.
- 2) PQC and pedestal joints: -Injection cement grouting with admixture should be applied to seal joints. However, if needed PU grouting/Epoxy should be used to treat this problem.
- 3) Minor and major cracks: - Cement grouting should be used to treat this problem.
- 4) Chocking of drains: -Cleaning of drains should have to be done for smooth flow of water inside the drain.
- 5) Damaged drain cleaning pipe: - Repairing of damaged drain cleaning pipes have been required. Moreover, if required PU grouting after cement grouting shall be applied to stabilize water flow.
- 6) Chocking of drains: -Cleaning of drains is required on regular intervals, which is the most important activity duringto avoid unto wards water channelization.

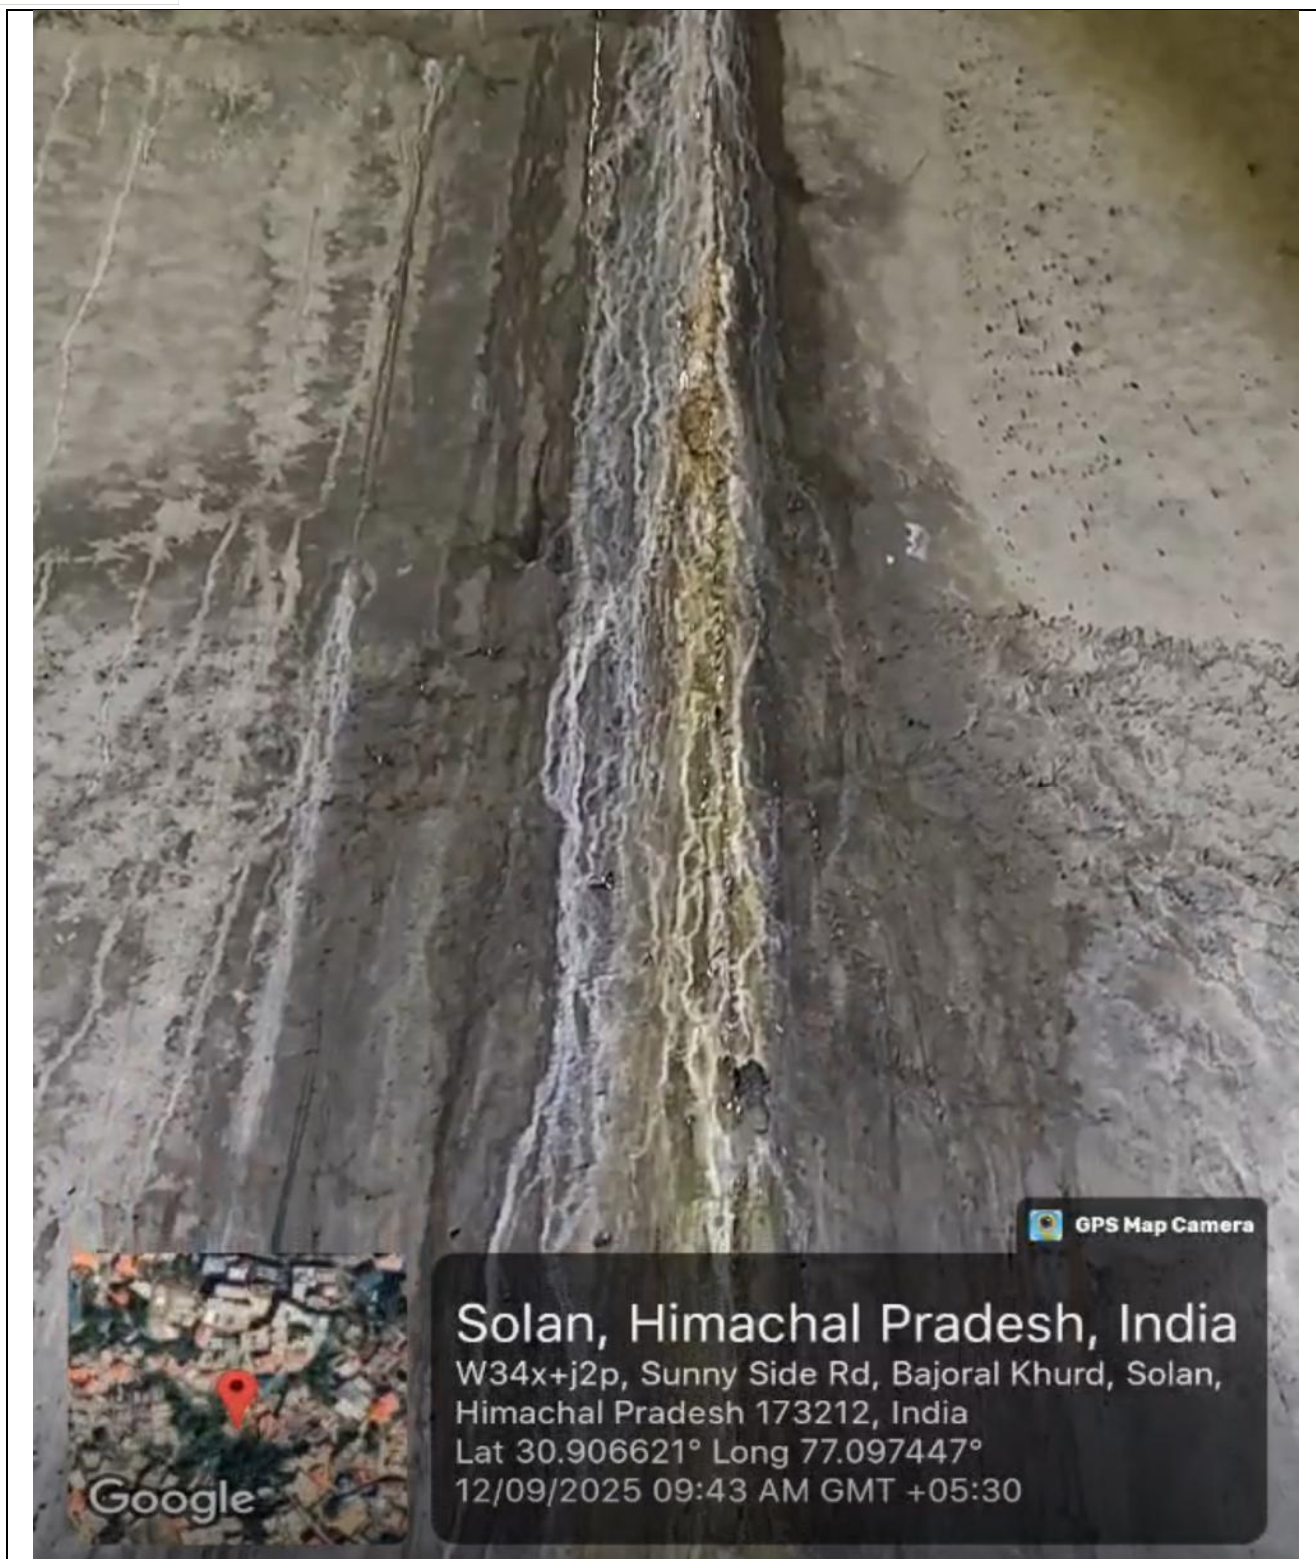
- 1) Seepage of water from construction joints in lining part: - Seepage of water from construction joints at gantry number 23, 24, 25, 26, 27, 52, 58, 59 has been observed, thereby causing dampness and leaching at various locations. There might be of every possibility of eruption of waterproof membrane.

Leaching in lining.

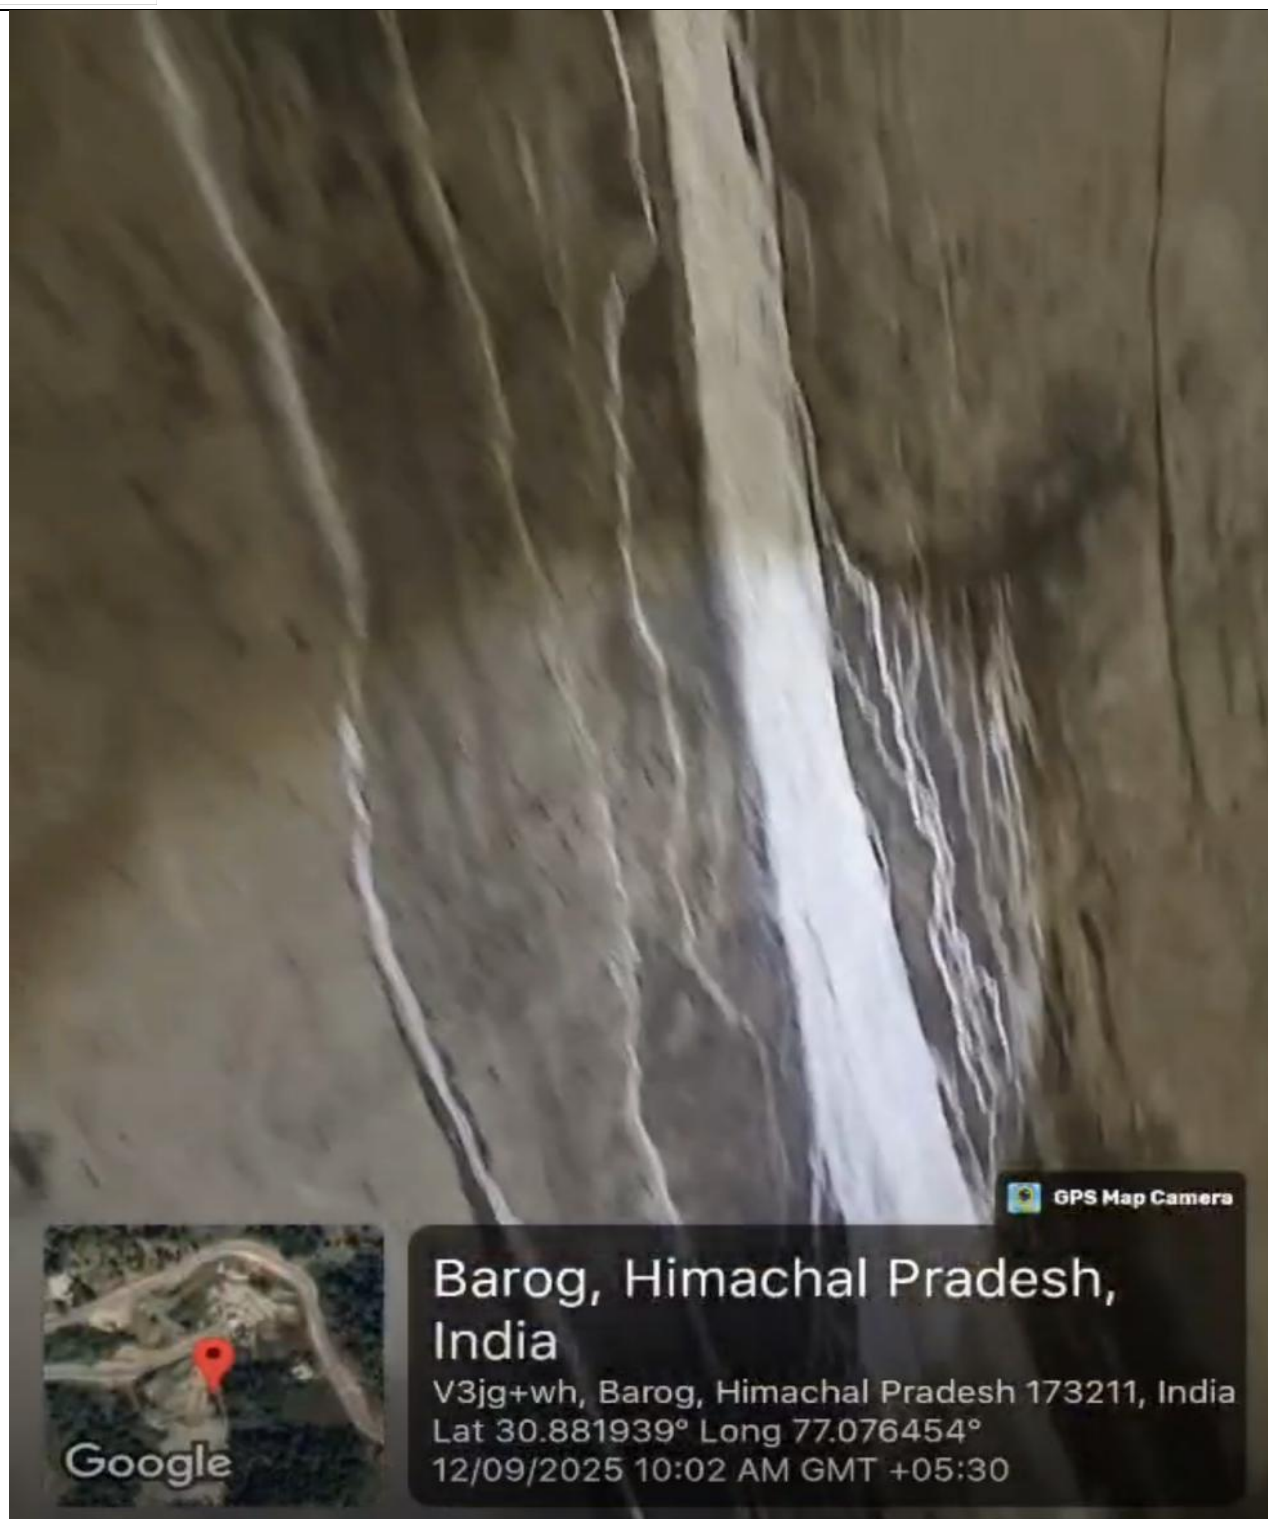
Seepage of water from construction joints.

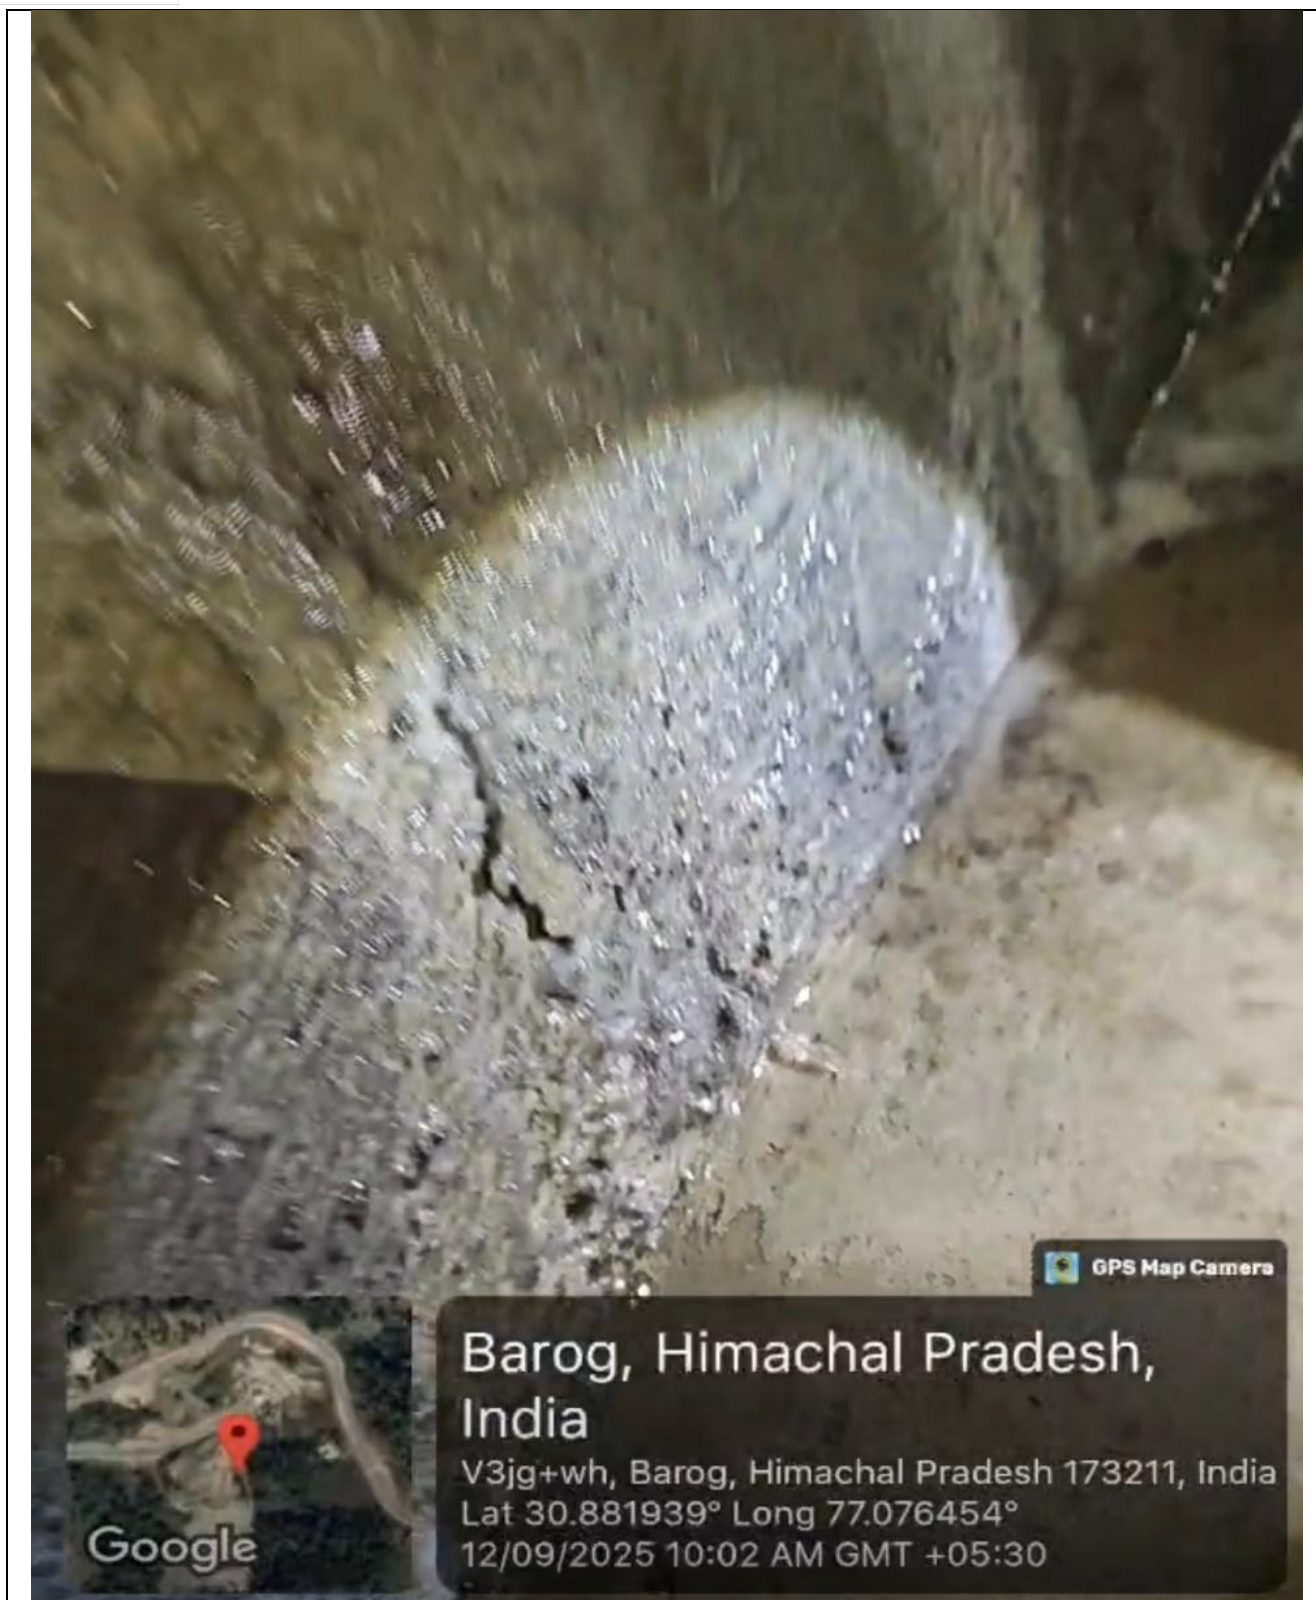
- 3) Minor and major cracks: - Some minor, hairlike cracks have been observed at most of the locations. Even some major cracks at very specified locations have been noticed which in turn causing dampness and flowing of water from gantry joints. There might be of every possibility of eruption of waterproof membrane.

Seepage of water from cracks of lining.

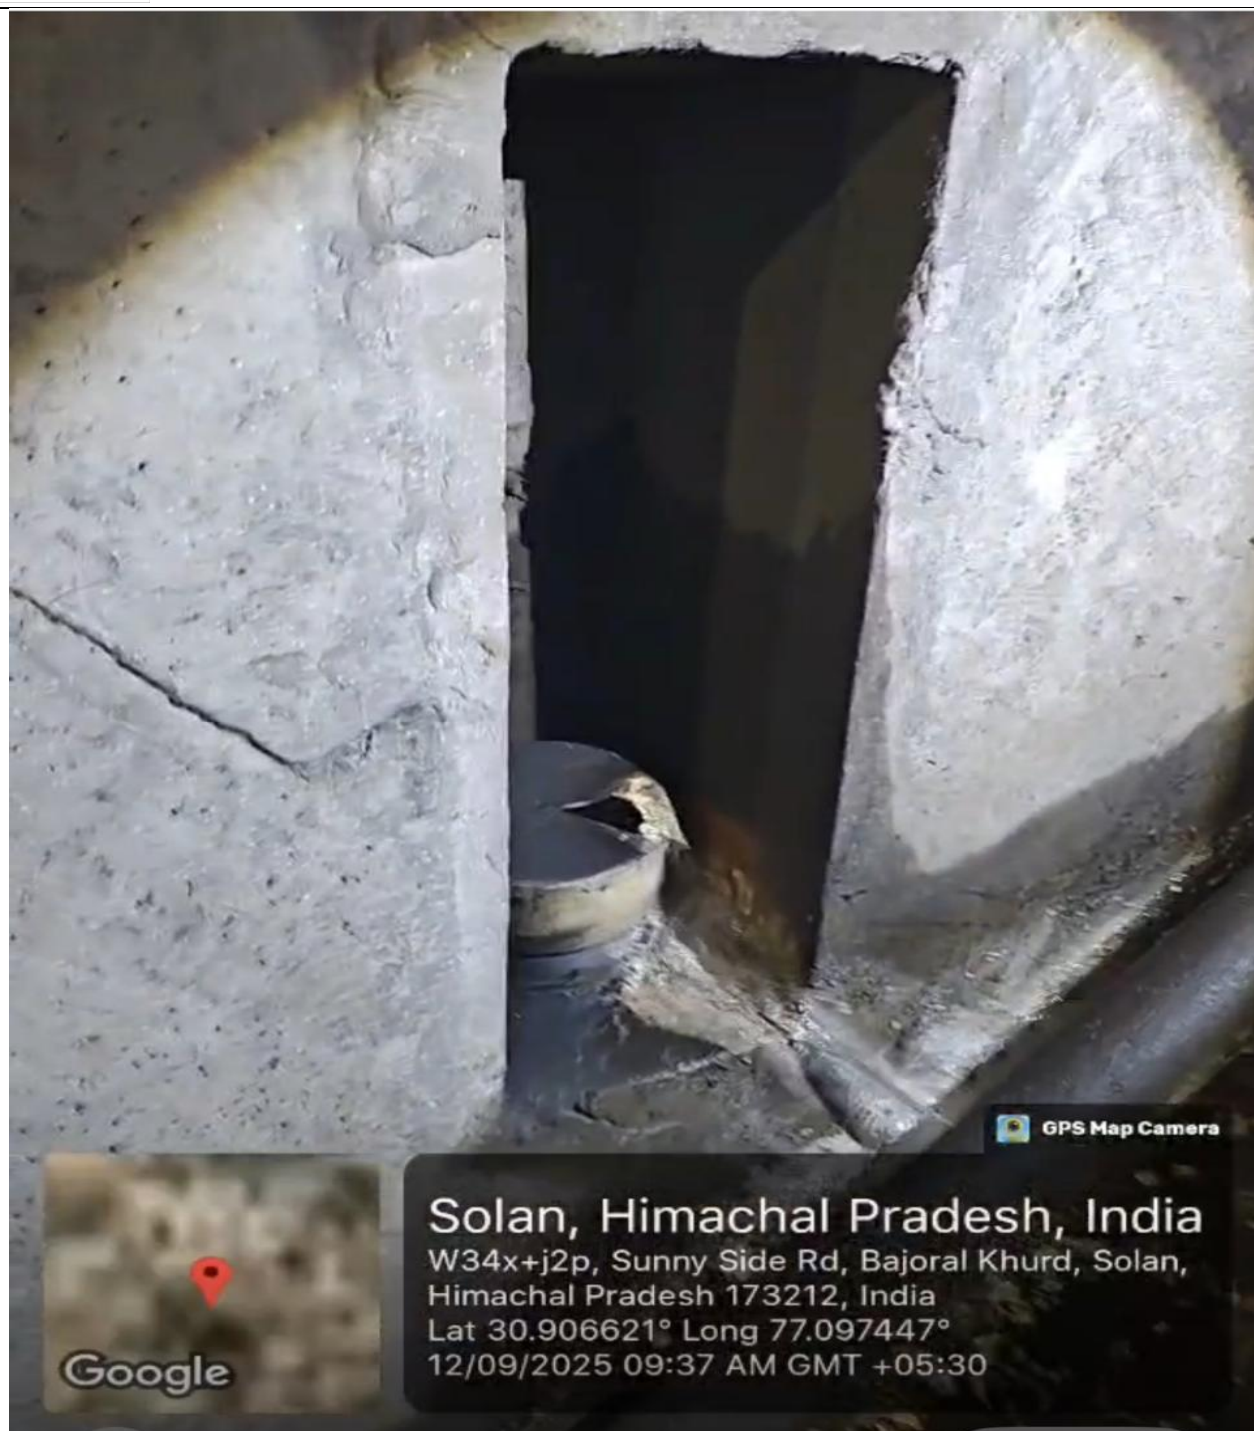
- 4) Chocked drains: - It is observed that at various locations the drains have been chocked and resulting in unavoidable flow of water inside tunnel.
- 5) Damaged drain cleaning pipe: - Drainage cleaning pipe at gantry number 29 is found damaged thereby causing flowing of water over 4-to-5-liter water/minute.

Leakage of water from drain cleaning pipe
