# Condition Assessment Using None Destructive Tests at Montauk Bridge Deck

**Abstract:** Ground penetrating radar (GPR) and portable seismic property analyzer (PSPA), was used in concrete structures for monitoring, quantifying, and mapping the deterioration of bridge decks. The Montauk Bridge deck was assessed based on PSPA and GPR data. Based on the analysis of the PSPA data, it was determined that over 65% of bridge conditions were rated serious to poor condition with an average compressive strength of less than 2500 psi; less than 35% of bridge deck conditions were rated fair to good with an average compressive strength over 2500 psi. Based on GPR data, it was determined that 72% of the bridge deck was in serious to poor condition, and only 28% of the bridge deck was in fair to good condition. Additionally, the analyses of the ground penetrating radar data indicated possible rebar corrosion in places. For these reasons, it is recommended that the Montauk bridge's deck be completely replaced.

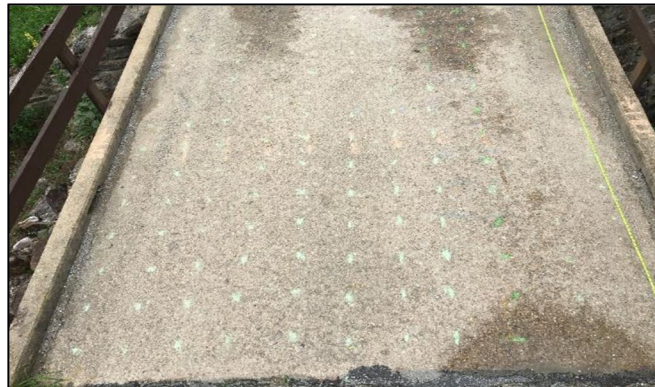
Visual inspection was performed on both the top and bottom of the bridge deck. Loose of concrete surface were recorded and marked on the bridge plan on most of the deck area (Figure 2). Grooves about 2-3 inches deep were in a different location on the bridge deck (Figure 3), and exposed steel bars were found in another location, showing evidence of corrosion (Figure 4). The visual data was used to create a map of the defects to compare it with the PSPA data and the GPR data (Figure 5).

Figure 2. Visual evidence of loss of concrete surface.

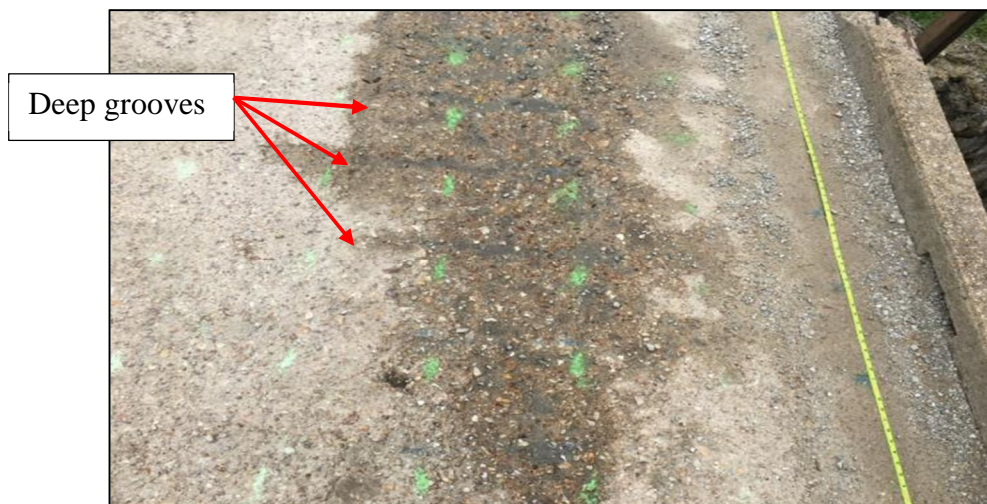
Figure 3. Visual evidence shows deep grooves. (Grooves about 3 inches deep cover over half of the bridge deck area)

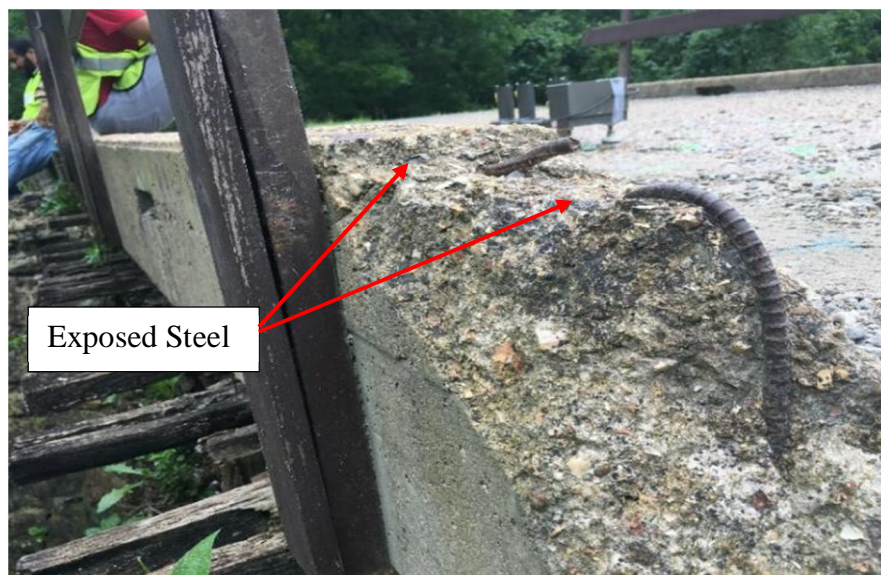
Figure 4. Visual evidence shows the exposed reinforcement steel bar. (In the picture is a corroded steel bars on the girder.)

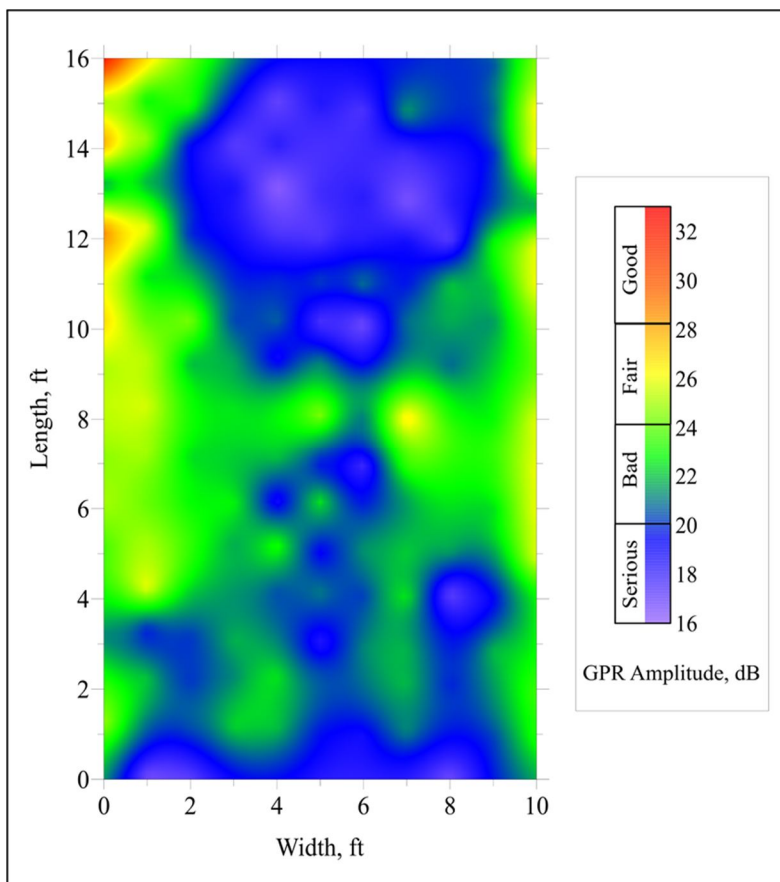
The condition of the bridge deck is a function of the moisture content. The more moisture content in the concrete, the more conductivity. Additionally, the dielectric permittivity increased. As the signal attenuated more rapidly, moisture conductivity increased, and the amplitude of the reflection decreased. As shown in Figure 10, low amplitude was in most of the bridge deck. Figure 11 is a side-by-side comparison between the 2D map of the average compressive strength and the 2D map of GPR amplitude reflection. The figure shows consistency where the area of the bridge deck was expected to be deteriorated. It is also very consistent where the concrete was expected to be in a good shape.

Figure 10. Amplitude reflection (dB) of Montauk bridge deck.
