Condition Monitoring of Spur Gear Box based on Acoustic Emission Signal Analysis

Vikas. G. N¹, V. C. Chandra shekara², Madhusudana C. K³, Srinivasa. M. R⁴

^{1, 2, 3, 4}Department of Mechanical Engineering, PES College of Engineering, Mandya-571401

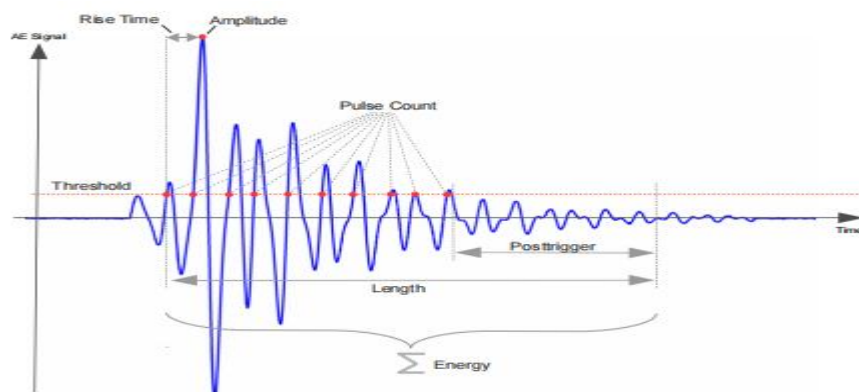
Figure 2:- Illustration of AE parameters, Josua Hunziker et al,(2012)^[2].

The above diagram shows the features of AE parameters such as rise time, amplitude, RMS, energy, duration, peak count and count. These parameters are acquired by an AE sensor and analyzed through an AE win software. The specifications of spur gear is given in table 1.

In this study, AE signals were acquired using WS α SN AF79 AE sensor, which is mounted on the outside casing surface of the test gearbox. Simultaneously 2 analog input channels, 24 bit DAQ system was used for signal conditioning and processing of AE signals. The experiment was conducted at a speed of 600 RPM and AE signals were acquired in three operating conditions such as 0N, 50N and 100N. These AE signals were acquired and analyzed to correlate the condition of the gearbox. The AE signal parameters are shown in fig 2.
