Condition Monitoring of Spur Gear Box based on Acoustic Emission Signal Analysis

Vikas. G. N¹, V. C. Chandra shekara², Madhusudana C. K³, Srinivasa. M. R⁴

^{1, 2, 3, 4}Department of Mechanical Engineering, PES College of Engineering, Mandya-571401

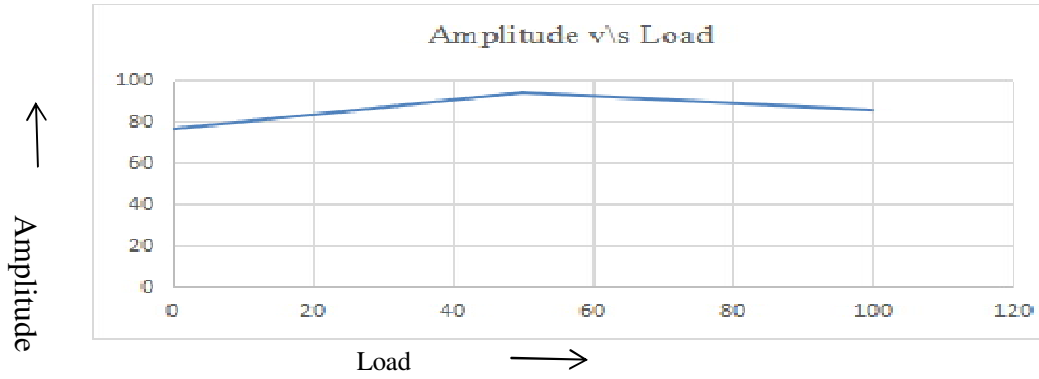
Figure 4:- Amplitude versus Load

Fig. 4 presents the variation of amplitude with respect to load on the gear box test rig, initially the value of the amplitude at without loading condition was measured about 76.12db. For 50N and 100N the value of the amplitude are 93.77db and 85.36 db respectively. It can be seen that value of the amplitude at maximum load condition is high compared to no load condition. The effect of load variation on RMS value as shown in fig 5.

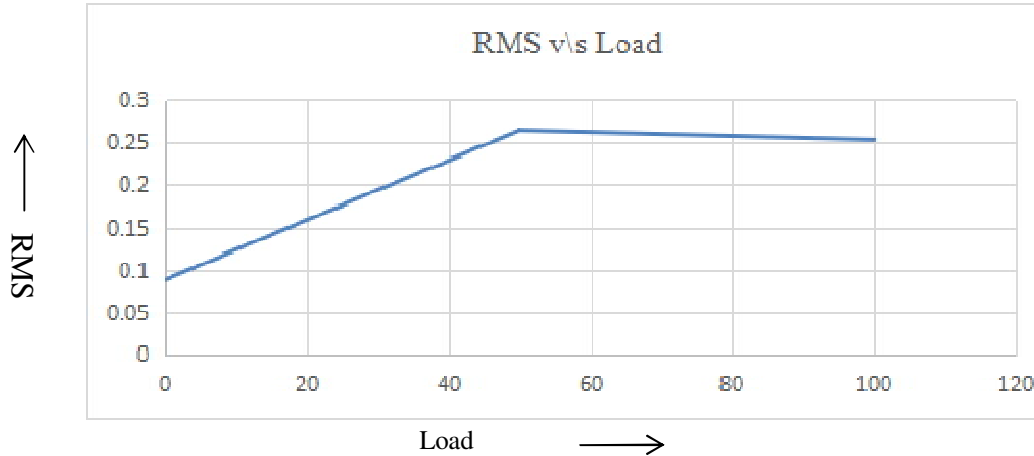
Figure 5:-RMS versus Load

In the above diagram shows that the effects of load deviation on RMS value. The RMS value is increased up to 0.2643v at loading condition compared to the RMS value about 0.0884v at initial(no load) condition. This variation in value of AE rms clearly shows the change in condition of gear. The variation of rise time with respect to load as shown in figure 6.
