Effectiveness and Efficiency of the Existing Building in Seismic Zone-III: A Case Study of Hotel Kaashi Building in Ujire

Vinay M R¹, Divyashree K S², M R Shivani³, Prathiksha J N⁴, Rakshitha G⁵

¹Assistant Professor, ^{2,3,4,5}B.E student, Department of Civil Engineering, Sri Dharmasthala Manjunatheshwara Institute of Technology, Ujire – 574240 and Affiliated to Visvesvaraya Technological University, Belagavi, Karnataka, India.

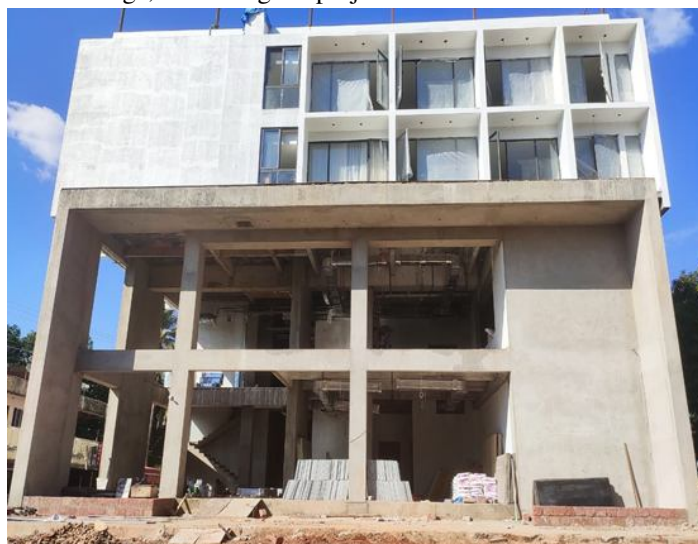
Fig. 1 Front view of Hotel Kaashi Building

This study examines a commercial complex building as shown in fig 1. The building is designed to withstand seismic loads in accordance with IS 1893 (Part 1): 2016. The building is in a Moderate Seismic Zone (Zone III) and is a G+3 structure, although the section sizes of the structure appear to be large, increasing the project's cost.

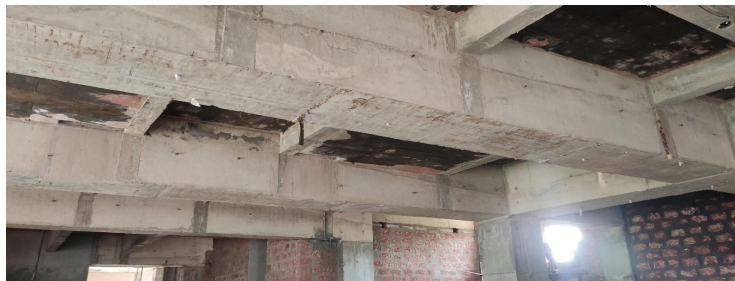
Fig. 2 Primary beams in Ground Floor

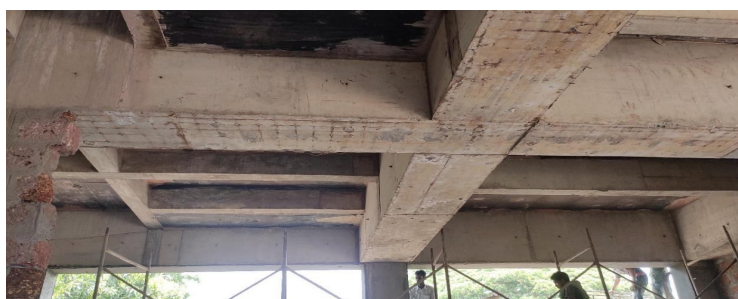
Fig. 3 Primary and Secondary beams in First Floor

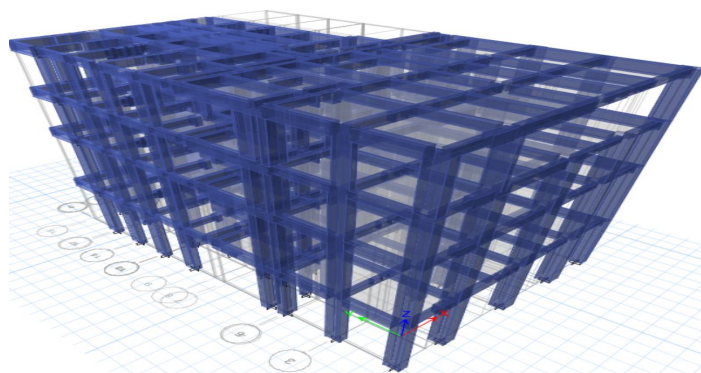
Fig. 5 Isometric View

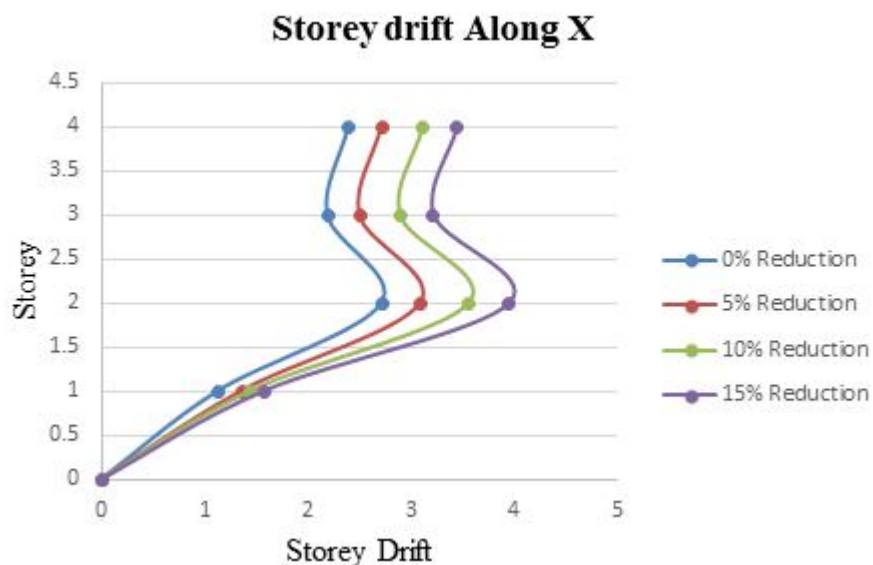
Fig. 6 Storey Drift of 0%, 5%, 10%, and 15% with 1.2 (DL + LL + EQX)

A storey drift was considered the point at which the junction of beam and column met. These points, where the maximum drifts occurred, were compared in this study. Storey drifts among G+3 storey building models are subjected to X and Y directions. Figs 6 and 7 indicate the plot of storey number versus storey drifts for earthquake loads.

- 1) Results show that storey drift and storey displacement increase with a decrease in cross-section from 0% to 10%
- 2) The second and third floors will not meet the storey drift requirements in EQY direction for a 15% reduction in cross section due to plan irregularity and stiffness irregularity.
- 3) Despite a drop in cross-section of 0% to 15%, the base shear only decreased by 2 to 3% respectively
- 4) All of the above results suggest that the existing building satisfies all the earthquake requirements with only a 10% reduction in cross sectional area due to its plan irregularity and stiffness irregularity
- 5) As a result, in light of the safety considerations, it is not advised to modify the specified cross-section sizes. In other words, the existing building details are adequate to satisfy the earthquake criteria as described in IS1893 (Part-1):2016

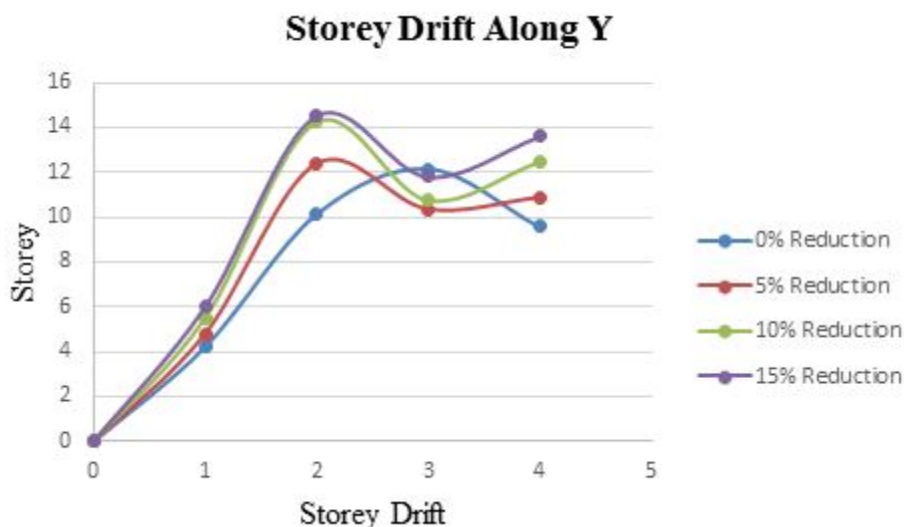
Fig. 7 Storey Drift of 0%, 5%, 10%, and 15% with 1.2 (DL + LL + EQY)

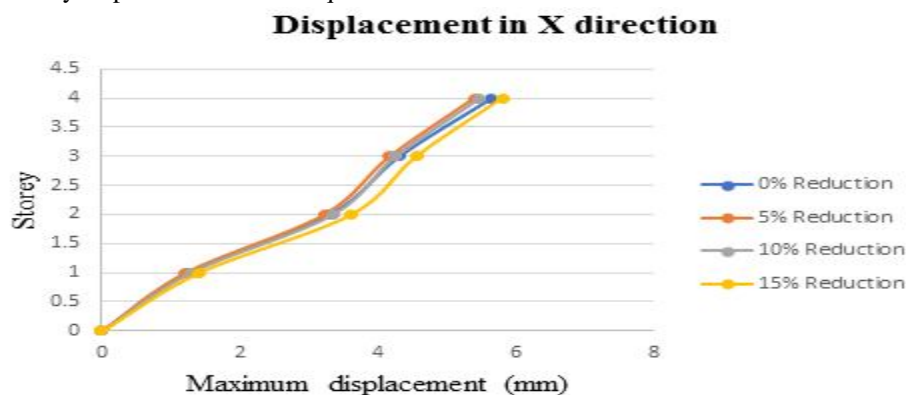
Fig. 8 Storey Displacement of 0%, 5%, 10%, & 15% in X direction

A storey displacement was considered the point at which the maximum storey displacement occurred. Figs 8 and 9 indicate the plot of storey number versus storey displacement for earthquake loads.

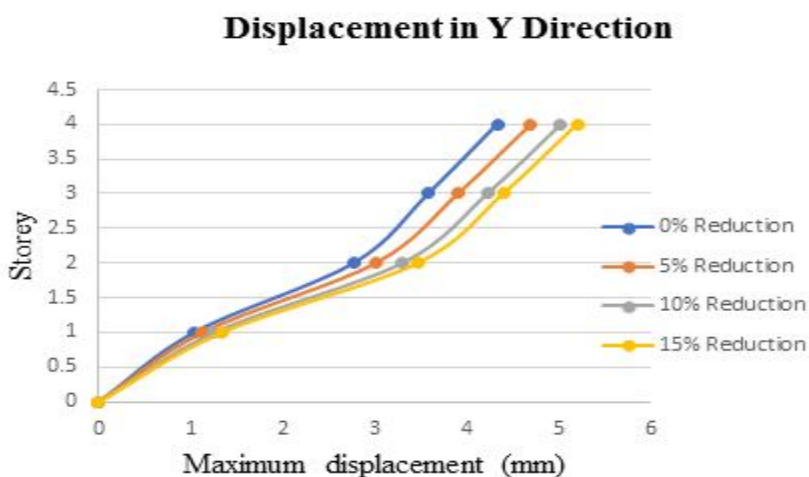
Fig. 9 Storey Displacement of 0%, 5%, 10%, & 15% in Y direction

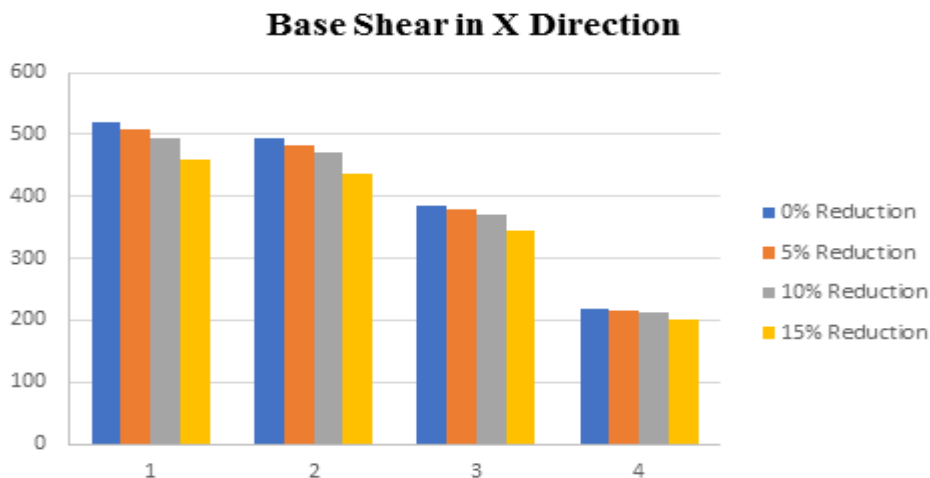
Fig. 10 Show Comparison of Base Shear of 0%, 5%, 10%, 15% in X direction

The shear force occurred in a column at base level were compared in this study. Figs 10 and 11 indicate the plot of Base shear versus storey number for earthquake loads.

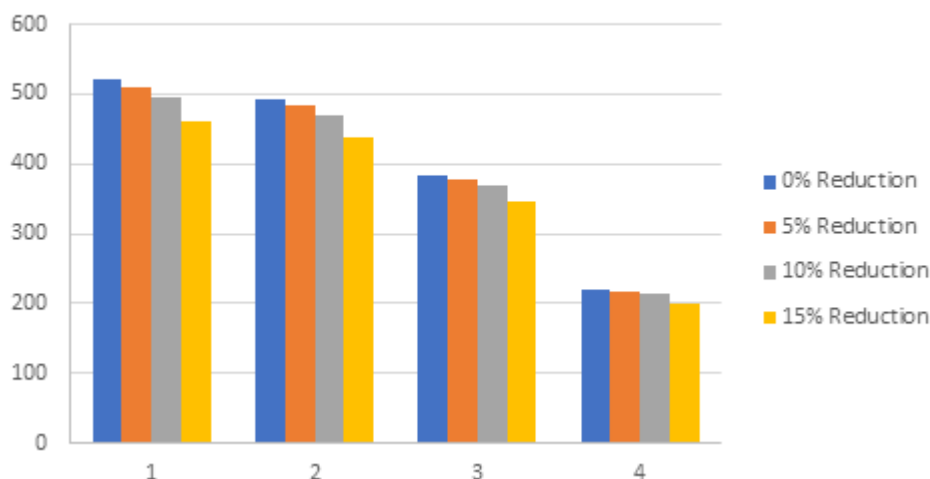
Fig. 11 Show Comparison of Base Shear of 0%, 5%, 10%, 15% in Y direction
