Effectiveness and Efficiency of the Existing Building in Seismic Zone-III: A Case Study of Hotel Kaashi Building in Ujire

Vinay M R¹, Divyashree K S², M R Shivani³, Prathiksha J N⁴, Rakshitha G⁵

Abstract: Building irregularities are an important concern when they are subjected to strong earthquakes. In structures, an abrupt change in the vertical or plan configuration tends to weaken the stability. It is necessary to study how irregular structures respond to lateral loads in order to prevent failure and reduce the risk of hazards. In this case study, a G+3 storey building is modeled using the existing beam and column cross sections. In addition, models with reduced cross sectional areas of 5%, 10%, and 15% were developed and static linear analysis was performed using Etabs software in accordance with IS1893 (Part-1):2016. The parameters considered in this study are storey displacement, storey drift, and base shear. The analytical results obtained are compared with those of the existing building model.

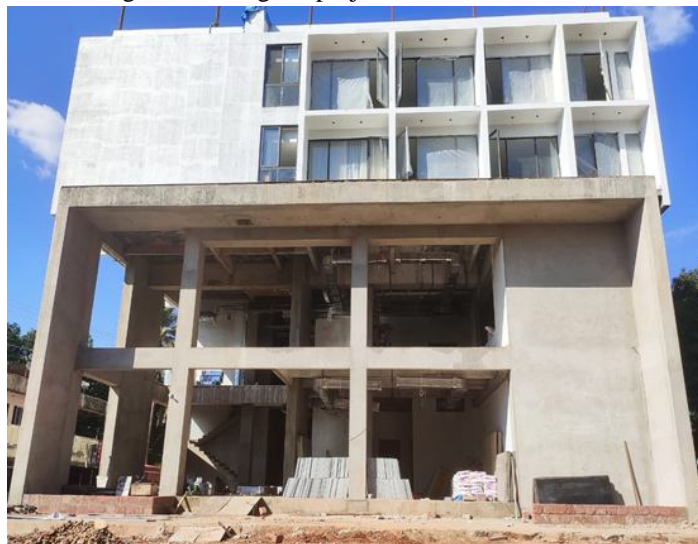
Fig. 1 Front view of Hotel Kaashi Building

This study examines a commercial complex building as shown in fig 1. The building is designed to withstand seismic loads in accordance with IS 1893 (Part 1): 2016. The building is in a Moderate Seismic Zone (Zone III) and is a G+3 structure, although the section sizes of the structure appear to be large, increasing the project's cost.

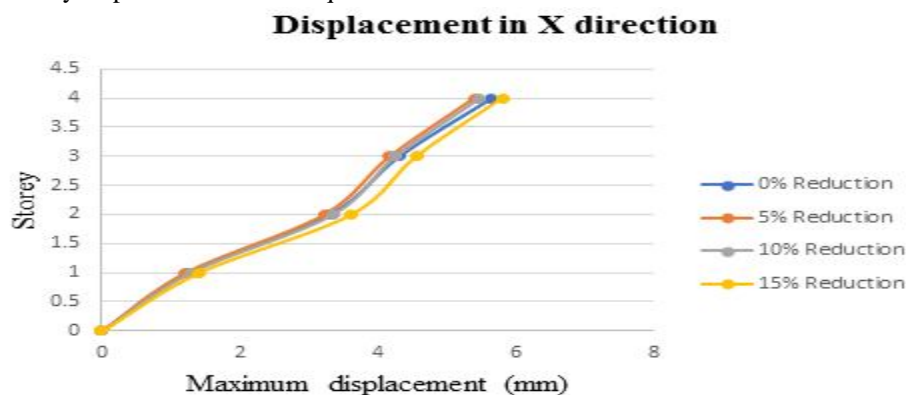
Fig. 8 Storey Displacement of 0%, 5%, 10%, & 15% in X direction

A storey displacement was considered the point at which the maximum storey displacement occurred. Figs 8 and 9 indicate the plot of storey number versus storey displacement for earthquake loads.
