Erosion and Dam Siltation in an Arzangarzan Earthen Dam in Budgam District of Jammu and Kashmir

Dr. Bashir Ahmad Pandit

Abstract: Many check dams were built in the Budgam district of Jammu and Kashmir during the 1970s, however after a few years, their entire infill was caused by significant siltation rates. This effort aimed to evaluate the mechanisms producing soil particles and their accumulation in the Arzangarzan dam. To measure the amount of sediments and the overall rate of erosion, a bathymetric survey was conducted.

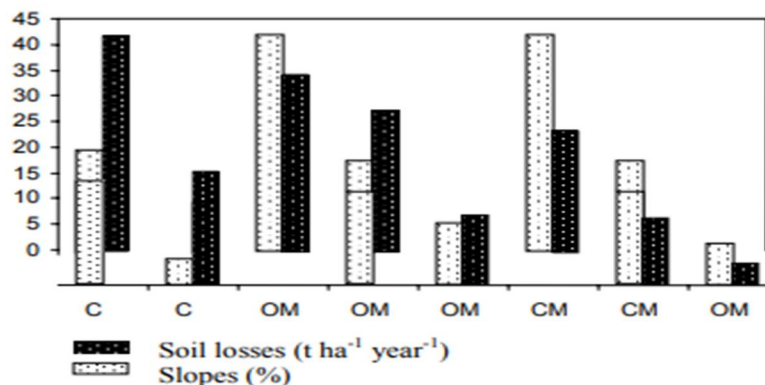
Erosion rates based on slopes and land use of Arzangarzan dam

The majority of the sediment is supplied by the cereal-growing soils on steeper slopes compared to the cultivated soils on lower slopes. The regions of open "matorral," or bushy Mediterranean-type vegetation made up of different shrubs, exhibit varying contributions to the sediment load; steep slopes have the highest rates of erosion while less steep slopes have significantly lower rates. More thick plant cover, like that found in a close-growing "matorral," tends to shield the soil surface from erosion, which lowers erosion rates for slopes that are of the same gradient. Thus, it seems that the terrain and vegetative cover are the main elements regulating erosion in the watershed. Therefore, it would seem that slope gradient and land use are the primary factors influencing the distribution and significance of the sediment source areas.
