# Experimental Evaluation of Quality of TMT/QST Steel Bar by Using TM Ring Test

Mohini Dhongade<sup>1</sup>, Rajpari Khair<sup>2</sup>, Shubham Shinde<sup>3</sup>, Amar Shelke<sup>4</sup>, A.N. Humnabad<sup>5</sup>, N. V. Khadake<sup>6</sup>

<sup>1, 2, 3, 4, 5, 6</sup>Dept. Of Civil Engineering, JSPM Imperial College of Engineering and Research, Pune

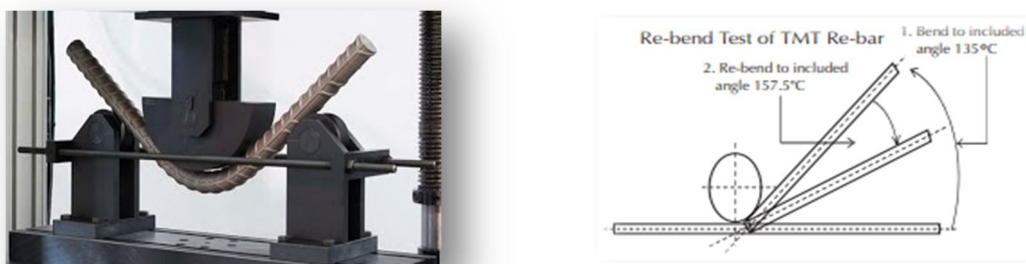
Fig 1) Re- bend test

The Re-bend test involves bending a sample of TMT Re-bar through plastic deformation by placing a force against an appropriate mandrel to a 135-degree included angle. The bend sample should be aged for 30 minutes in boiling water (100 degrees Celsius) and then let to cool. The sample should be bent back to a 157.5 degree included angle. Typically, tests are performed at room temperature. The mandrel diameters used for various grades of TMT Re-bar are listed below.

The sample used for the bend test should not be used for the re-bend test.

It is critical to ensure that the load applied to the sample bar is uniform, smooth, and vertically downwards. It is best to avoid using an impulse load.

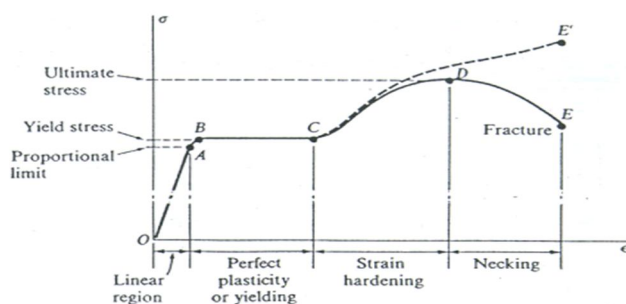
Fig 2) Yield strength of steel

Which level of stress can a material withstand? At what point will it begin to deform plastically? This information can be obtained during the Yield Stress Test/0.2% Proof Stress. The material will bend elastically until it reaches the yield point and then revert to its original shape when the applied load is removed.

Starting at 0.002 strains, the conventional technique is to project a line parallel to the initial elastic area. The 0.002 strain point is also known as the 0.2% offset strain point.

The material's behaviour can be divided into two categories: brittle and ductile. Steel and aluminium are common ductile material failures. Glass and cast iron are examples of fragile materials. The stress-strain curve can be used to distinguish between the two types. Alternating Current Components

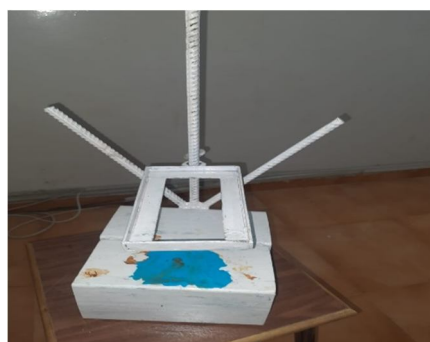
Fig 3) Model

- 1) 12 mm dia. of bar = 02 Nos, 18" length.
- 2) Square tube = 02 Nos.
- 3) Colour= half a liter.
- 4) LED Lights = 02 Nos.
- 5) Bolts = 02 Nos.
- 6) Angels = 04 Nos, 4" length.

[Note:- 90% model is made from scrap materials.]

After that, we took the welding machine and welding rod from the fabrication worker on our site to make the model and started making the model.

- a) The mobile holder had to be adjustable.
- b) The color of the model had to be changed.
- c) The lighting angle had to be changed.
- d) Sample holder had to be fixed in place.

- 1) *Mobile holder had to be Adjustable:* In the previous model we kept the sample holder adjustable. But because of that we were not getting accurate results. Because the steel sample used to be in a state and the photo could not be taken properly due to the movement of the sample.
- 2) *The color of the Model had to be Changed:* The color of the previous model was black. But the color of the sample was black. Then 2 because the color was black, I could not understand what the result was on the sample and the photo was not coming out.
- 3) *Lighting Angle had to be Changed:* The angle of the light had to be changed for this, because the mobile holder was adjustable, the light was not focused on the sample which was kept on the plain surface.

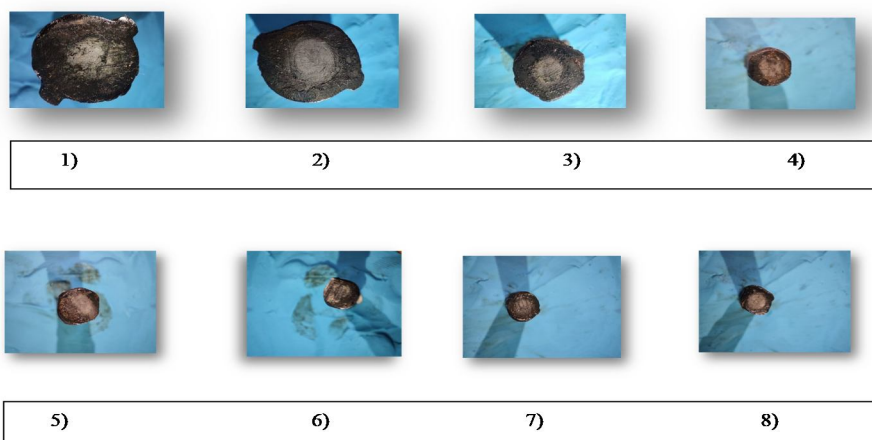
EXPERIMENTED BARS OF DIFFERENT DIAMETER

- Place the made model on a flat surface.
- After that all the STEEL BAR's were cut to 2" length and filed.
- Take ethyl alcohol 93% and 7% nitric acid in a beaker and mix well in the same manner.
- After mixing all the bars cut in the mixture, keep the mixture for at least 5 minutes.
- And to see its result, put it in the bar model and take its photo and get its result.
