# Flood Plain Mapping and Identification of Warning Level Prior to Flood for Chalakudy River

Shinto M D<sup>1</sup>, Chinnamma M A<sup>2</sup>, Deepa Davis<sup>3</sup>

<sup>1</sup>M. Tech Student, <sup>2</sup>Professor, Department of Civil Engineering, Malabar College of Engineering and Technology Desamangalam, Thrissur

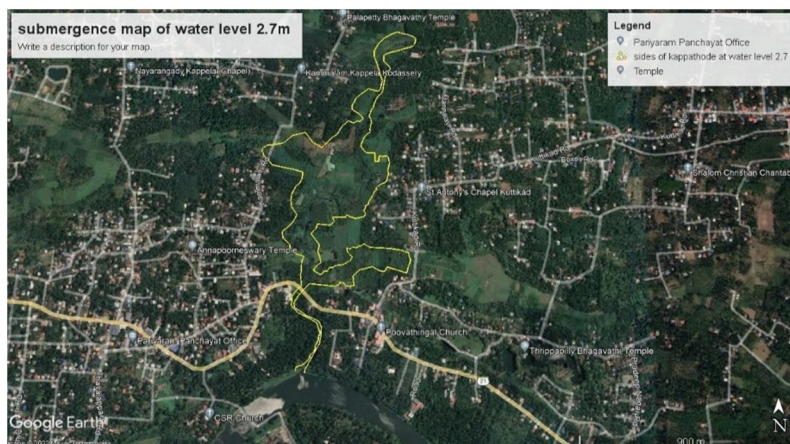
Fig.4 Flood inundation map of Pariyaram by google earth at water level 2.7m

- 1) *Pariyaram Panchayat*: The flood water level and spatial extent will be documented through the survey along with the duration of flood and rate of water level increase during the period. From the field observation and enquiry, the area which is affected by flood in Chalakudy river basin is very first is at Kammalam. This place is in pariaram panchayat ward. This place is flooded due to over flows Kappathode which is a tributary of Chalakudy river. This happened when the river gauge reading reached at 2.7 m and the height of inundation was 0.5 m. water level and inundation heights are shown in Table 5 and inundation map of Pariyaram panchayat at water level 2.7 m is shown in Fig.4.

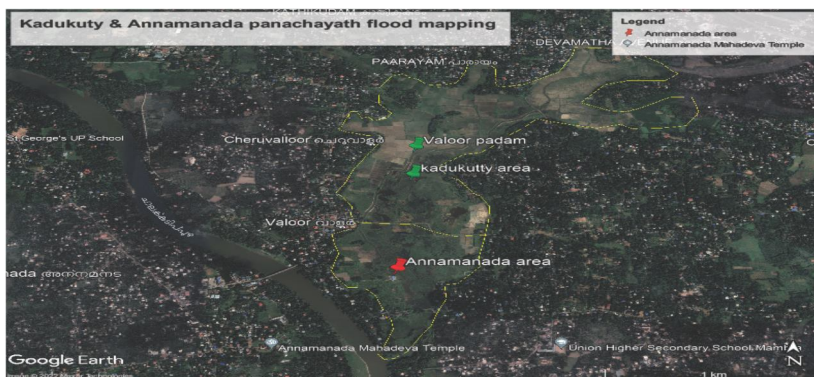
Fig.5 Flood inundation map of Kadukutty and Annamanada panchayats

- 4) *Annamanada Panchayat*: From the surveys and analysis, it is clear that left bank of Cheruvaloor and upstream side of Pulikakadavu bridge was the initially drowned area. Area inundated when river gauge reading reached 4.26 m at arangaly station and the corresponding inundation height was 0.1 m. Table 8 explains river gauge readings and corresponding inundation heights at vettilappara and arangaly station. Fig.5 shows inundation map of Kadukutty and Annamanada panchayats.
