Flood Plain Mapping and Identification of Warning Level Prior to Flood for Chalakudy River

Shinto M D¹, Chinnamma M A², Deepa Davis³

Abstract: Flood is one of the most dangerous disasters occur in the world. It endangers the lives of humans and other species. In India one – fifth of the global death rate is happening due to flood. From 2018 June 1 st to August 19 Kerala also experienced a high intense rainfall which results severe flooding. Five million people were affected and 433 people loss their life during this flood. Hence one way to minimize the effect of flood is proper operation of flood forecasting and flood control systems. In this paper we analysed drastic flood situations in Chalakudy river basin during the years 2018 - 2021. Mapping of flood plain of Chalakudy river basin was prepared using HEC – RAS and ARC GIS and initially drowned areas were mapped using Google Earth Engine. Also identified the flood warning level of Chalakudy river and each local bodies based on actual data and field surveys.

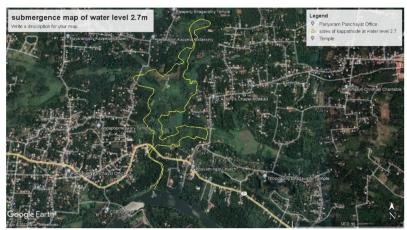
Fig.4 Flood inundation map of Pariyaram by google earth at water level 2.7m

1) Pariyaram Panchayat: The flood water level and spatial extent will be documented through the survey along with the duration of flood and rate of water level increase during the period. From the field observation and enquiry, the area which is affected by flood in Chalakudy river basin is very first is at Kammalam. This place is in pariyaram panchayat ward. This place is flooded due to over flows Kappathode which is a tributary of Chalakudy river. This happened when the river gauge reading reached at 2.7 m and the height of indundation was 0.5 m. water level and indundation heights are shown in Table 5 and indundation map of Pariyaram panchayat at water level 2.7 m is shown in Fig.4.

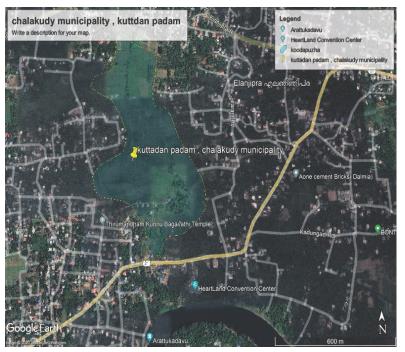
Fig.6 Flood inundation map at Chalakudy Municipality

6) Chalakudy Municipality: Chalakudy municipality is mainly depending the water level at Arangaly station. From the analysis it is clear that this area was inundated when the water level reached at 5.11 m at Arangaly station and the corresponding height of inundation was 0.6 m. Table 10 shows the river gauge readings and corresponding inundation heights at Vettilappara and Arangaly stations. Kuttan padam in ward 12 was initially drowned during 2018 flood. Fig.6 shows the flood inundation map at Chalakudy municipality.
