### Study on Identified Blackspots and Rectification Measures: A Case study

Abstract: In this paper, the survey was conducted in the Sirmour district of Himachal Pradesh where National highway 72 (NEW NH-07) runs through the district and other state highways connecting the state to the rest of the country. However, due to the district's abrupt bends, cliffs, and narrow streets, it has experienced the large number of traffic accidents.

As a result, the study of the accident blackspots on this stretch is crucial for road safety. The study area lies between Dhaulakuan to Kyarda having a length of 9 km in the plain area has already identified 4 blackspots by police authorities and P.W.D. Department.

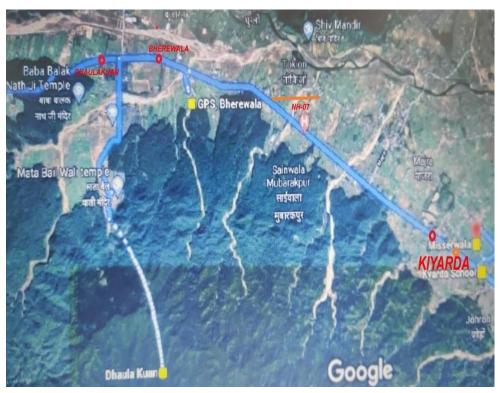
Figure 1: Image of identified black spots

The selected location for the case study of identified black spots was on the NH-07 and the study area lies between Dhaulakuan to Kyarda having a length of 9 km in plain area and having an average width of flexible pavement is 10m with paved shoulders. In the project area police authorities and P.W.D. department has already identified 4 nos. blackspots as shown in Fig,1

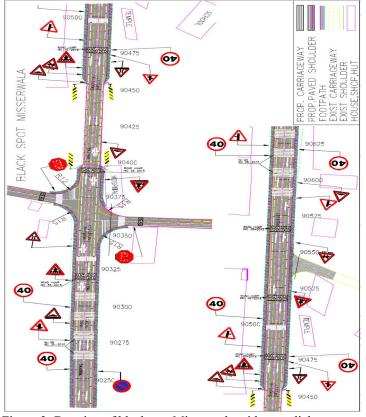
Figure 3: Drawing of blackspot Misserwala with remedial measures

After analyzing and evaluating the entire data it was concluded that *Misserwala* had high WASI value i.e., 3.25 hence it was more prone to road accidents and major reasons for accidents on blackspots were poor visibility, unclear intersections, carelessness of driver, over speeding, narrow bridge, absence of pedestrian path, absence of crash barriers, lack of road markings, sign boards and zebra crossing and so proper remedial measures from IRC codes and MORTH were suggested and implemented to reduce the road accidents.

- 14) Advisory speed limits at sharp bends and provide regular speed limits.
- 15) Provide the guard rails.
- 16) Widening of lane and providing overtaking lanes which can improve traffic flow.
- 17) Footpath can also be provided at the bridge.
- 18) We can provide RCC crash barriers (M40) for all bridges in Highway to safeguard against errant vehicles. (IRC: 21 2000).
- 19) We can also install speed detecting devices.
