Infrastructure Planning for TOD Zone of Chikkabanawara of Sub-urban Station, Bengaluru

Mudavath Meghanath¹, Dr. Muhammad Danish²

¹MURP 4th Sem, Department of Architecture and Planning, NIT Patna.

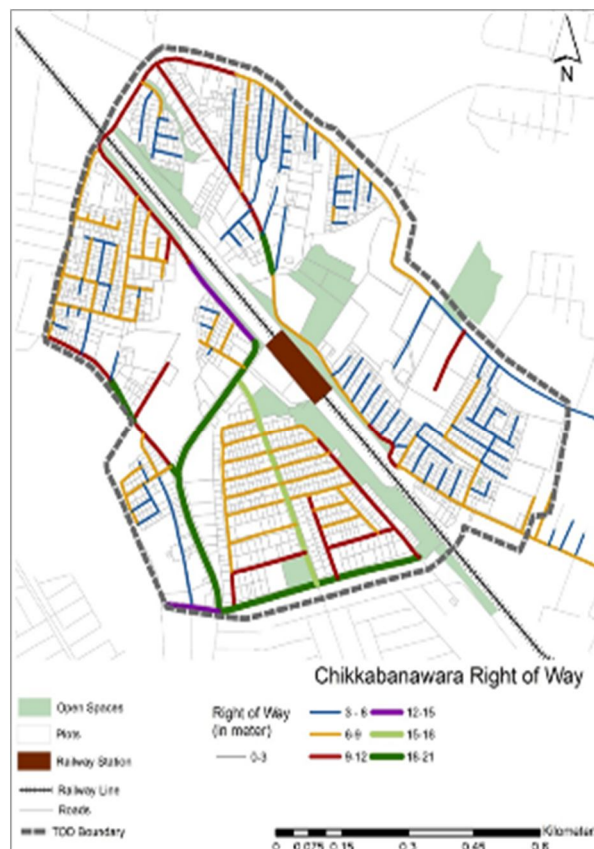
Figure 3: Chikkabanawara Right of Way map

The total length of the road network is 17.8km. The main roads have ROW in the range of 9-21m. The smaller ROWs of 3-6m width are majorly observed on the Northern side of the railway line. From the audit, it is evident that, around 33% of the total road network have ROW in the range of 6-9m.

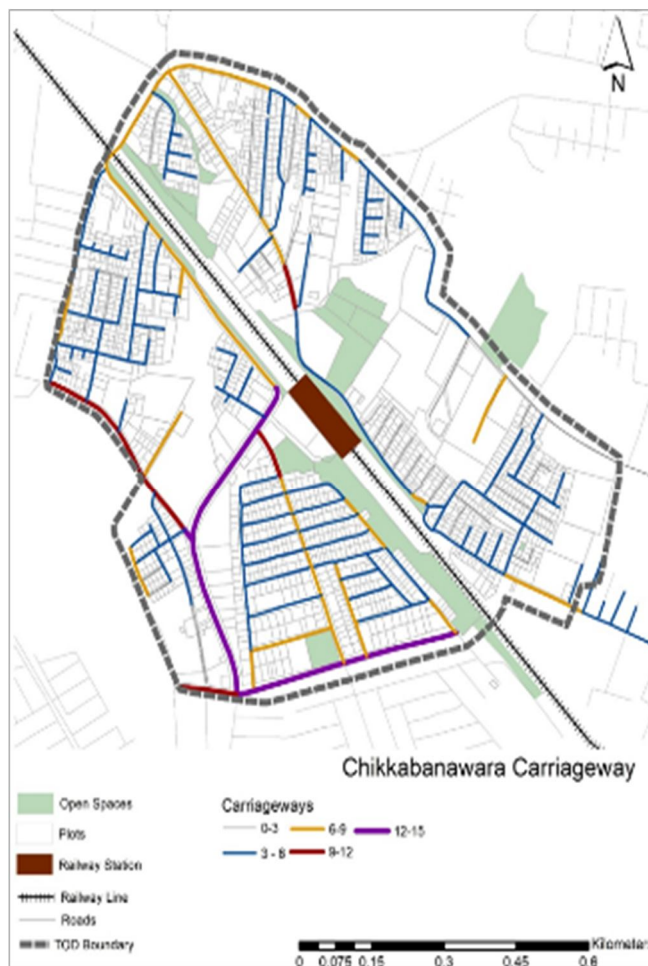
Figure 6: Chikkabanawara Carriageway Map

The total road network length is 17.8km. Out of which, 62% of the roads have carriage ways in the range of 3-6m, which coincides with the ROW of 6-9m. Distinct hierarchy of streets can be observed with respect to road widths.

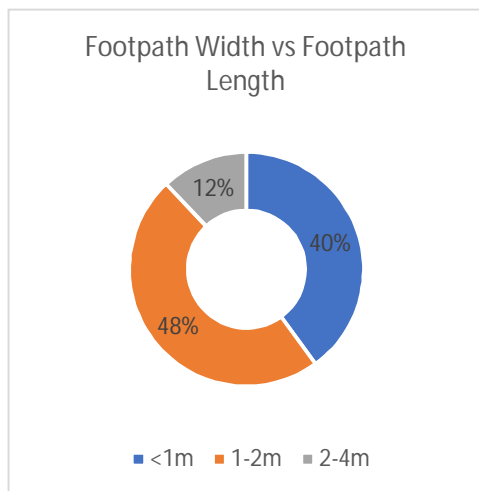
Widths 17% of the total roads have footpaths, which is about 6.09km. 48% of the footpaths have widths in the range of 1-2m. It is majorly seen on the main roads, while the internal roads lacked the presence of footpath.

Figure 9:Footpath Width vs Footpath Length
Source: Author

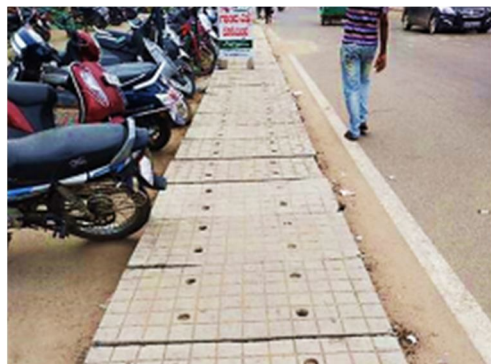
Figure 10:Drain covering as <1m footpath
Source: Author

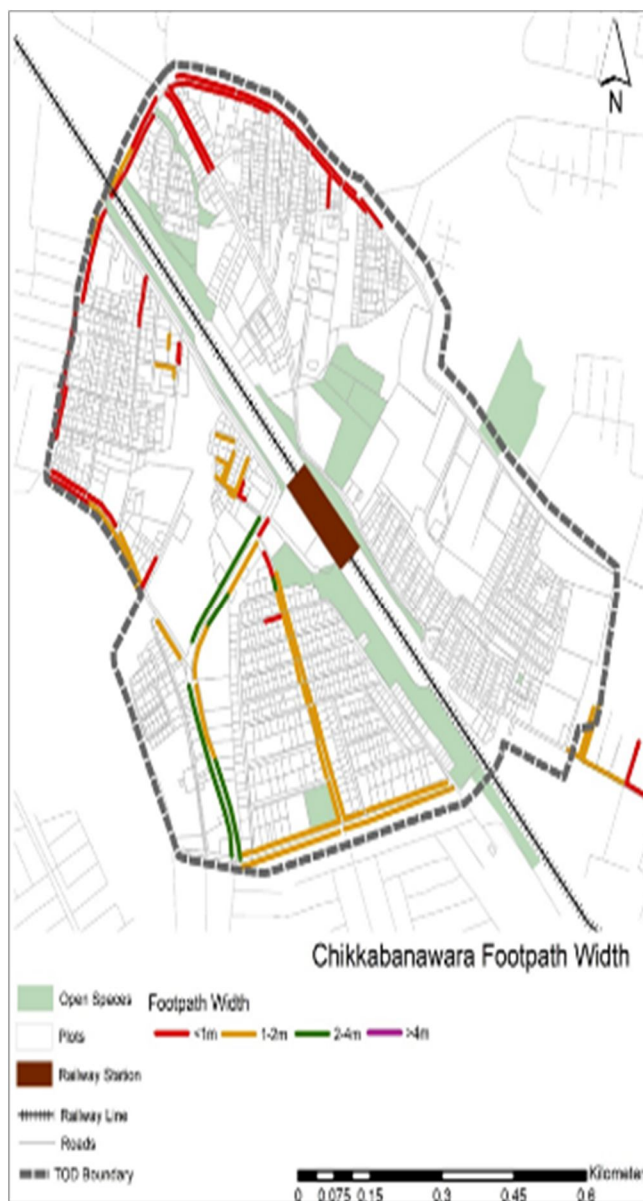
Figure 11:Chikkabanawara Footpath Width map
Source: Author

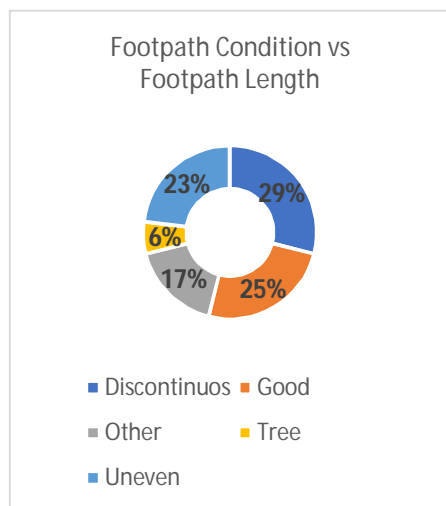
The total length of good and useable footpath is 1.47km, out of 6.09 km total footpath length. 29% of the footpath length is discontinuous due to breaks for entry/exit of residential and commercial establishments. It is observed that majority of the footpaths along the main roads have uneven surfaces.

Figure 12: Footpath condition vs Length
Source: Author

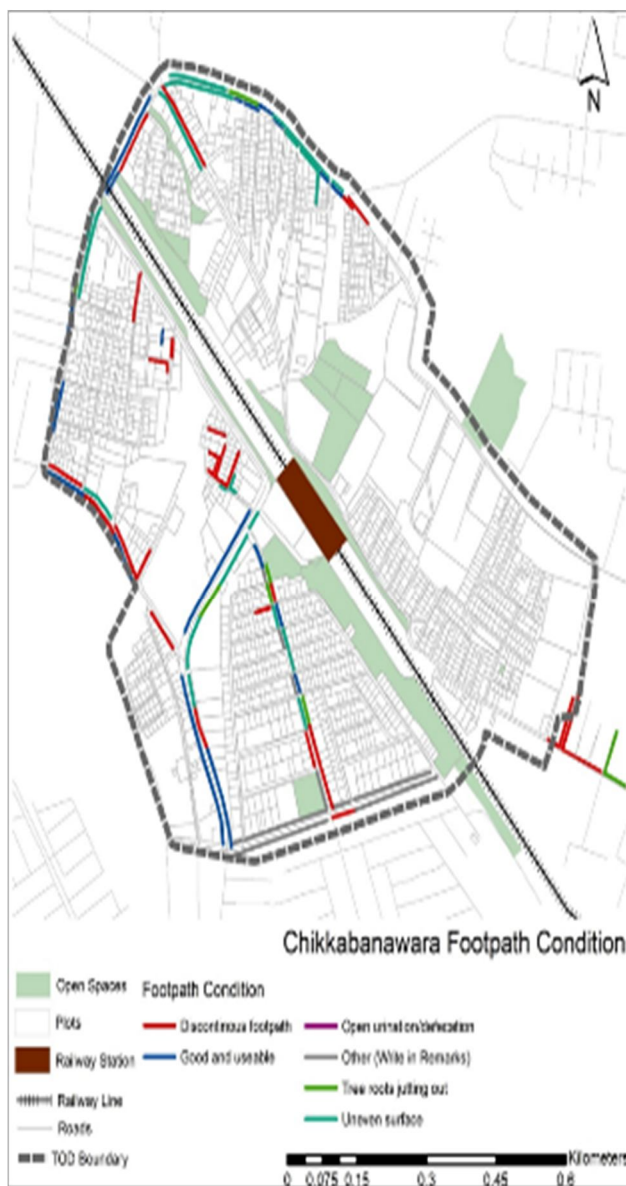
Figure 14: Chikkabanawara Footpath Condition map
Source: Author

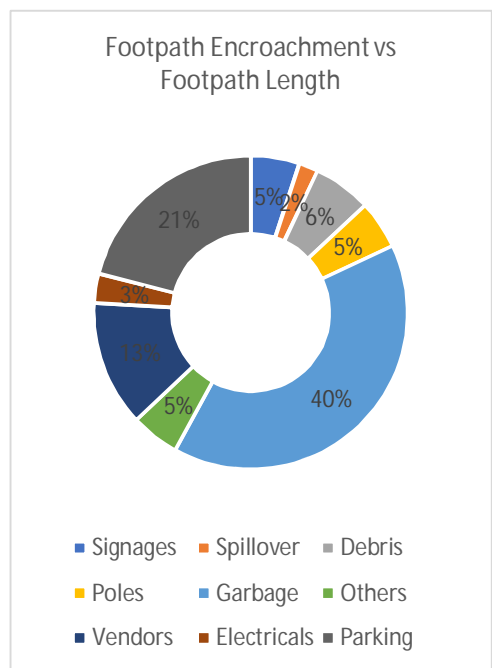
The total length of footpath encroachment is 1.21km, which is 25% of the total footpath length. Vehicular parking constitutes to 40% of the total footpath encroachment. A majority of the encroachments are on the Southern side of the Railway line.

Figure 16:Footpath Encroachment vs Length
Source: Author

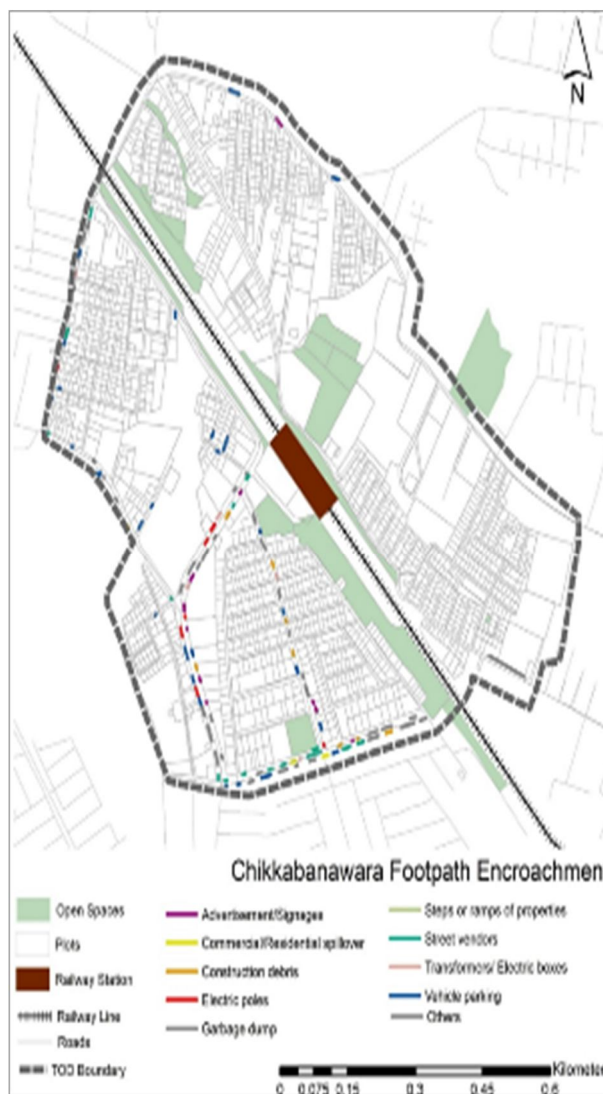
Figure 17: Chikkabanawara Footpath Encroachment map
Source: Author

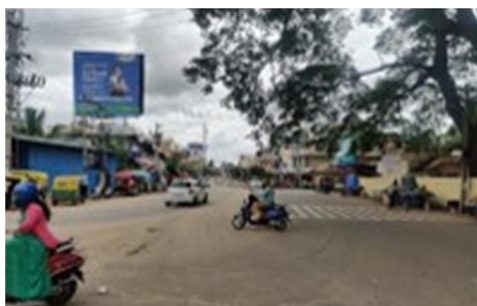
All the junctions are unsafe for pedestrians due to poor pedestrian crossing facilities. The zebra crossing in Sathabeedi junction is interrupted by the median. The foot over bridge present inside the Railway station is a connectivity between the southern and northern side of the railway line.

Figure 23: Santhe beedi discontinuous zebra crossing

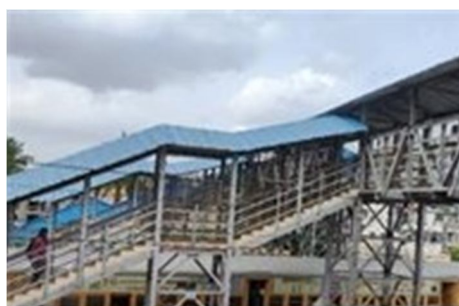
Figure 22: Foot over bridge in railway junction

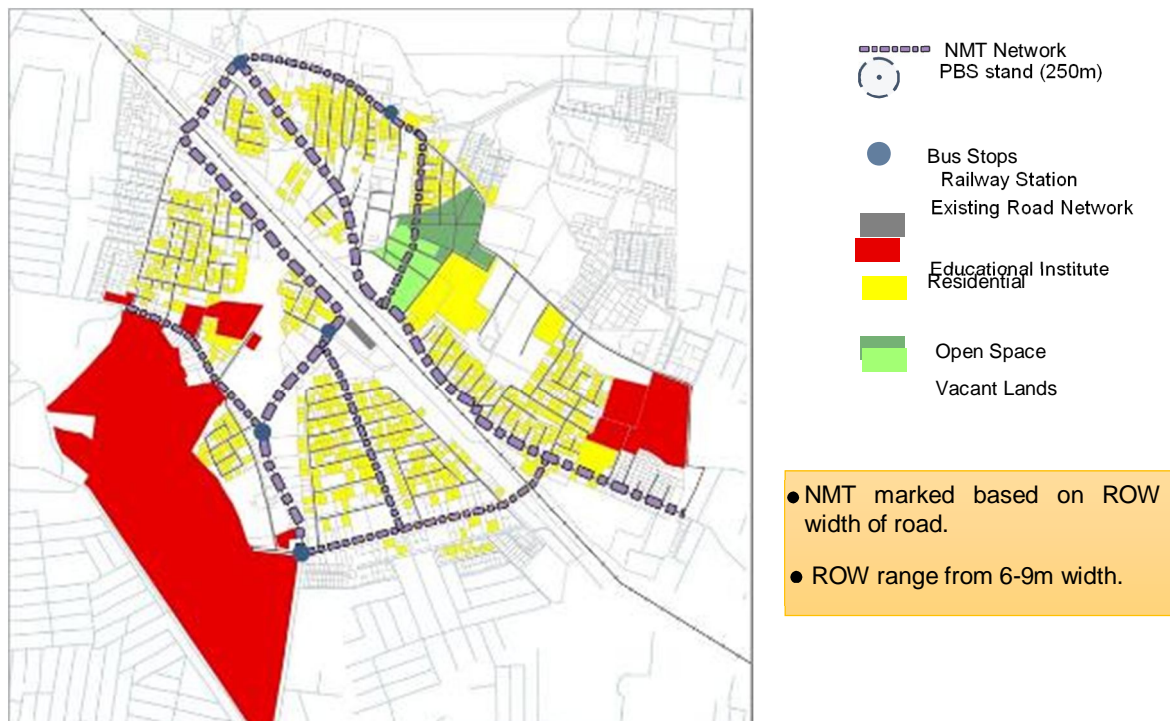
Figure 27: NMT network is proposed to connect the PT stops, residential areas and educational institutions with the sub-urban station.

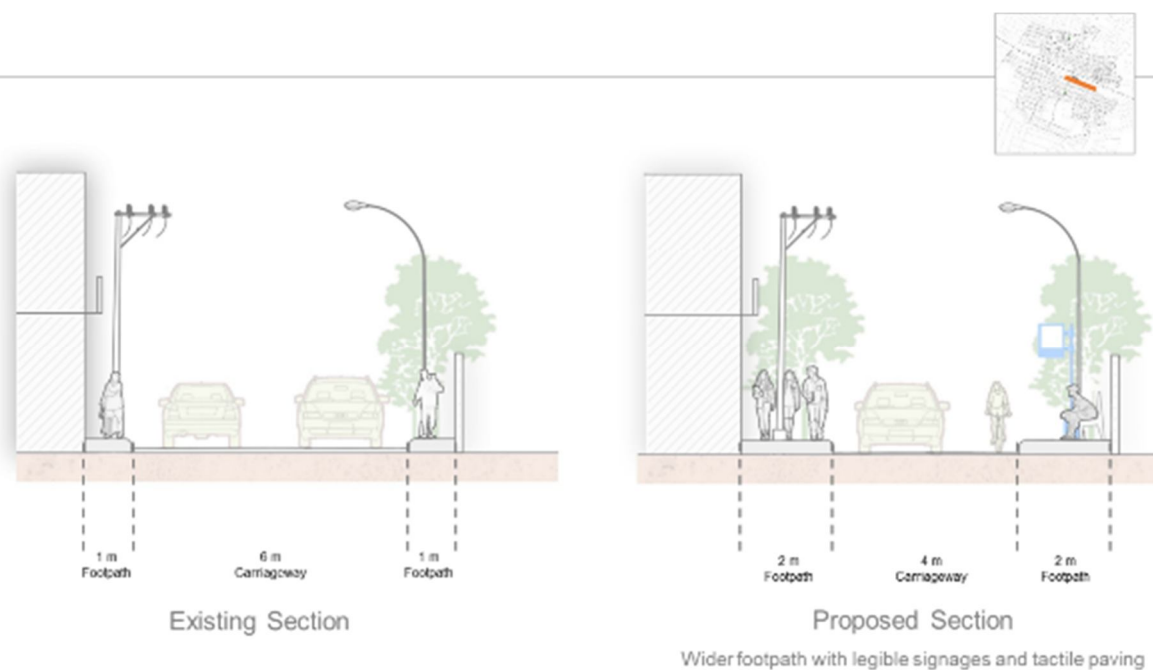
Figure 28: Cross section of Hesaraghatta Main Road near Sapthagiri Junction.

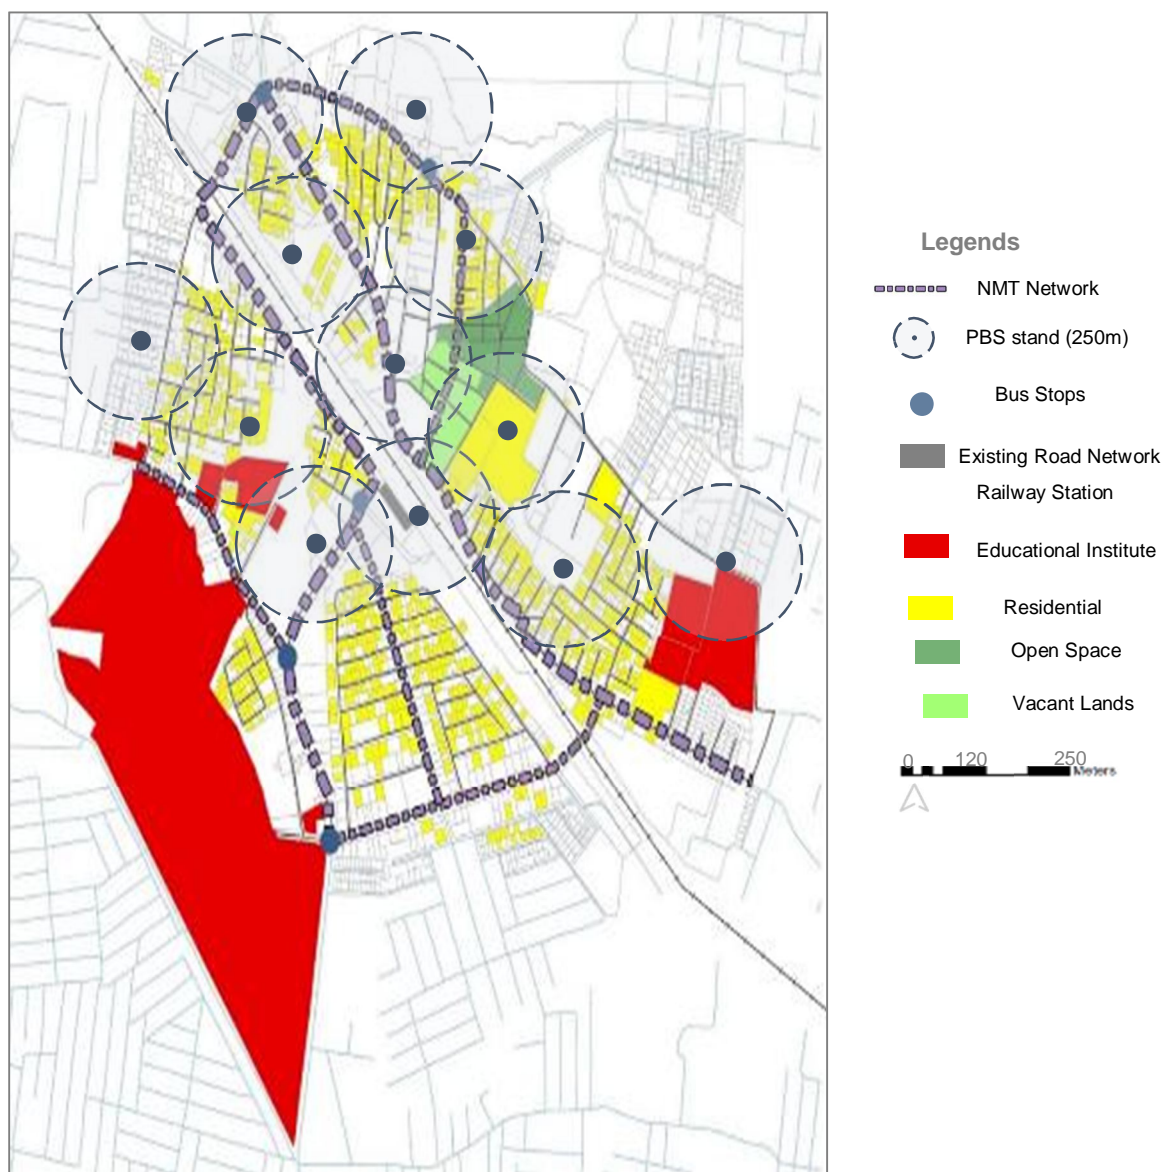
Figure 29:Chikkabanawara – Proposed NMT Network.

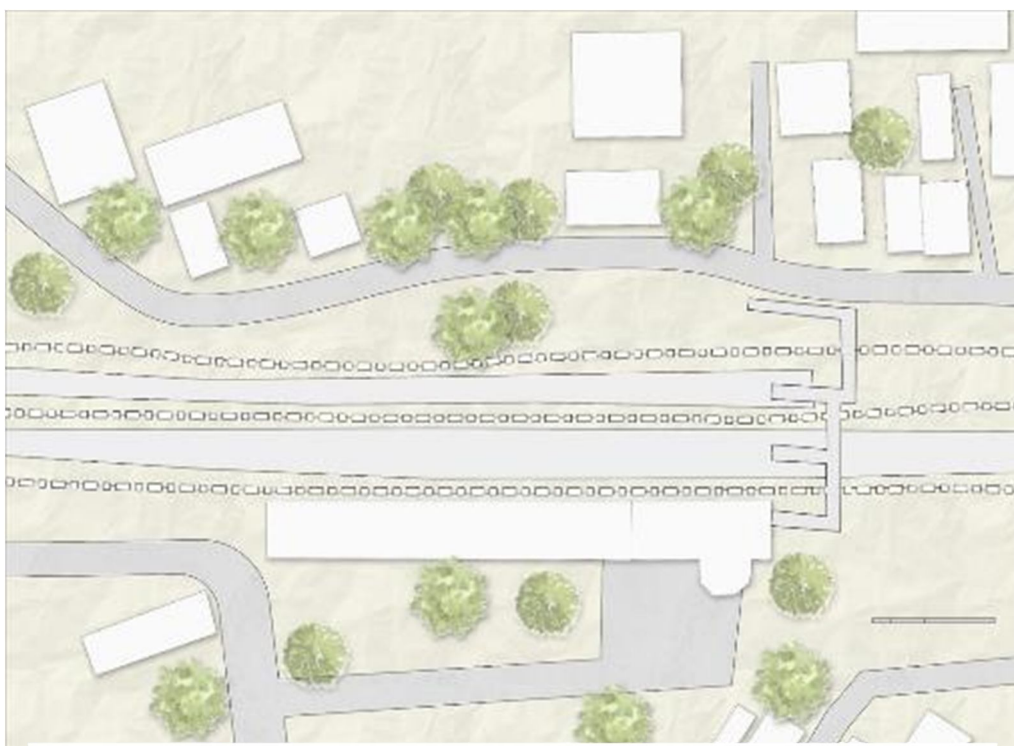
Figure 31:Chikkabanawara – Station Road Design (Existing Plan).

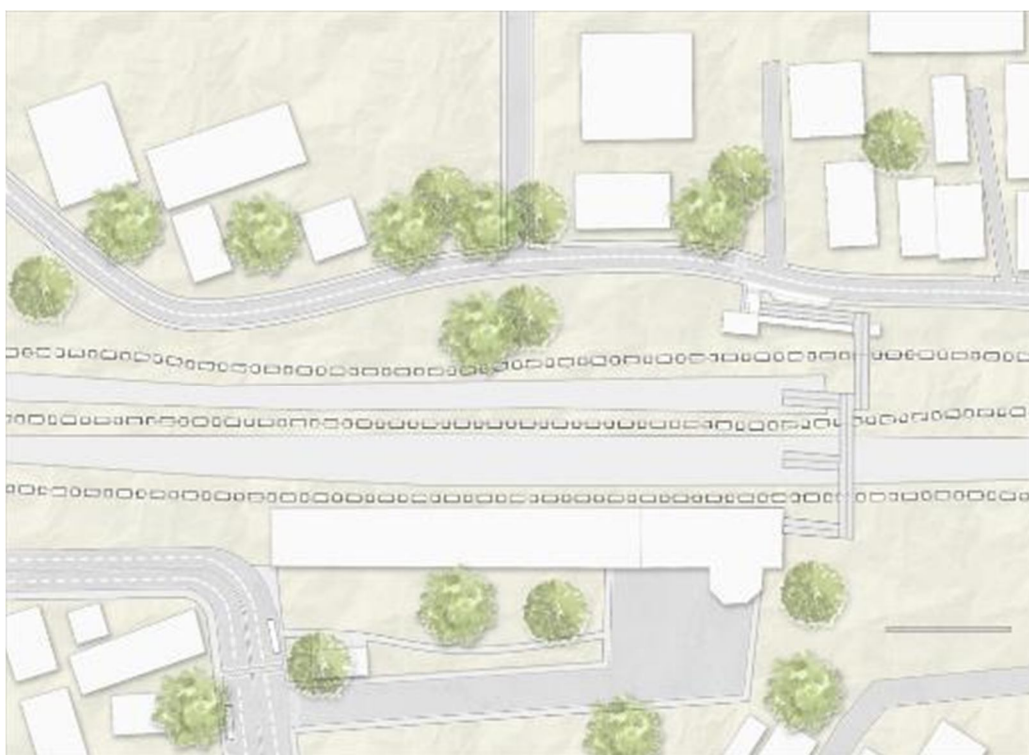
Figure 30:Chikkabanawara – Station Road Design (Proposed Plan).

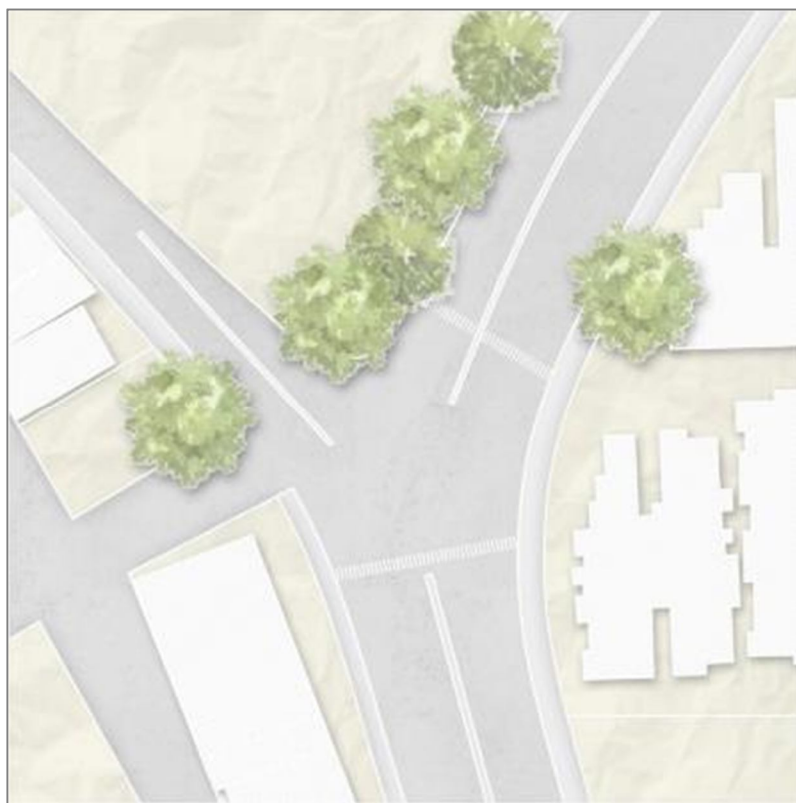
Figure 32: Existing Condition of Janapriya Junction.

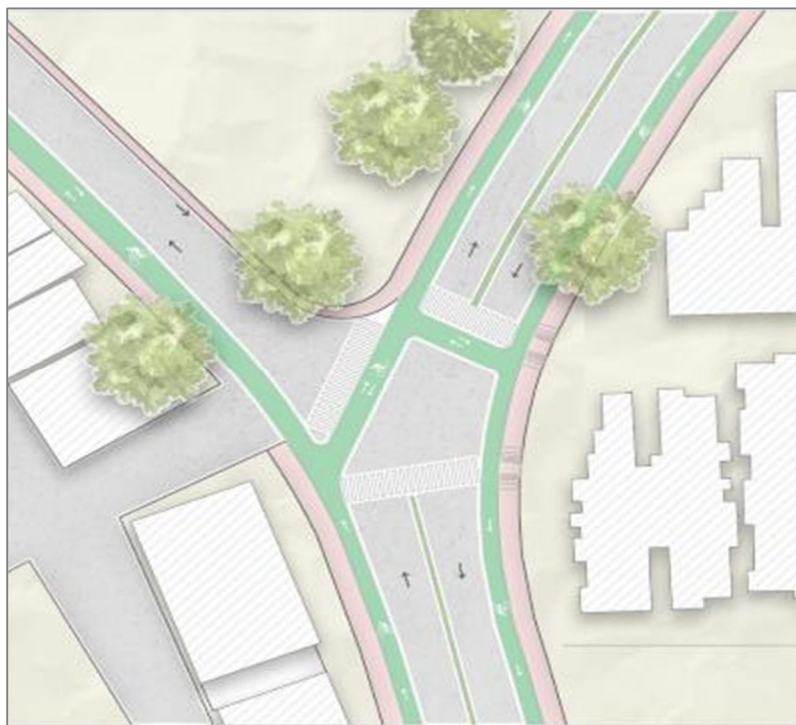
Figure 33: Proposed Janapriya Junction.
