Infrastructure Planning for TOD Zone of Chikkabanawara of Sub-urban Station, Bengaluru

Mudavath Meghanath¹, Dr. Muhammad Danish²

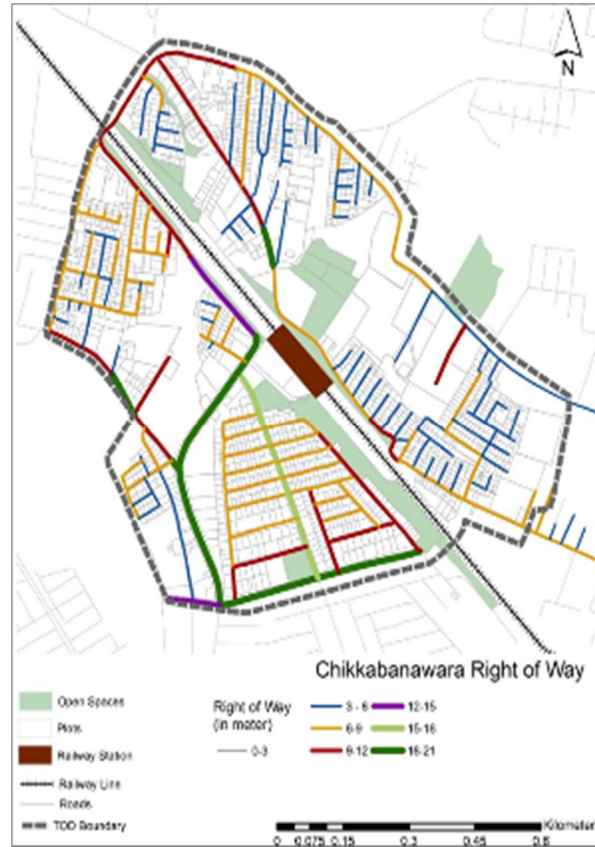
The total length of the road network is 17.8km. The main roads have ROW in the range of 9-21m. The smaller ROWs of 3-6m width are majorly observed on the Northern side of the railway line. From the audit, it is evident that, around 33% of the total road network have ROW in the range of 6-9m.

Figure 3: Chikkabanawara Right of Way map

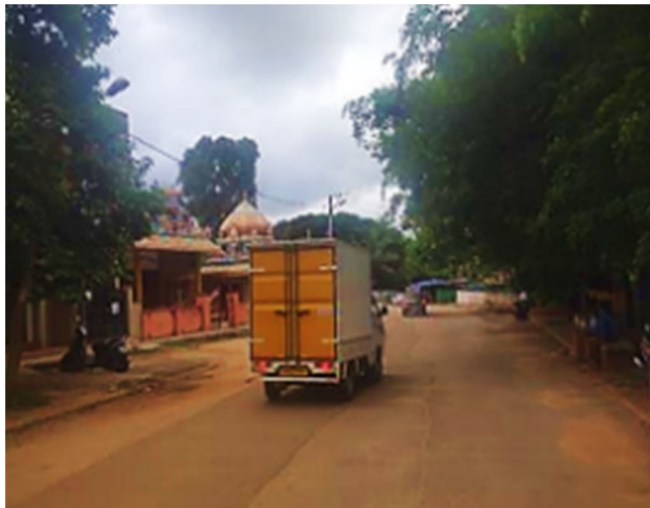
Figure 4: varying Right of Way width along the network

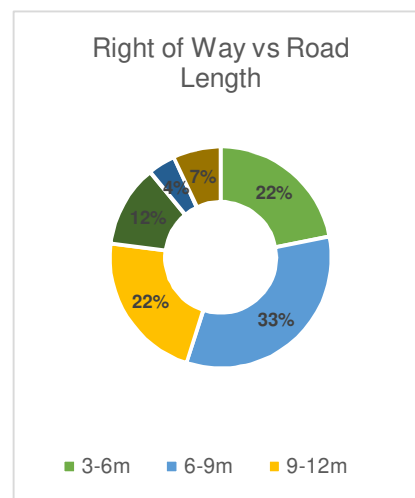
Figure 5: Right of Way width vs Road Length

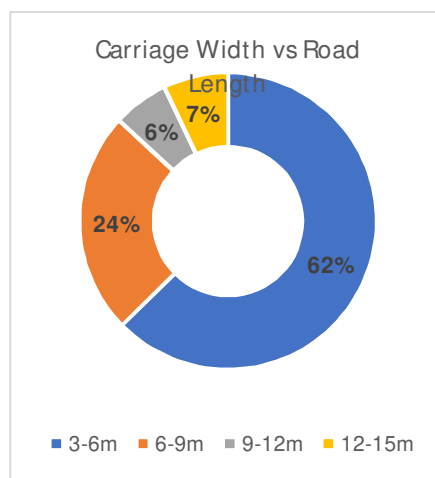
Figure 7: Carriageway Width vs Road length
Source: Author

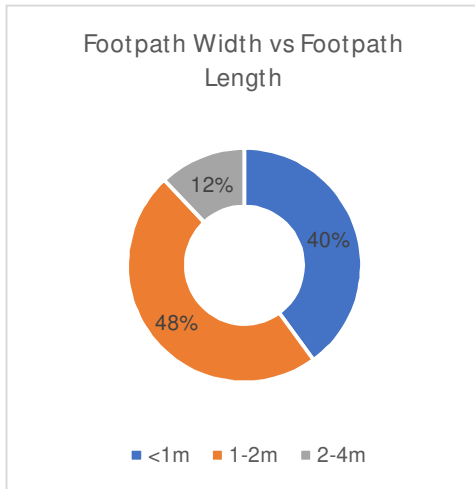
Widths 17% of the total roads have footpaths, which is about 6.09km. 48% of the footpaths have widths in the range of 1-2m. It is majorly seen on the main roads, while the internal roads lacked the presence of footpath.

Figure 9:Footpath Width vs Footpath Length
Source: Author

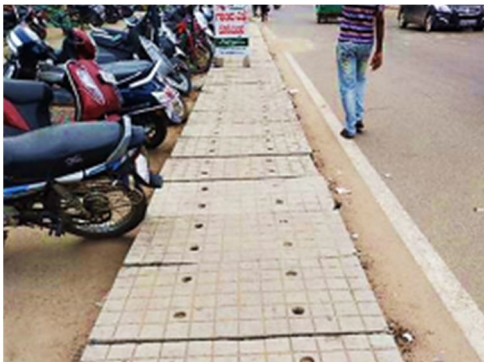
Figure 10:Drain covering as <1m footpath
Source: Author

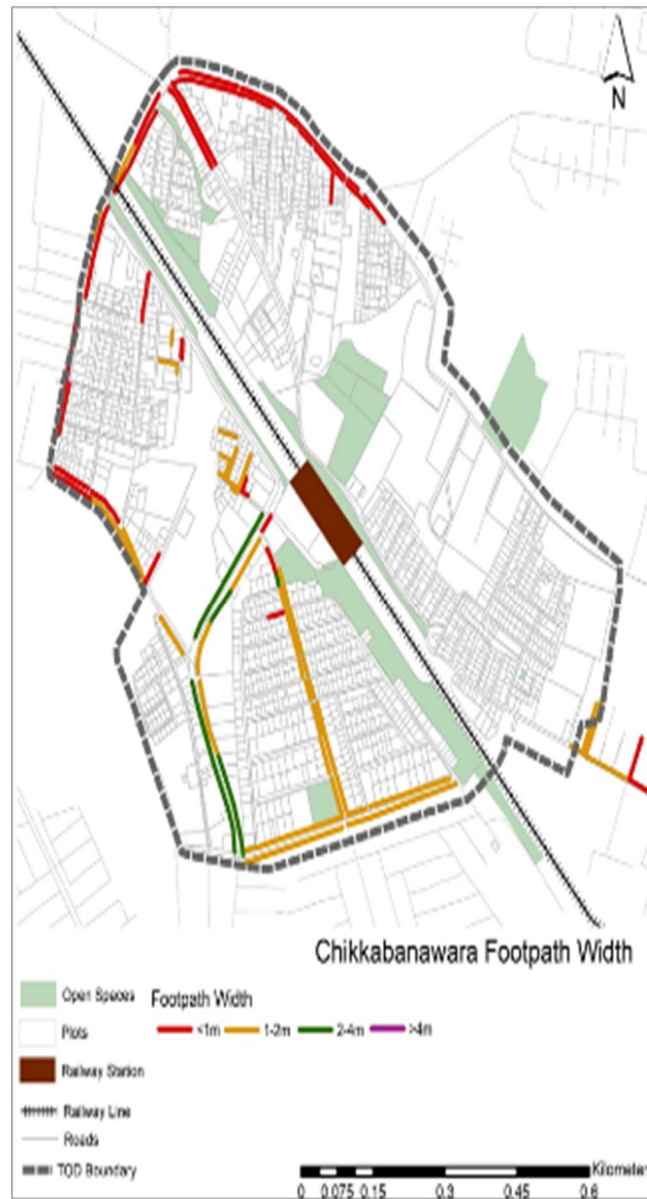
Figure 11:Chikkabanawara Footpath Width map
Source: Author

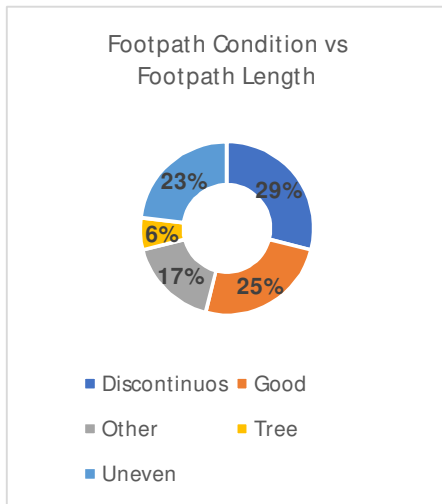
The total length of good and useable footpath is 1.47km, out of 6.09 km total footpath length. 29% of the footpath length is discontinuous due to breaks for entry/exit of residential and commercial establishments. It is observed that majority of the footpaths along the main roads have uneven surfaces.

Figure 12; Footpath condition vs Length
Source: Author

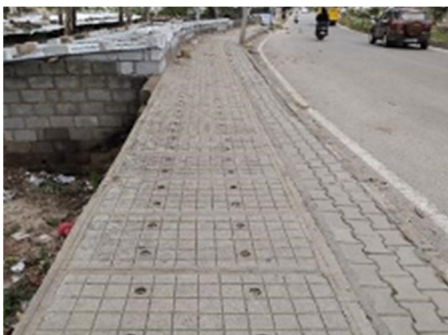
Figure 13: Good & Useable footpath Condition
Source: Author

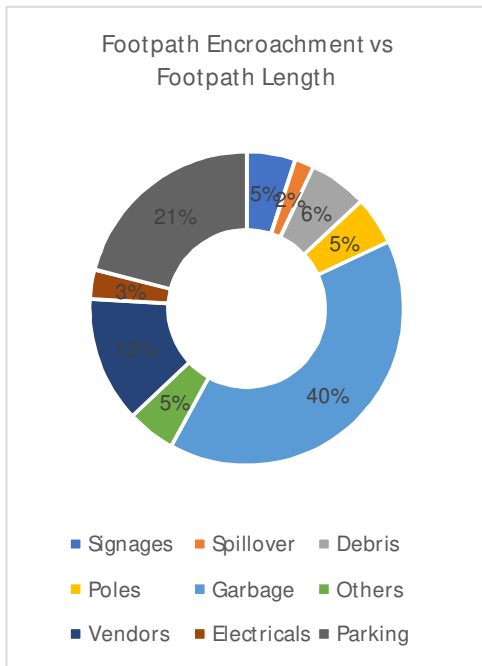
The total length of footpath encroachment is 1.21km, which is 25% of the total footpath length. Vehicular parking constitutes to 40% of the total footpath encroachment. A majority of the encroachments are on the Southern side of the Railway line.

Figure 16: Footpath Encroachment vs Length
Source: Author

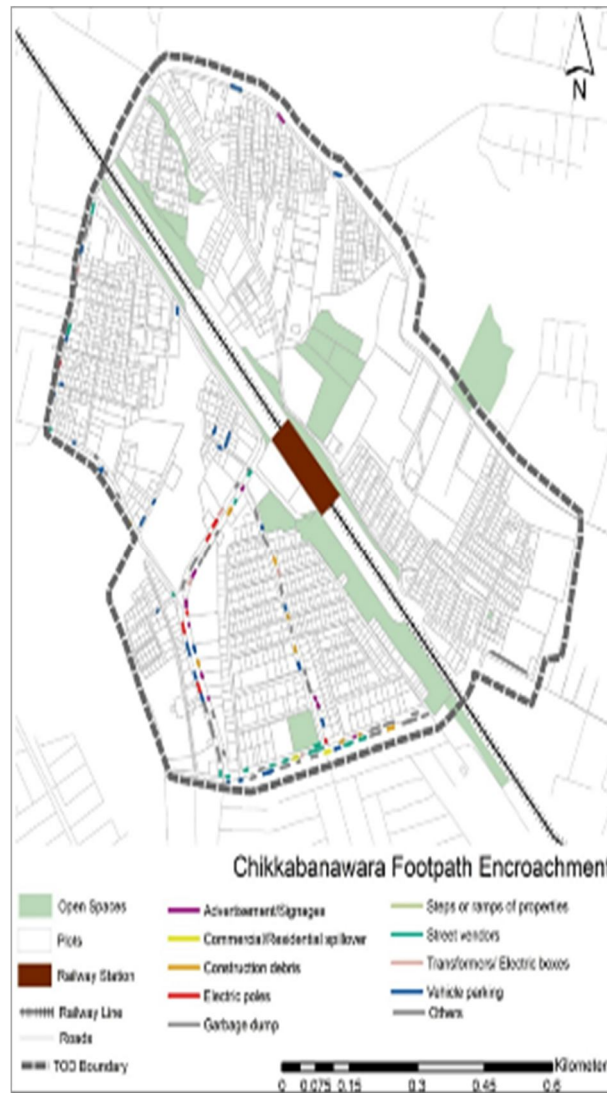
Figure 17: Chikkabanawara Footpath Encroachment map
Source: Author

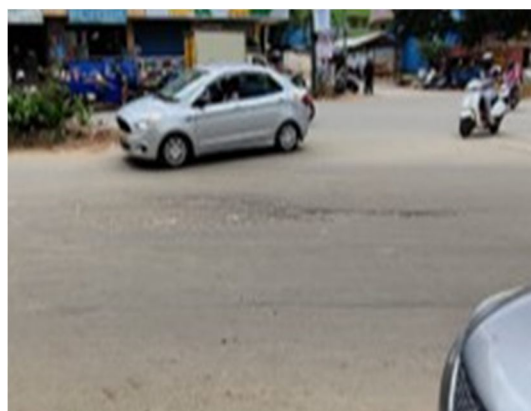
Figure 26: Incomplete Pedestrian Network

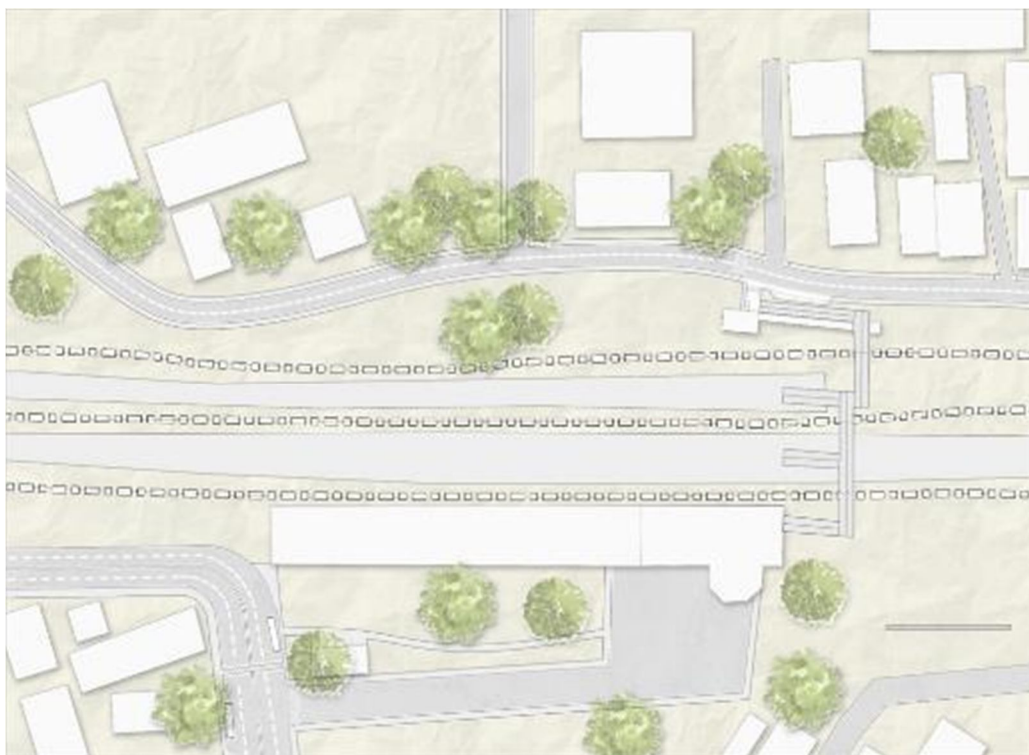
Figure 30:Chikkabanawara – Station Road Design (Proposed Plan).
