# Investigation on Effects and Properties of Concrete Structure after Exposed to Fire

Prof. S. V. Dhoke<sup>1</sup>, Akshay Chikate<sup>2</sup>, Abhijit Andhare<sup>3</sup>, Anikesh Sable<sup>4</sup>, Ashish Gabhane<sup>5</sup>, Himanshu Bhabutkar<sup>6</sup>, Yash Gandhe<sup>7</sup>

**Abstract:** *The integrity and strength of the materials used in reinforced concrete structures are highly influenced by their exposure environment. Exposing the building materials to high temperature changes their performance. The change in the performance is a result of the change in the material properties. When subjecting a building material to fire, the occurring damage depends on the severity of the fire in terms of the fire temperature and time of exposure.*

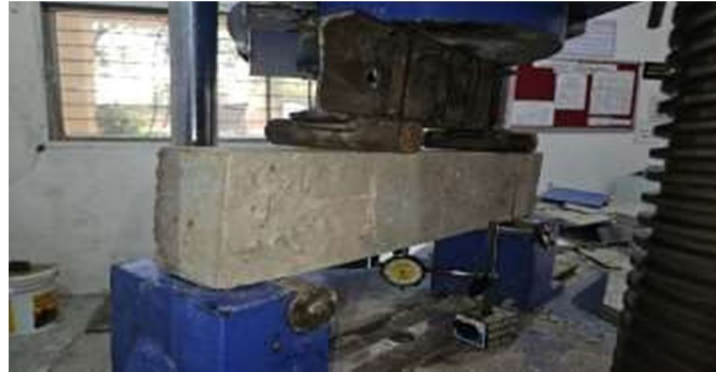
Apply Load On (RS2)

3) *Apply Load On (RS2)*

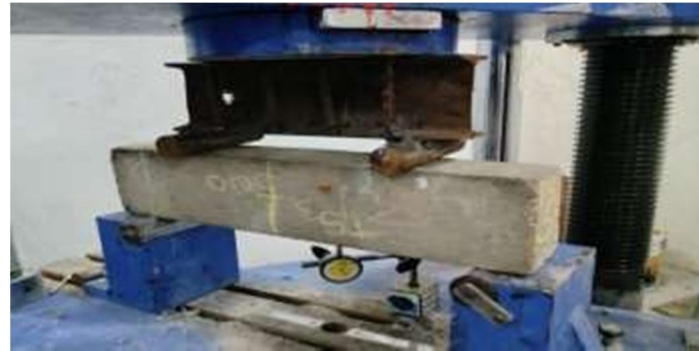
Apply Load On (RS3)

4) *Apply Load On (RS3)*

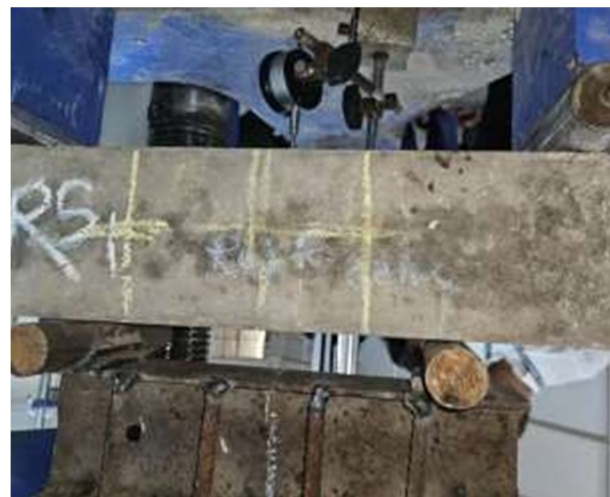
4.1.1 Reference Specimen one

Reference Specimen One (RS1)

This Reference specimen is use as reference point of view. This Reference specimen compare with the fired beam. Remaining beam are fire provided is different by using muffle Furnace after the testing of that beam all results compare RS1.
